DAS35

Tow truck frame made of high strength steel under cyclic loading

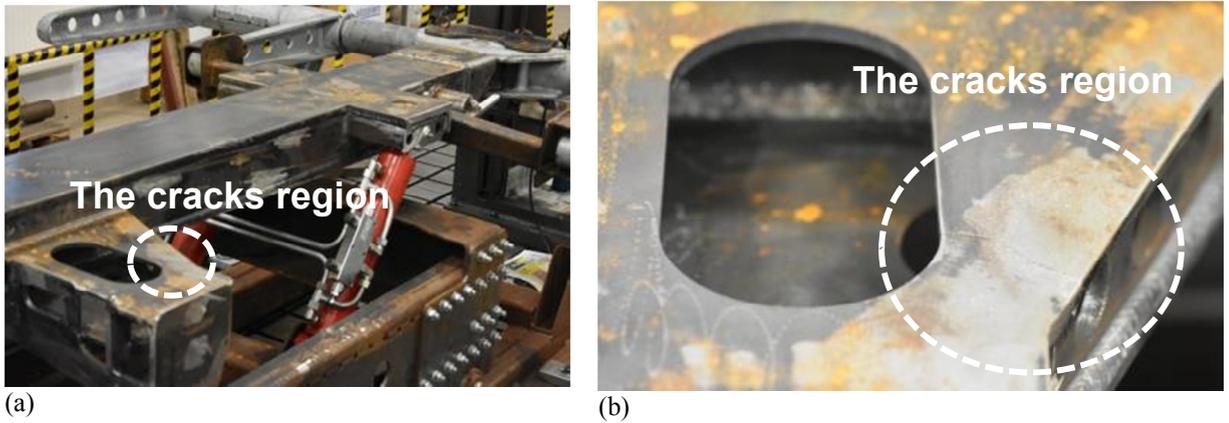
The experiment was carried out up to the frame fracture that has taken place after 573 000 cycles. The crack developed along two paths in the upper and lower parts of the arm, Fig. 5. This was observed in the section between the hole and the edge of arm, Fig. 5b. The crack path had non-linear shape throwing the upper beam of the arm, Fig. 6. The lower region of the beam indicated on significant role the Heat Affected Zone for the crack nucleation, Fig. 7. The fatigue traces were located close to the outer section of the upper beam of the arm with various sizes, Fig. 7b. The zone containing traces was vanishing with material fracture development, Fig. 7c. A fracture zone was

Fig. 5. Localisation of the cracks in the high strength frame: (a) general view; (b) side view on the arm and crack

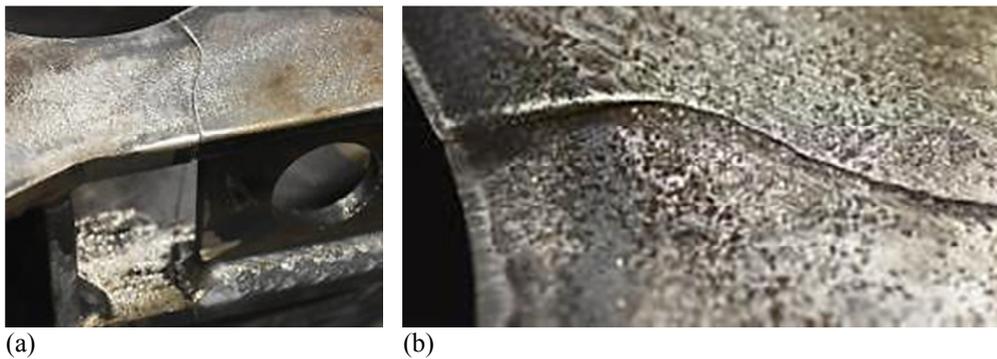
Fig. 6. Visualization of the crack in the frame's arm (a) general view; (b) magnified view of the upper part.

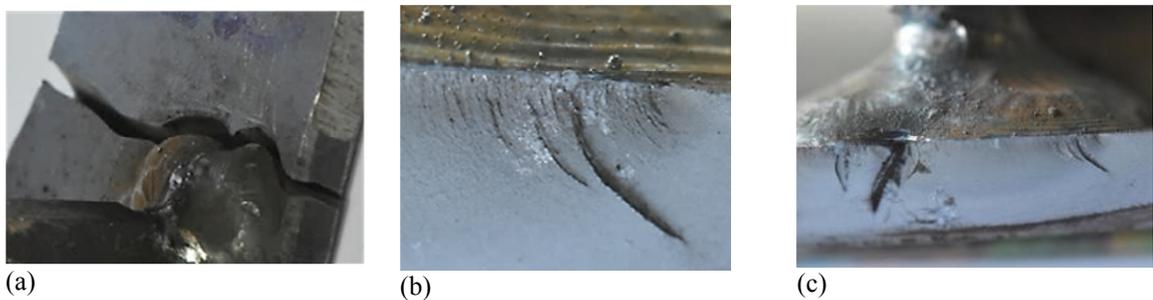
represented by a plane oriented at different angles, which expressed variations of stress state components. This was also reflected by the significant crack located in the middle of the beam.

Fig. 7. Visualization of the crack in the upper beam: (a) general view; (b) fatigue traces; (c) the major crack.

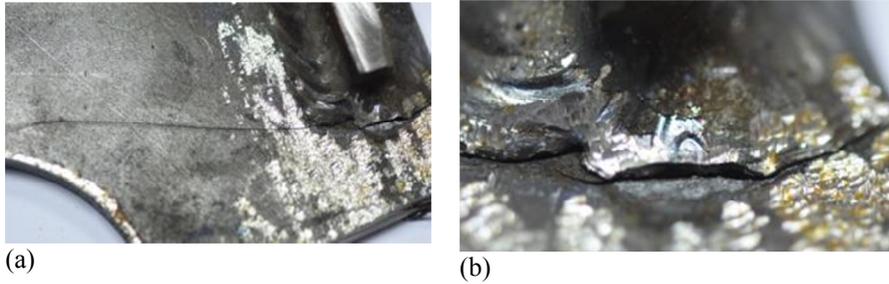
The fracture zone of the lower beam of the arm exhibited similar reason of the crack occurrence, but in this case the crack did not reach the opposite edge of the beam, Fig. 8. This was related to lower values of stress state components than in the case of the upper beam. This feature was connected with the kinematics of the tested object under cyclic loading. Nevertheless, this fact did not allow to explain the cracks occurrence. In order to get better

Fig. 8. Visualization of the crack in the lower beam

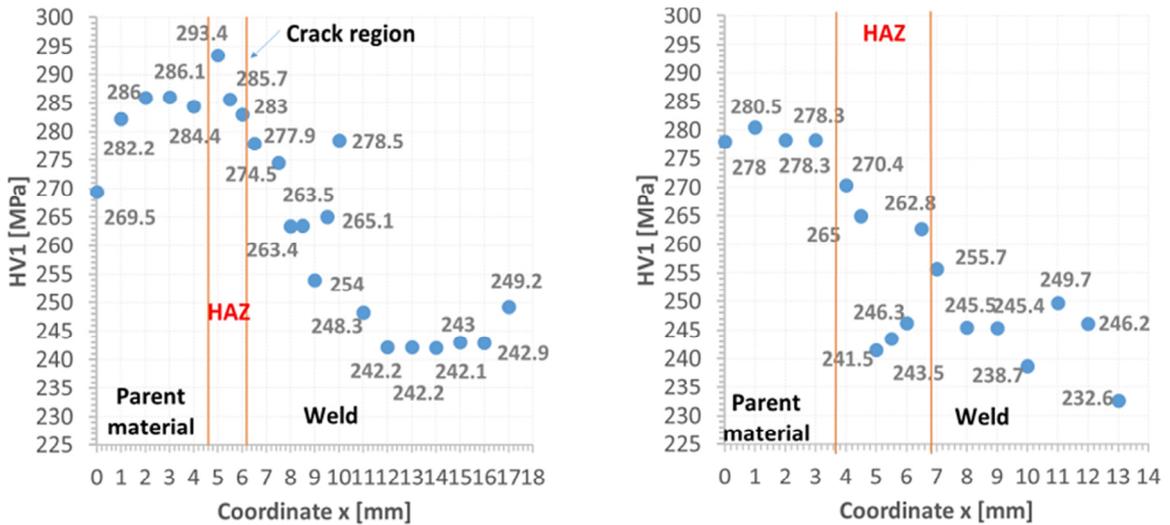
Fig. 9. HV distribution for directions of measurements: (a) No.I, (b) No. II.

On the fracture plane the hardness of the parent material was equal to 285 MPa. It was larger of around 40 MPa than that in the weld section measured. It should be taken into account, that the soft zone was not identified, Fig. 9. These features were examined for both measuring directions throwing the fracture zone (Fig. 9a) and a region without the crack (Fig. 9b). The hardness values of the HAZ with the crack were 15 MPa higher (Fig. 9a) than in the case of the similar region outside the main fracture zone (Fig. 9b). Moreover, differences between the HAZ width were clearly evidenced. In the case of region with the crack (Fig. 9a) the HAZ zone was 3 times smaller.

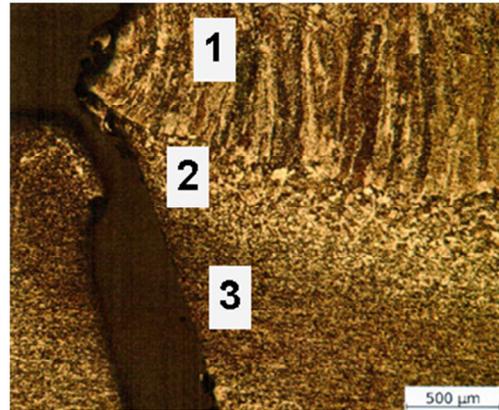
Fig. 11. The crack zone at magnification of 25×; 1- weld ; 2- HAZ; 3 – normalized area

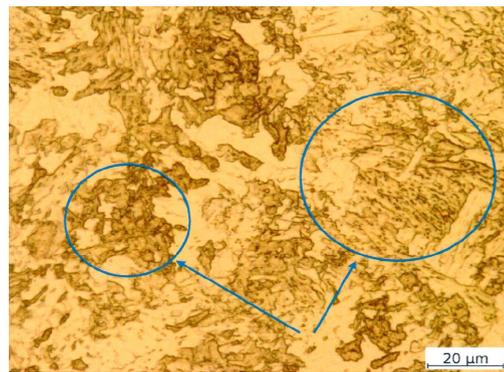
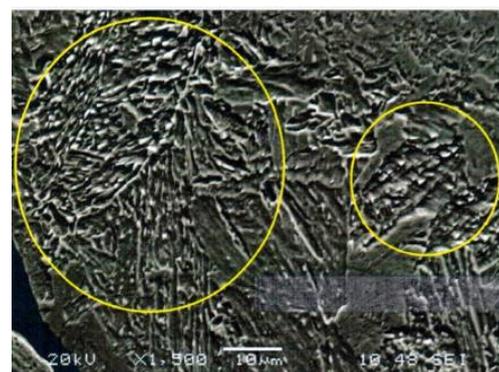
Microscopic observations expressed various microstructure features, Figs. 10-12. In the case of parent material a ferritic/bainitic microstructures was evidenced, Fig. 11. In the HAZ a higher content of sintered carbides can be observed in comparison to the parent material. This was evidenced by SEM analysis at magnification of 1500 \times . It also revealed their irregular distribution, Fig. 12.

Fig. 12. The HAZ from microscopic observations: (a) LM 500×; (b) SEM 1500×.
