Fatigue of structural components for special vehicles

Tadeusz Szymczak^{1, a}, Adam Brodecki^{2, b}, Zbigniew L. Kowalewski^{2, c}

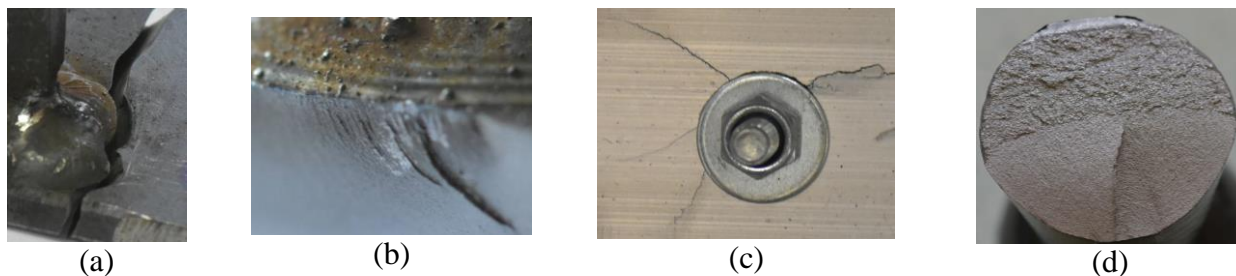
Fig. 1. Illustration of the fracture zones due to fatigue: (a) and (b) crack in HAZ section and fatigue fringes in parent material, respectively, for component made of the S700 MC steel; (c) distribution of multi-cracks in the rear beam made of the 6005 aluminium alloy; (d) A50-X coupling device
