TOW TRUCK FRAME MADE OF HIGH STRENGTH STEEL UNDER CYCLIC LOADING

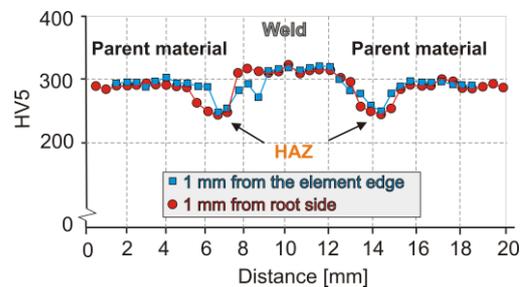
The S700 MC steel can be characterised by the attractive mechanical parameters. A good welding properties are of particular importance. For this type of steel the hardness in the heat affected zone (HAZ) should be lower than that for the parent material, Fig. 2. An importance of HAZ is related to the dominant crack appearance, i.e. the multi-axial stress state components appear in the HAZ, and as a consequence, prevent further crack propagation. Therefore, failure does not take place in the HAZ, but in the parent material or weld [2].

Fig. 2. Vickers hardness distribution for the S700 MC steel after welding, plate thickness 6 mm [2].

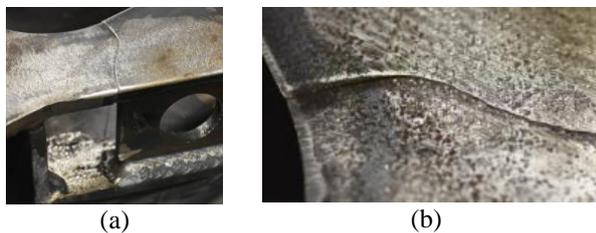
The experiment was carried out up to the frame fracture that has taken place after 573 000 cycles. The crack developed along two paths in the upper and lower parts of the arm. The fatigue fringes were well evidenced at the edge of arm close to the HAZ, Figs. 4, 5.

Fig. 4. Visualization of the crack in the frame's arm (a) general view; (b) magnified view of the upper part.

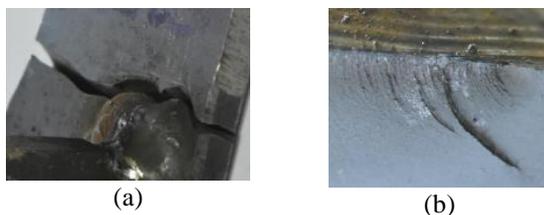
Fig. 5. Visualization of the crack in the upper beam: (a) bottom view; (b) fatigue fringes.

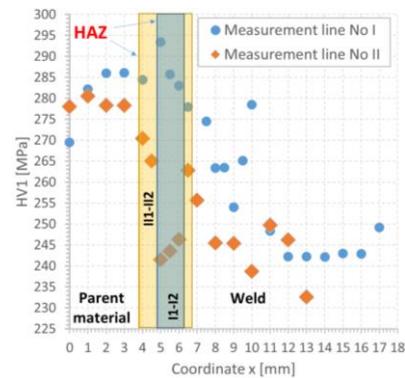
On the fracture plane the hardness of the parent material was equal to 285 MPa. It was larger of around 40 MPa than that in the weld section measured. It should be taken into account, that the soft zone was not identified, Fig. 6. Microstructural analysis of the HAZ showed a higher content of sintered carbides in comparison to the parent

Fig. 6. HV distribution in the fracture plane.

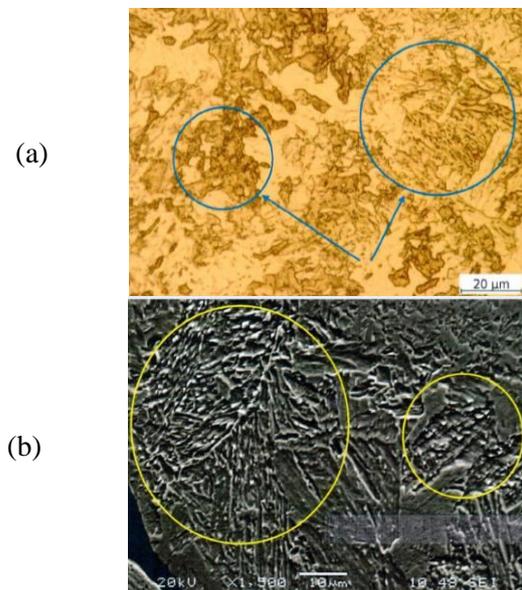
material. It also revealed their irregular distribution, Fig. 7.

Fig. 7. The HAZ from microscopic observation: (a) LM 500 \times ; (b) SEM 1500 \times
