ASSESSMENT OF MECHANICAL PROPERTIES OF THE HISTORICAL BRICKS OF BURGOS GATE IN ALCALA DE HENARES IN MADRID

Keywords: micro-core, CoDiT, minor-destructive testing, brick, Alcala de Henares

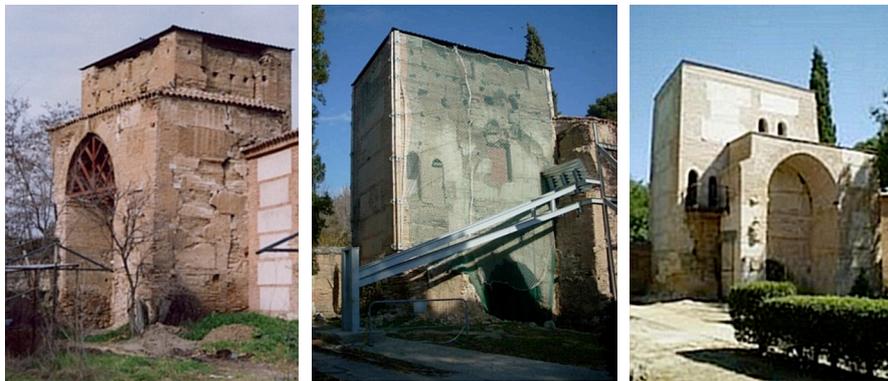
Figure 1: The Gate of Burgos, from left to right: South façade: in 2003; after the 2005's collapse; in 2012, after its restoration.

The first stretch of the fortified wall in which the Burgos wall is enclosed dates back from the 13th century, as the main entry to the Archbishop's Palace. At this stage a first cubic structure was built, a little bit higher than the wall in which it was embedded. The Gate was successively enlarged, both in surface and height, in the 14th and 15th centuries with superimposed bodies [1]. Some collapses of part of the structure occurred along the history of the Gate, the latest in 2005. This collapse probably happened because during a long period the structure was in a semi-ruined state caused by a complete lack of maintenance. The last restoration was carried out in 2011, mainly focused on its structural consolidation (Figs. 1, 2).

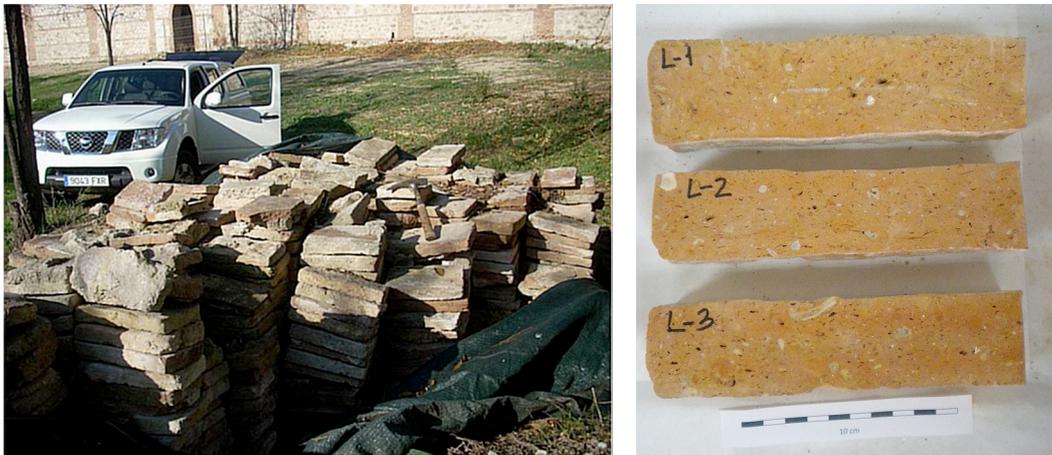
Figure 3: Stockpile of bricks from the 2005's collapse of the structure, left, and bricks sampled (right).

The average size of the bricks employed in the Gate is 273 mm long, 168 wide and 39 mm thick. Bricks from corresponding to the 3rd construction stage (15th century) available after the last collapse were sampled (Figure 3). From previous studies [3], these bricks show a real density of $2460 \text{ Kg}\cdot\text{m}^{-3}$, a bulk density of $1670 \text{ Kg}\cdot\text{m}^{-3}$, a porosity accessible to water or open porosity (n_0) of 32%, a capillarity coefficient of $6.2 \text{ Kg}\cdot\text{m}^{-2}\cdot\text{h}^{0.5}$, and a coefficient of water absorption after 48 hours of 18%.

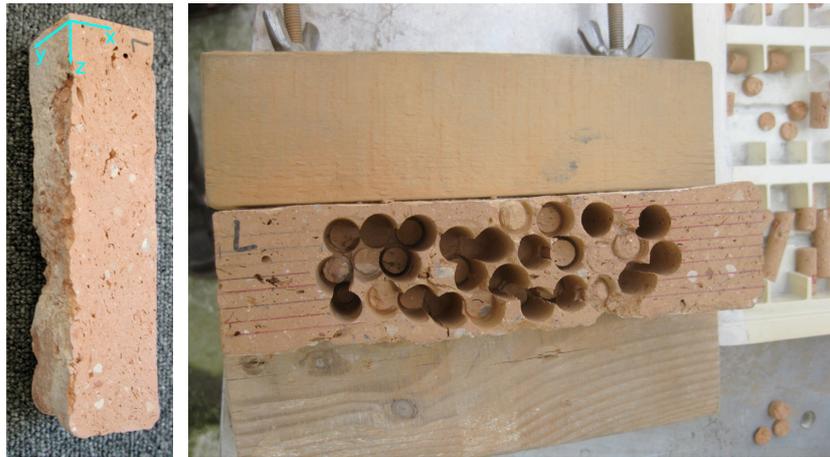
Figure 4: Sample of the brick from Puerta de Burgos with sample coordinate system (left) and drilled micro-core specimens (right).

Brick sample from Burgos Gate is shown in Fig. 4. The sample and assigned local coordinate system is shown on the left. The right image shows drilled sample surface and micro-cores. On the brick surface several lines parallel to Z-direction were drawn prior to drilling to allow further orientation of micro-core specimens with respect to the coordinate system. The orientation is necessary during FS and ITS measurements to ensure identical loading direction of each specimen.
