7th Scientific-Technical Conference Material Problems in Civil Engineering (MATBUD'2015)

Properties of the thirty years old concrete in unfinished Żarnowiec Nuclear Power Plant

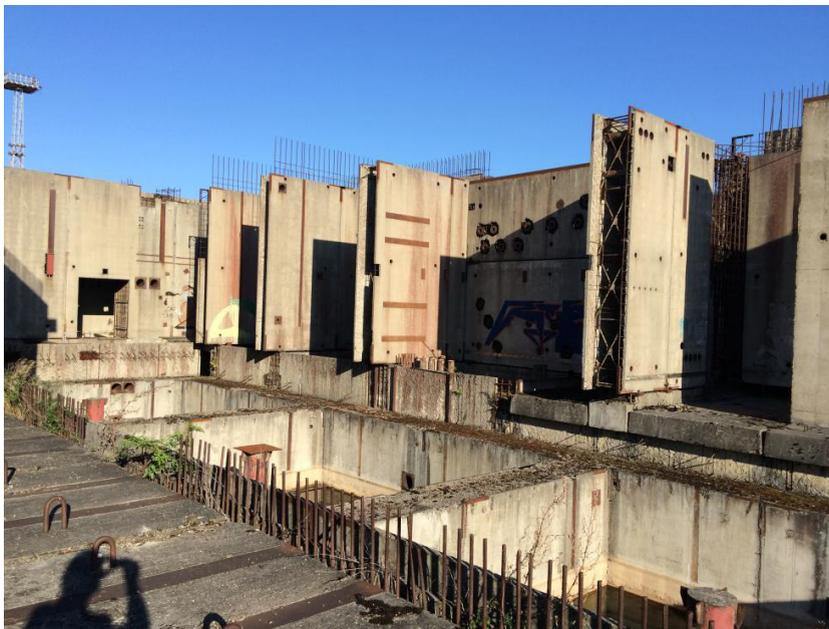
The plant was designed for pressurized water reactors of Soviet design - four reactors WWR-440 W-213 type with a total power of 1860 MW of gross electrical output (4 x 465 MW). The plant was located adjacent to Lake Żarnowieckie which was to be used for cooling. An adjacent pumped-storage hydroelectric plant was supposed to act as a load balancer and energy reservoir to ensure continued power delivery during reactor maintenance. The unfinished structures of reactor buildings, turbine buildings and many auxiliary buildings were left without any maintenance for almost 30 years until now. The remains of abandoned main building of Żarnowiec nuclear power plant are shown in Fig. 1, as seen in September 2014.

Fig. 1. The remains of abandoned concrete structures of Żarnowiec nuclear power plant.

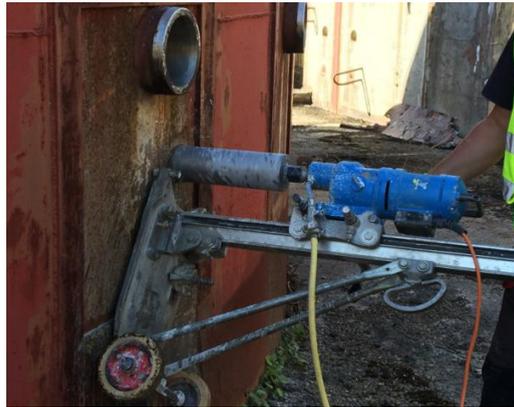
The cores specimens were taken using the electric drill with a 100 mm diamond bit, 400 mm in length (Fig. 2). The work was performed according to the safety instructions NCBJ [4], Łuszcz et al. [5]. The core location is indicated on a sketch of buildings of unfinished nuclear power plant (Fig. 3).

Fig. 2. View of specimen coring from concrete containment wall.
