# Monitoring and Numerical Analyses of the Steel Railway Arch Bridge: A Case Study

**Abstract:** The subject of research is a steel arch-tied bridge at a high-speed railway line in Poland. After the construction was completed, a resonance phenomenon was observed at the bridge, consisting of the occurrence of intense (visible to the unaided eye) undamped vibrations of some vertical hangers in the horizontal direction, transverse to the track axis. These vibrations occurred without the presence of a railway load on the bridge. Before the bridge was put into operation, an acceptance static and dynamic load test was performed, and then the bridge deck vibrations were monitored for a year. The research during dynamic loads testing included both quasi-static (10 km/h) and high-speed (200 km/h) testing train passages. The vertical displacement measurements were carried out in three cross sections of the span, and the acceleration of vibrations on girders and selected hangers was also measured. Next, an innovative system for determining displacements indirectly using inertial sensors (inclinometers and accelerometers) was used for bridge deck vibration monitoring. The primary aim of the r

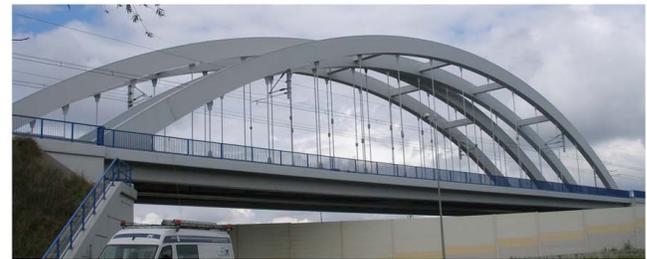
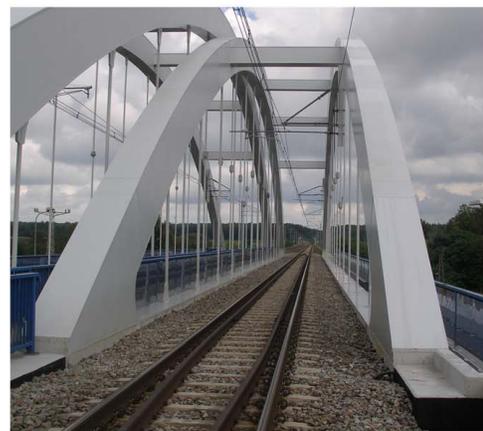
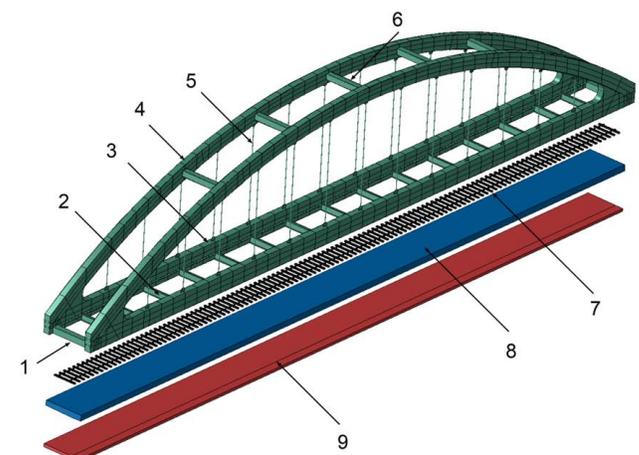
**Fig. 1.** Tested bridge: (a) side view; (b) view from the track level; and (c) modeled structural components of the bridge: 1 = box section cross beam; 2 = I section cross beam; 3 = beam girder; 4 = arch girder; 5 = hanger; 6 = lateral bracing; 7 = track; 8 = ballast; and 9 = concrete slab. (Image by Piotr Olaszek.)

The bridge consists of two separate steel arch structures, each for a single rail track. The span of both bridge structures is 75.00 m (Fig. 1). Each of the structures was designed for train speeds up to 250 km/h, and after load testing, it was approved for this speed, with the condition that additional experimental verification would be required for train speeding above 200 km/h. However, during the initial monitoring period, the maximum speed was 160 km/h, which was later increased to 200 km/h after 5 months. A general view of the components included in the numerical model for a single structure is illustrated in Fig. 1(c). The main

steel structure consists of a pair of parallel arch girders, rigidly connected using five lateral bracings and a pair of horizontal beam girders linked to each other by means of 17 cross beams. The arch and beam girders are connected using 13 evenly distributed pairs of hangers modeled by the Euler–Bernoulli beam elements. The hangers were welded to the arch and beam girders without possibly adjusting the tension force. For the numerical model purposes, the hangers' tension force values were taken from the technical documentation of the bridge. At support zones, the arch and beam girders were joined together.

Due to their complex closed box cross sections, all girders, side braces, and the two extreme transverse beams were modeled using shell elements. The model includes longitudinal and transversal internal stiffeners of the girders. The shell elements were also applied for the remaining 15 equidistant cross I-beams linking beam girders. A concrete slab was installed on the upper side of the cross beams using steel bolts. The concrete slab, analogous to the railway ballast, was modeled by hexahedral elements. The kinematic constraints couple the generalized displacements between the cross beams and the concrete slab and between the concrete slab and railway ballast.

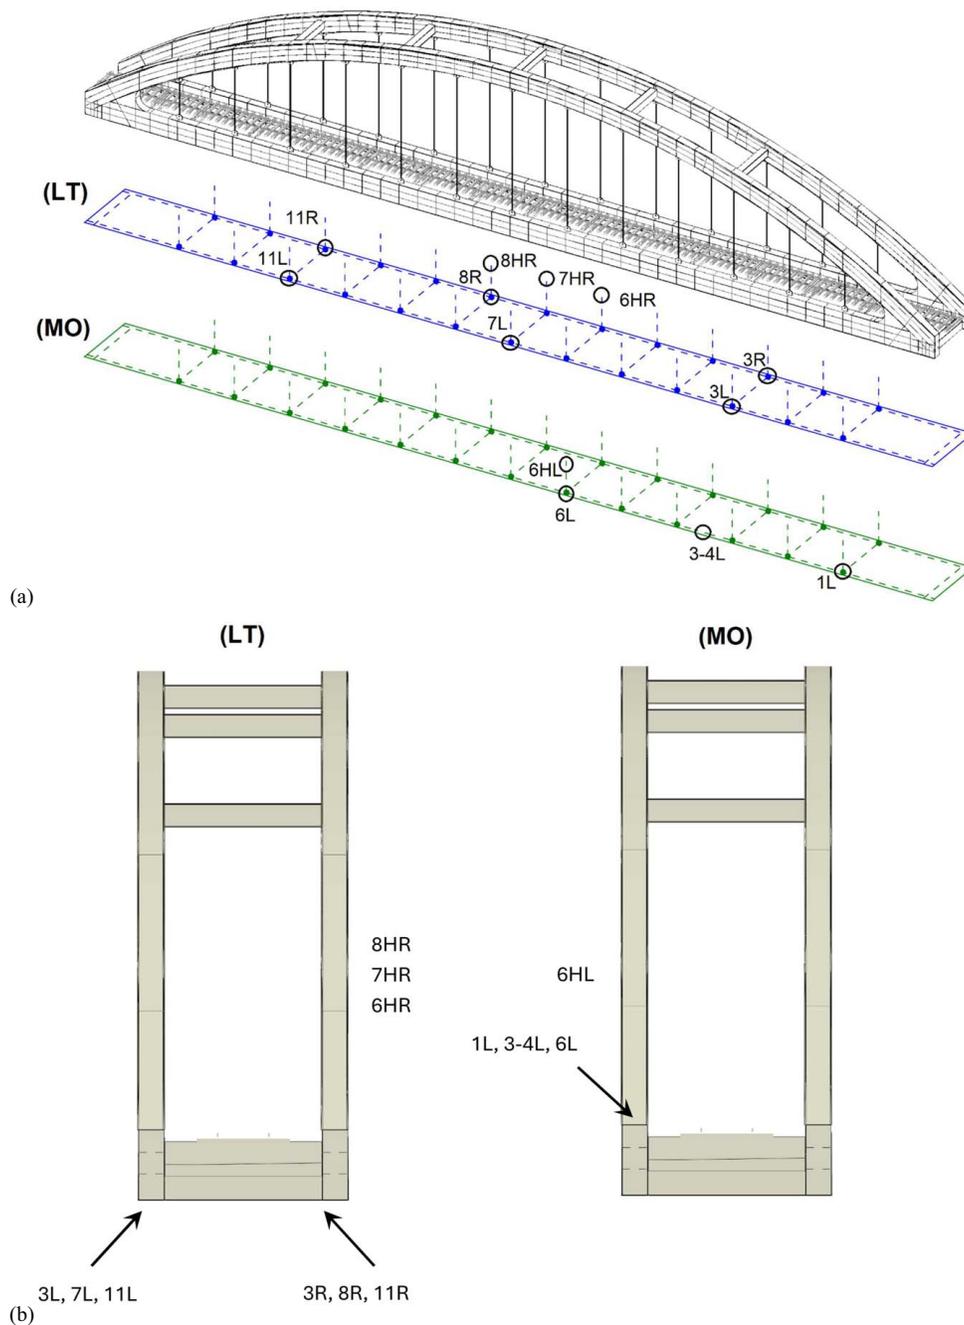
**Fig. 2.** Diagram of measuring points' location in (a) isometric; and (b) cross-sectional views. LT = load testing; 3L, 3R, 7L, 8R, 11L, and 11R = points of deck vertical displacement measurement and deck vibration acceleration measurement; 6HR, 7HR, and 8HR = points of hanger vibration acceleration measurement; MO = monitoring; 1L, 3-4L, and 6L = points of deck inclination measurement; 3-4L = point of deck vibration acceleration measurement and deck vertical displacement monitoring; 6HL = point of hanger vibration acceleration measurement. The numbering of points is consistent with the numbering of hangers; L and R stand for the left and right sides of the viaduct, respectively.

During the static and dynamic load testing, measurements of vertical displacements were taken at three cross sections of the span, located at 1/4, 1/2, and 3/4 of the span. During load testing, the highway traffic under the bridge was partly limited, which allowed the application of inductive gauges located under the bridge. Wires were attached at one end to the girder at the measurement location points and at the other end to springs fixed to the ground. Sensors (inductive gauges) were attached to the wires. During the dynamic tests, the acceleration of vibrations on girders and selected hangers was also measured. An innovative system for determining displacements indirectly using inertial sensors (inclinometers and accelerometers) was used for monitoring. Inclinometers were installed in one line on a bridge span, and an accelerometer was installed at the point of displacement examination. Signals from inclinometers were used to determine the so-called quasi-static component of the displacement, while signals from the accelerometer were used to determine the dynamic component. Details of the sensors and algorithms used for signal processing and indirect displacement determination are presented in Olaszek et al. (2020). For testing purposes, a limited number of sensors were applied. Extreme displacement values were determined and compared with numerically determined values, whereas extreme amplitudes of vibration

acceleration in specific frequency ranges were compared with permissible or numerically determined values. A diagram of the location of measurement points is presented in Fig. 2.

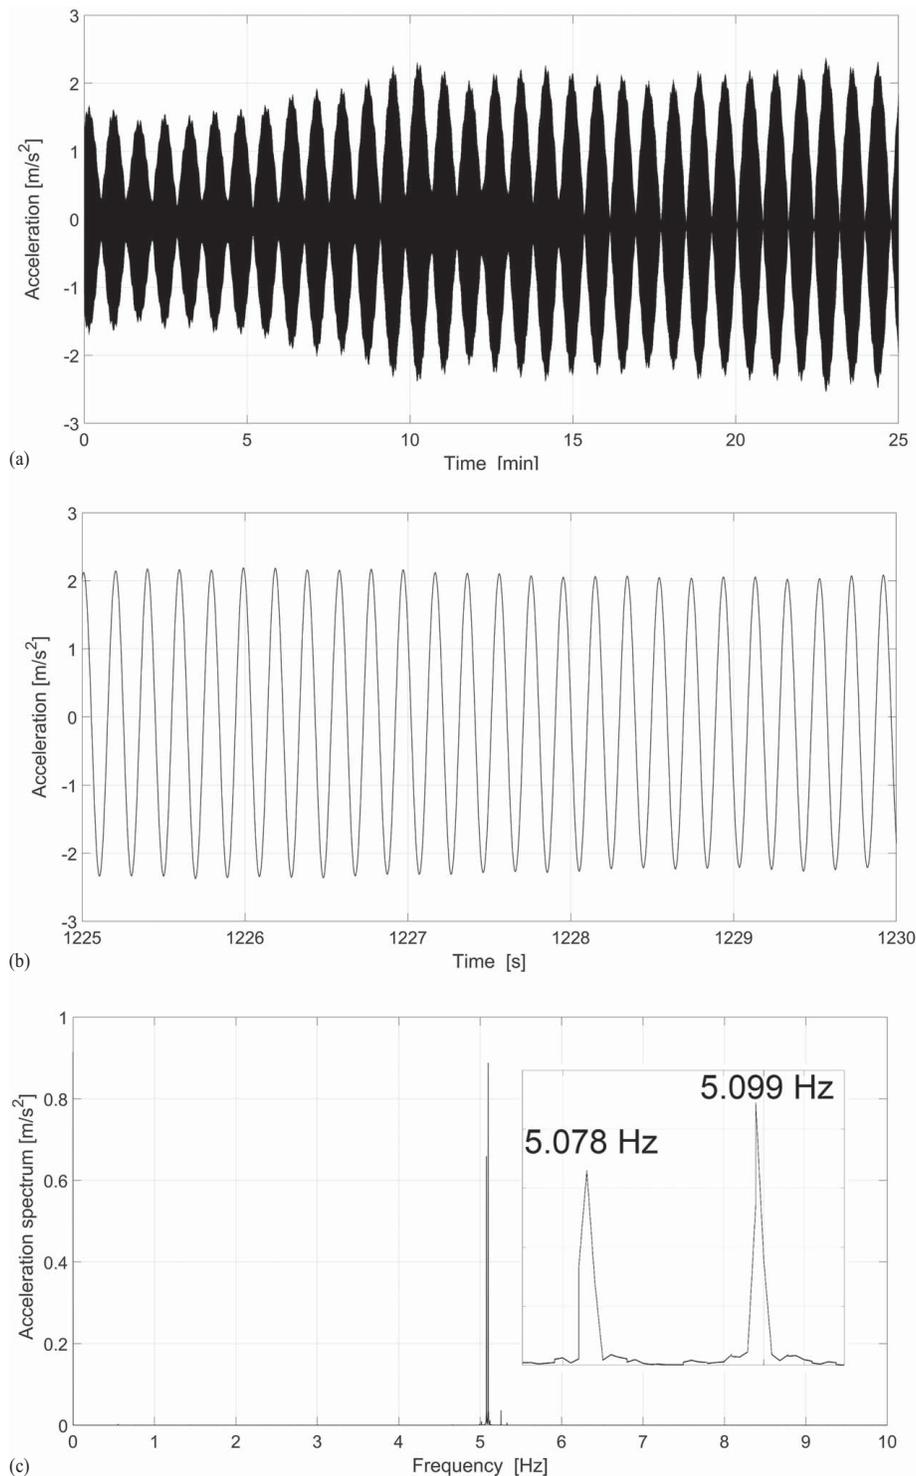
**Fig. 3.** Accelerations of vibrations of one of the hangers (No. 8HR) recorded at 1/4 length before starting the static tests (with 10-Hz low-pass filtering): (a) nonstopping vibrations recorded for over 25 min; (b) 5-s fragment of vibrations from about 20 min of recording; and (c) spectral analysis of vibrations with additional fragment magnification of about 5.090 Hz.

Before the static tests of the first span began, the presence of intense (visible to the unaided eye) undamped vibrations of some hangers in the horizontal direction transverse to the track axis was noticed. The accelerations of the vibrations of one of the hangers (No. 8HR), recorded at 1/4 length, are presented in Fig. 3.

The double vibration amplitude of the hangers was determined by double integration of the recorded acceleration fragment. The double integration error was reduced by removing any linear trends to obtain symmetric vibrations about the zero position. The determined displacement history was also verified by the double integral of the trigonometric function with known frequency and amplitude. The obtained value of the double amplitude of displacement was approximately 4 mm at 1/4 of the length of the hanger, which, due to the shape of the modal vibrations, indicates that a double amplitude of displacement (at 1/2 of the hanger length) was about 8 mm. There were two similar frequencies in the spectrum of measured vibration accelerations (5.078 and 5.099 Hz). A very small difference in the natural frequencies of only about 0.02 Hz was the reason for the beating phenomenon, i.e., the overlapping of vibrations leading to oscillations with very large amplitudes. Beating is an internal resonance in which slight external excitations, such as vibrations caused by the road traffic under the bridge or gusts of wind, can cause very large amplitudes of vibrations. It was also observed that high-amplitude vibrations were transmitted from one hanger to another, both within one arch and to the adjacent arch, and there was significant excitation of vibrations of hangers during the passage of trains.

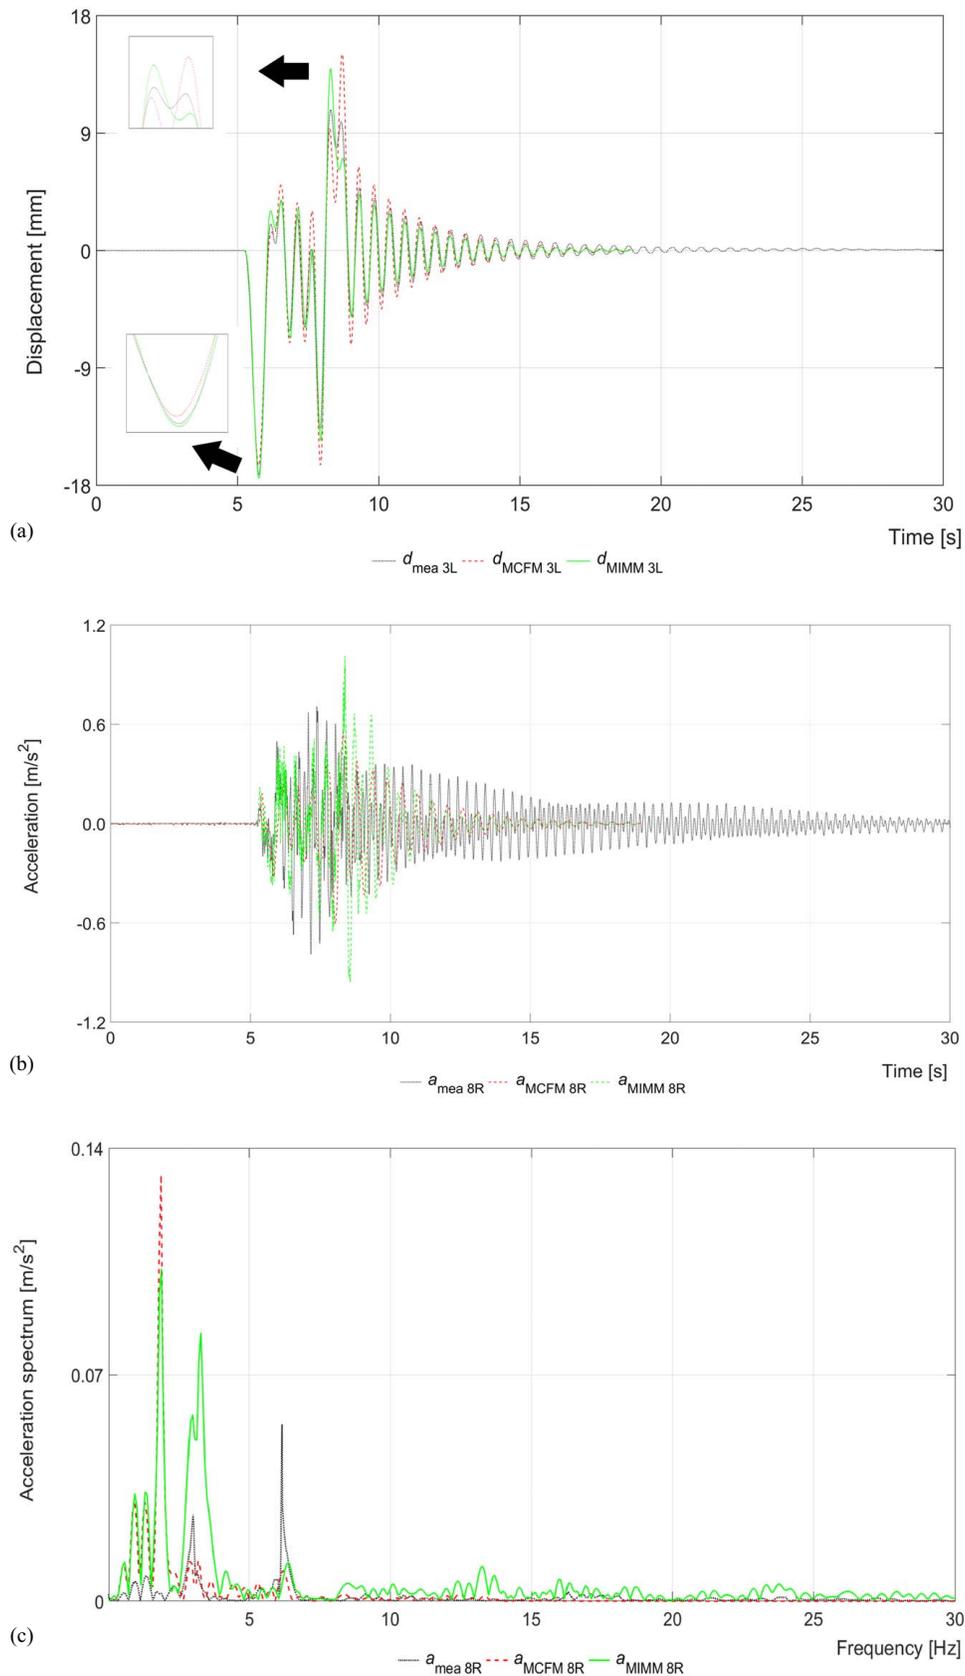
**Fig. 4.** Comparison of measured and calculated (with MCFM and MIMM) values during the passage of a test train at a speed of about 200 km/h: (a) vertical displacement of the beam girder near Hanger no. 3: time history of measured displacement, Line  $d_{\text{mea } 3L}$ ; time history of calculated displacement, Lines  $d_{\text{MCFM } 3L}$  and  $d_{\text{MIMM } 3L}$ ; (b) vertical acceleration of beam girder vibration near Hanger no. 8 (applying the low-pass filter of 30 Hz): time history of measured acceleration, Line  $a_{\text{mea } 8R}$ ; time history of calculated acceleration, Lines  $a_{\text{MCFM } 8R}$  and  $a_{\text{MIMM } 8R}$ ; and (c) acceleration frequency spectra of the measured and calculated bridge deck vibrations.

The comparison of measured and calculated (with the use of MCFM and MIMM) vertical displacement of the beam girder near Hanger no. 3 (extreme displacement section) during a test train passage with a speed of about 200 km/h is presented in Fig. 4(a). Analogous comparison of measured and calculated vertical acceleration of beam girder vibration near Hanger no. 8 (section of high-level hanger vibrations) during a test train passage with a speed of about 200 km/h is presented in Fig. 4(b). The low-pass filter of 30 Hz was applied to all the calculated and measured time histories of acceleration. In the case of bridge deck vibrations, the 30 Hz filtration limit frequency results from the ballast stability conditions (Calgaro et al. 2010). Fig. 4(c) shows the acceleration

frequency spectra of the measured and calculated bridge deck vibration. In the signals recorded by measurement sensors, two frequencies (3.0 and 6.2 Hz) dominate, while the frequency contributions in numerically modeled responses are mainly dispersed across lower frequencies; also, bridge vibrations modeled under inertial loading are observed in the frequency range above 6.2 Hz.

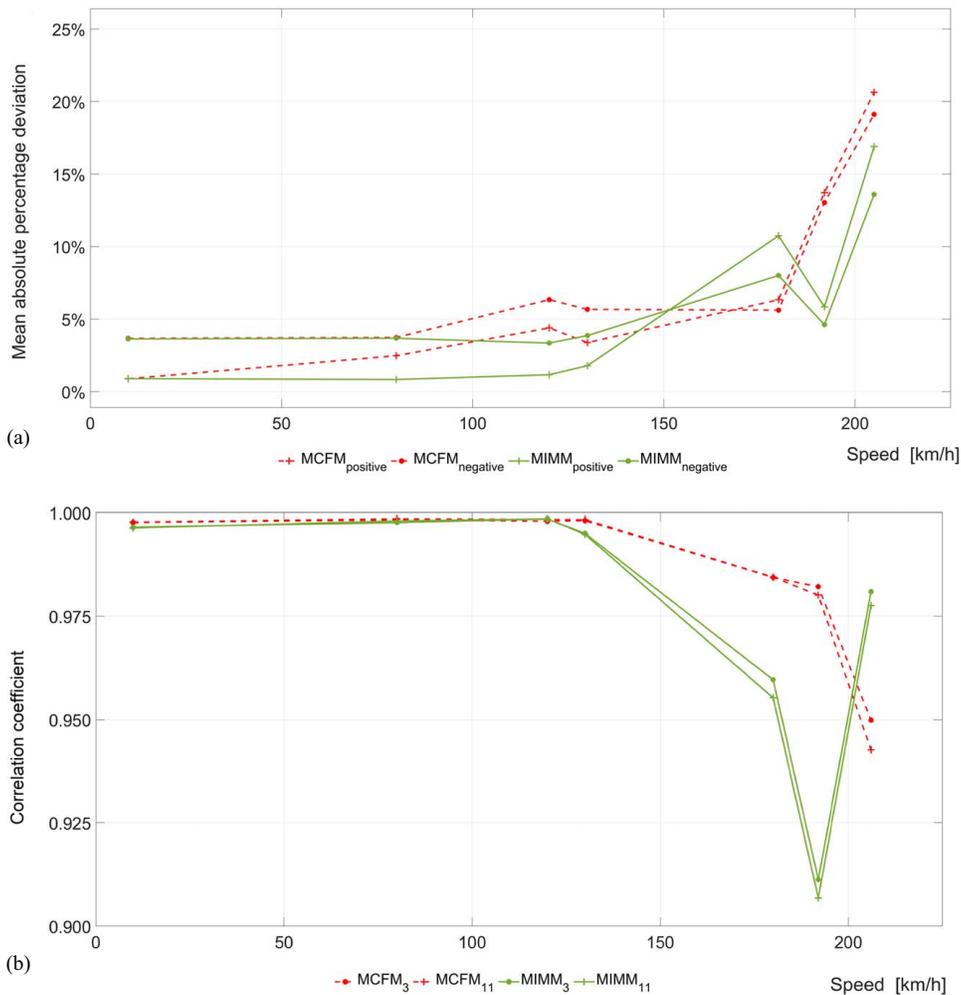
**Fig. 5.** Comparison of the calculated displacements of forced vibrations with those measured: (a) using MAPD calculated as average at Points 3L and 11L separately for negative (dot markers) and positive (plus markers) peaks for both moving load models (MCFM and MIMM); and (b) using CC calculated separately at Points 3L and 11L for both moving load models (MCFM and MIMM).

The determined parameters (MAPD and CC) for the passage of the test train at speeds from 10 to over 200 km/h (exactly 205 km/h) are shown in Fig. 5. In the case of MAPD,  $n = 2$  (number of compared pairs of calculated and measured values), and in the case of CC,  $N$  varies from 2,030 to 35,250 (number of observations—depending on the cycle duration and sampling rate). Up to the test train speed of about 130 km/h, both MAPD (<5% for MIMM and <7% for MCFM) and CC (>0.99 for MCFM and MIMM) indicate a high agreement between the calculated and measured displacements. From a speed of 180 km/h, the calculated values are no longer as consistent with the measured results. The greatest discrepancies occur at a speed of approximately 205 km/h. In the case of the MIMM, there is also a significant discrepancy at about 180 km/h. Due to smaller deviations of peak values at most speeds of the test train passage and good waveform conformance described by CC, MIMM was adopted for further analysis. The numerical models of the moving load included both concentrated forces and sliding mass over the rails with contact but without the suspension of the train. This may result in different responses for trains at higher speeds.

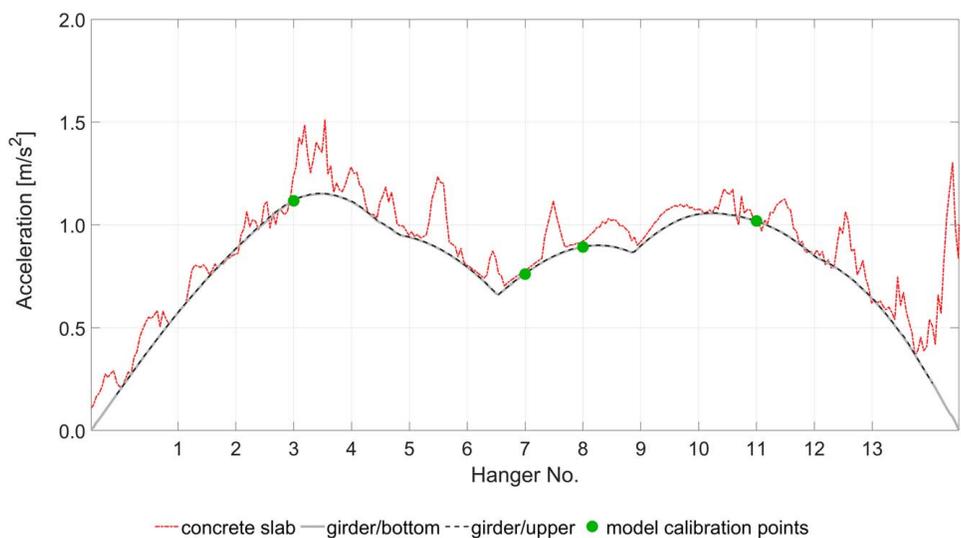
**Fig. 6.** Numerical analysis (MIMM) of acceleration of beam girder (bottom and upper surfaces) and concrete slab vibrations along the span length during the passage of a test train at a speed of about 205 km/h; graphs present the calculated extremal amplitudes of vibration acceleration along the span during train passage; a low-pass filter of 30 Hz was applied. Dots marked points of comparison (during model calibration) of calculated and measured values.

A detailed analysis of numerical results for bridge deck vibrations during a train passage with a speed of 205 km/h was conducted. Time histories of accelerations were determined at all points spaced every 0.25 m (acceleration control points) on the beam girder (along the middle line of the bottom and upper surfaces) and concrete slab (along the middle line of the bottom surface). After applying 30-Hz low-pass filtering, for each acceleration control point, extreme values from all waveforms were determined and are marked on the graphs presented in Fig. 6. Comparison of the calculated and measured values was carried out at four points of the girders (dot markers in Fig. 6). Extreme acceleration values occurred at control points of the concrete slab located in the zone between Hanger nos. 3 and 4 and at the end of the slab (looking in the direction of the traveling train). All extreme values were well below the limit value of 3.5 m/s<sup>2</sup>, which is a limit of creating the risk of destabilizing the ballast (Calgaro et al. 2010).

In a similar way, as shown in Fig. 6, the extreme values from the calculated time histories of vibration accelerations at the control points of the girders and concrete slab were determined and are presented in Figs. 9(a and b). The computations were performed for the train speeds of 150 km/h [responses presented in Fig. 7(b)] and 200 km/h [responses presented in Fig. 8(b)], respectively. In both cases, all extreme values were well below the limit value of 3.5 m/s<sup>2</sup>.

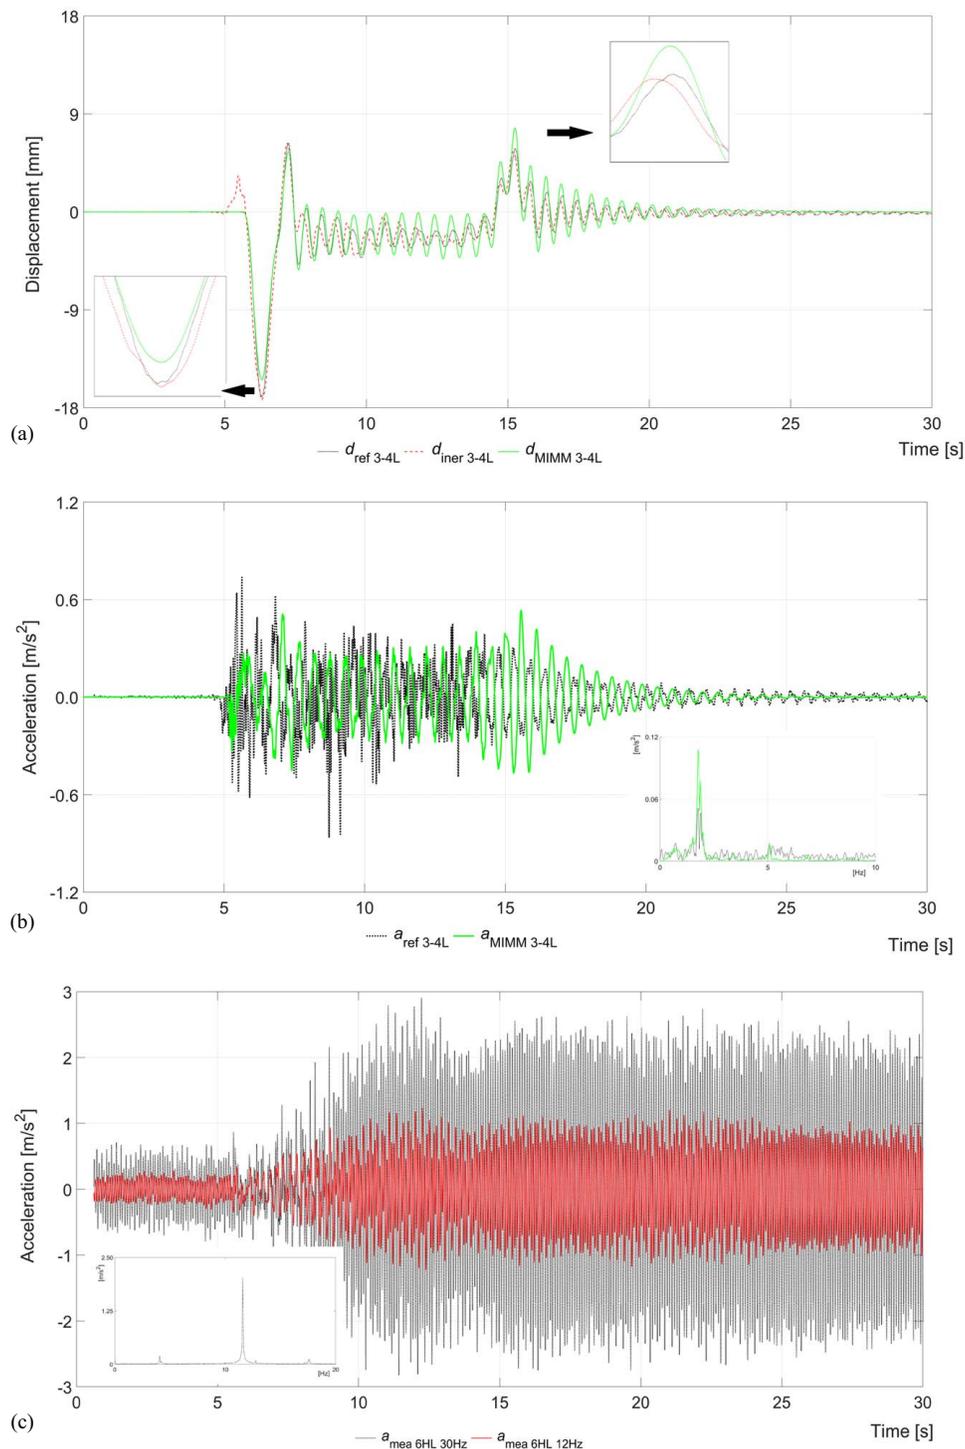
**Fig. 7.** Example of the recorded behavior of the bridge during the passage of a locomotive with 14 passenger cars at a speed of about 150 km/h: (a) time history of the displacement of the beam girder between Hanger nos. 3 and 4—measured with the reference sensor ( $d_{ref\ 3-4L}$ ), measured indirectly using inertial sensors ( $d_{iner\ 3-4L}$ ), and calculated ( $d_{MIMM\ 3-4L}$ ); (b) time history of the acceleration of beam girder vibrations between Hanger nos. 3 and 4—measured with the accelerometer (Line  $a_{mea\ 3-4L}$ ) and calculated (Line  $a_{cal\ MIMM\ 3-4L}$ ) using a low-pass filter of 30 Hz, along with the frequency spectra; (c) time history of the acceleration of Hanger no. 6—measured and low-pass-filtered 30 Hz (Line  $a_{mea\ 6HL\ 30Hz}$ ) and 12 Hz (Line  $a_{mea\ 6HL\ 12Hz}$ ), along with the frequency spectra.

The selected examples concern trains with significantly different axle load distributions. Fig. 7 shows the results of bridge behavior during the passage of a locomotive with 14 passenger cars traveling at a speed of about 150 km/h, while Fig. 8 illustrates bridge behavior during the passage of a multiple-unit passenger train moving at a speed of about 200 km/h. The following comparison parameters (presented in the section “Numerical Model Calibration”) for the displacement of forced vibrations were obtained and are presented in Table 3.

filtration thresholds were used in Figs. 7(c) and 8(c) (as illustrated by the frequency spectra). Measurements of vibration accelerations were carried out at 1/4 of the length of the hanger, and on their basis, the extreme values of the displacements occurring at this point were estimated using the double integration method. The vibrations in Fig. 7(c) had a frequency of approximately 11.6 Hz, which corresponded to double amplitudes of vibration

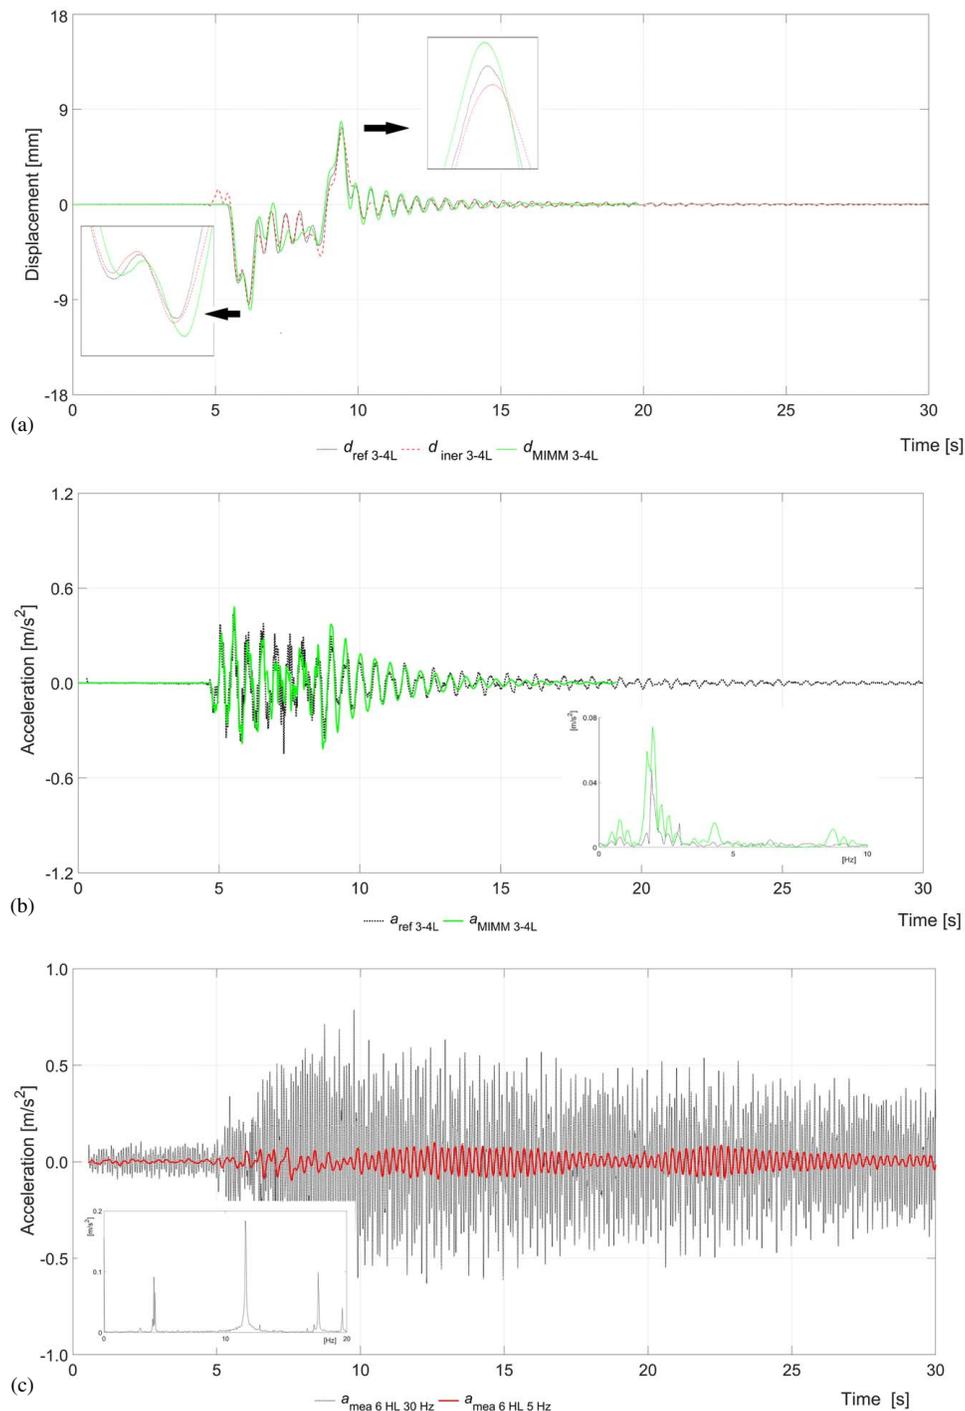
**Fig. 8.** Example of the recorded behavior of the bridge during the passage of a multiple-unit passenger train at a speed of about 200 km/h: (a) time history of the displacement of the beam girder between Hanger nos. 3 and 4—measured with the reference sensor ( $d_{ref\ 3-4L}$ ), measured indirectly using inertial sensors ( $d_{iner\ 3-4L}$ ), and calculated ( $d_{MIMM\ 3-4L}$ ); (b) time history of the acceleration of beam girder vibrations between Hanger nos. 3 and 4—measured with the accelerometer (Line  $a_{mea\ 3-4L}$ ) and calculated (Line  $a_{cal\ MiMM\ 3-4L}$ ) using a low-pass filter of 30 Hz, along with the frequency spectra; and (c) time history of the acceleration of Hanger no. 6—measured and low-pass-filtered 30 Hz (Line  $a_{mea\ 6HL\ 30\ Hz}$ ) and 5 Hz (Line  $a_{mea\ 6HL\ 5\ Hz}$ ), along with the frequency spectra.

displacement of approximately 0.37 mm, and the vibrations in Fig. 8(c) had a frequency of approximately 4.1 Hz, corresponding to double amplitudes of approximately 0.27 mm. Although these vibrations had much smaller amplitudes compared to the vibrations recorded in the first period of operation—before modifying the hangers by adding masses—there was still weak damping present. In Fig. 8(c), the beating phenomenon resulting from the occurrence

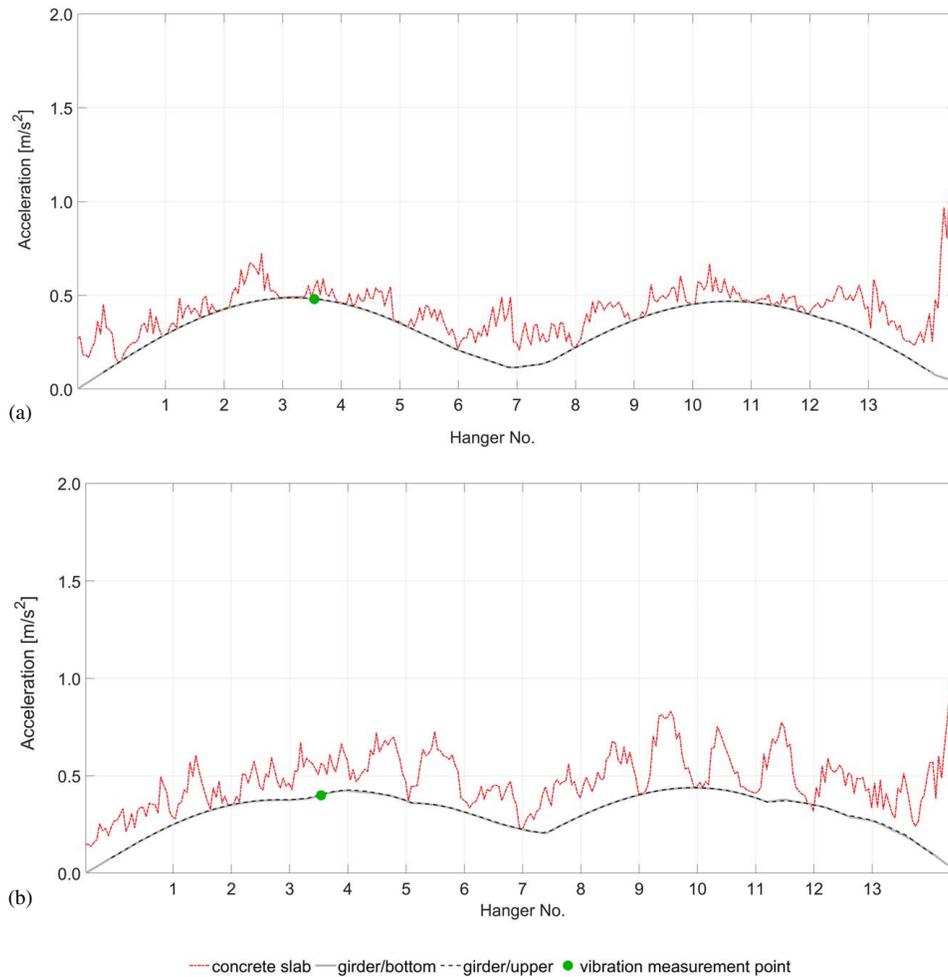
**Fig. 9.** Numerical analysis (MIMM) of the acceleration of beam girder (control points at bottom and upper surfaces) and concrete slab vibrations along the span length during the passage of (a) a locomotive with 14 passenger cars at a speed of about 150 km/h [Fig. 7(b)]; and (b) a multiple-unit passenger train at a speed of about 200 km/h [Fig. 8(b)]. Graphs present the calculated extremal amplitudes of vibration acceleration along the span during the passage of all trains; a low-pass filter of 30 Hz was applied. The dot marked point indicates the vibration measurement at the girder (control points on the upper surface) during monitoring.

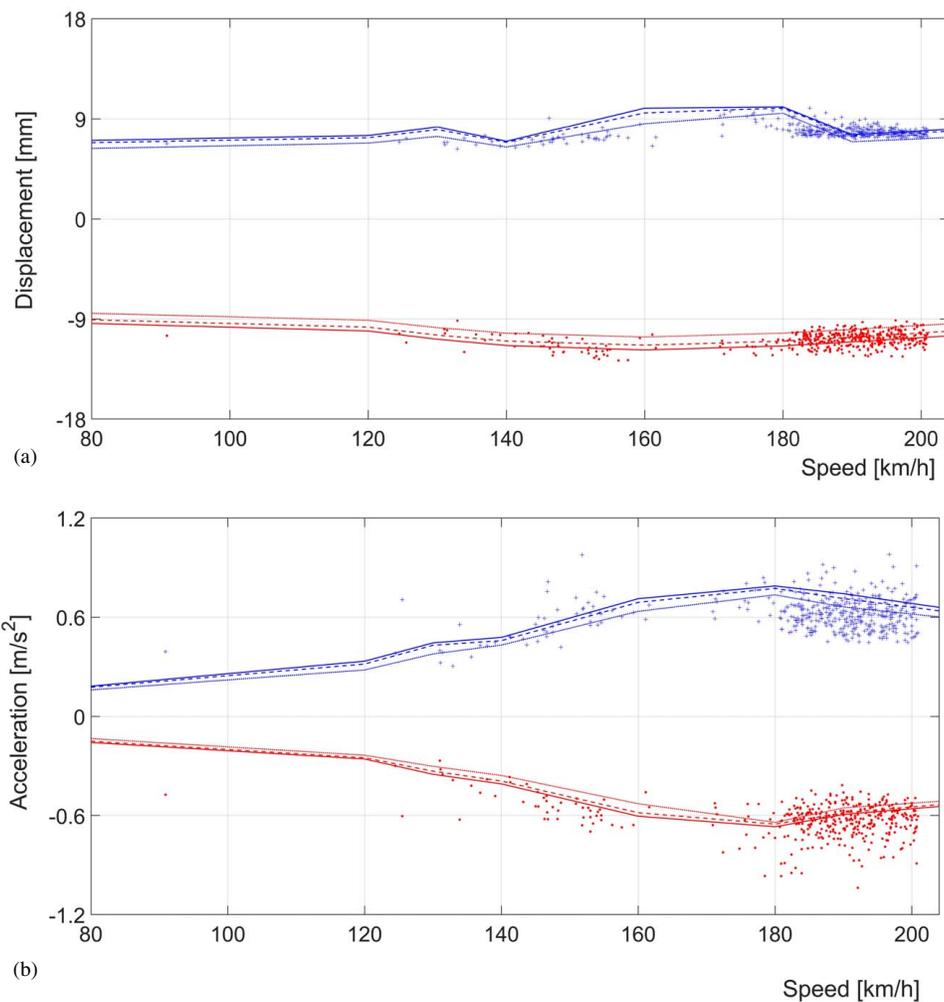
**Fig. 10.** Example of (a) displacement; and (b) acceleration of vibration after 30-Hz low-pass filtering of the beam girder between Hanger nos. 3 and 4 monitoring under a load of multiple-unit passenger trains for 1 month (415 passages): extreme displacement versus speed; upper dot markers, negative; lower plus markers, positive; three upper and lower lines correspond to the numerically determined extreme deflections (MIMM) from an empty train (dotted line), the state of normal use (dashed line), and the fully loaded state foreseen by the manufacturer (solid line).

Fig. 10 shows the relationship between the extreme negative and positive displacements and accelerations recorded by the system monitoring versus train speed during the 1-month period—415 passages of the multiple-unit passenger trains ED250. This was the month with a permissible speed of 200 km/h. It should be noted that due to time reserves in the timetable and the proximity of the destination station, not all trains were running at maximum speed. Most of the trains reached the speed of 180–200 km/h.

Fig. 10 illustrates a set of three lines (lower–upper for positive and lower for negative values), each corresponding to the numerically determined extreme deflections [Fig. 10(a)] and accelerations [Fig. 10(b)] from an empty train (dotted lines), the normal state of use (dashed lines), and the fully loaded state foreseen by the manufacturer (solid lines). A comparative analysis of the data from Fig. 10 is presented in Table 4.
