## STUDY OF FACTORS DETERMINANT OF SILICEOUS ELECTRICAL PORCELAIN RESISTANCE TO STRUCTURAL DEGRADATION

The subject of this study was investigation of the factors that have a decisive influence on the resistance of siliceous porcelain to degradation processes. There was tested material C 110 type, which is widely used for the production of low-voltage (LV) elements such as insulators and bushings. On the basis of mechanical-acoustic and microscopic research of small-sized samples, which were subjected to compression, there were distinguished successive stages of degradation of the material structure. In the authors' opinion, they have a reference to the ageing process, taking place during many years of work under operating conditions. Thus, it was possible to assess the structural factors that determine the durability and reliability of LV electroinsulating elements. The results were related to electrical aluminous porcelains.

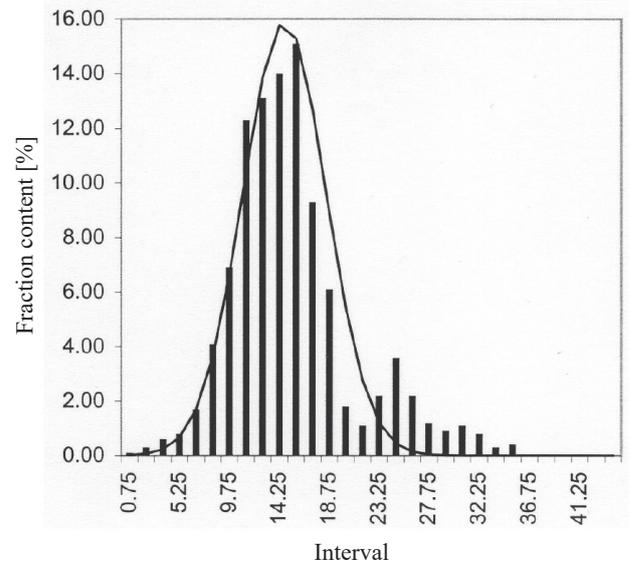
Fig. 1. The size distribution of quartz grains in the tested porcelain. The vertical axis - fraction content in percent, along the horizontal axis - an interval of particle size in microns. The distribution is dominated by two fractions - the size of a dozen or so and 20 - 30  $\mu\text{m}$ . The value of the average is 14.7  $\mu\text{m}$

The content of quartz was equal to  $20 \pm 2\%$ . Considering the size of quartz grains – explicitly dominated fraction of dozen or so micrometers, nevertheless a significant part constituted the relics in the range of  $20 \div 30$   $\mu\text{m}$ . Figure 1 presents distribution of the quartz grains diameter. Unfavorable phenomenon was the presence of agglomerations of larger quartz grains. Additionally, a significant part of the relics exhibited disadvantageous lamellar morphology. In the structure of majority of electrical porcelains, the quartz phase is mainly responsible for internal stresses and the initiation and development of cracks. This is the basic cause of increasing ageing processes with time passing. Significant part of quartz grains contained cracks and was insufficiently associated with matrix. As a result a substantial part of relics fell out during the preparation of surface of the tested samples.

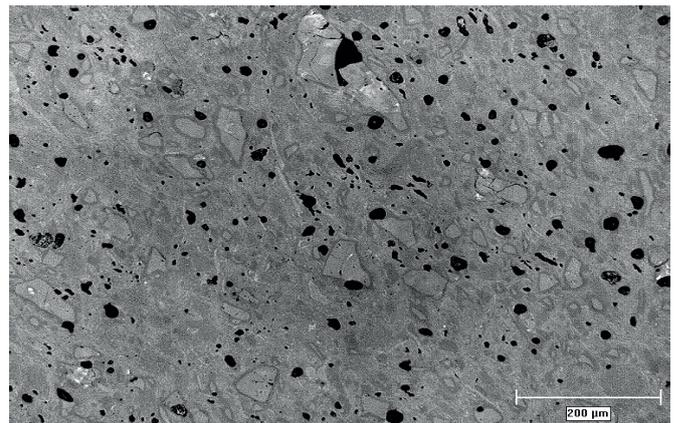
Fig. 2. Image of the microstructure of tested siliceous material, magnification 100x. There are visible brighter quartz relics and darker precipitates of mullite against the background of gray glassy matrix. Black cavities remaining after the crushed out quartz grains occupy about 6% of the surface. Pores are small - a few microns - and cover approximately 0.5%

The content of the glassy matrix was high - as compared to other electrical porcelains, even of the same class. It amounted to  $55 \pm 4\%$ . A high content of the glassy phase has advantageous influence on the cohesion and bonding of all porcelain phases. The material contained small amount of culet, originating from grinding media. Electrical siliceous porcelains are characterized by significant diversity, but the structure of the tested material can be regarded as homogeneous and representative. The phase composition was in general typical. In Fig. 2 is presented image of the material microstructure.

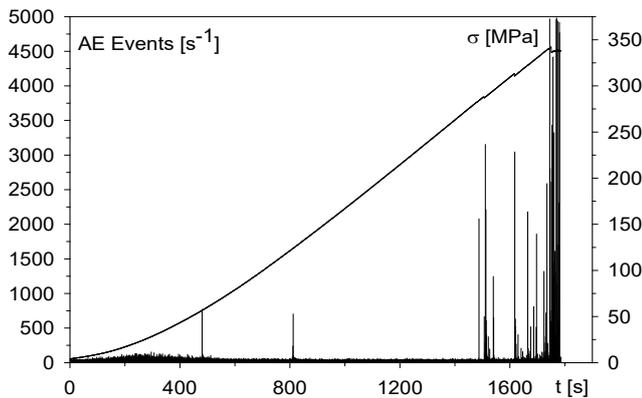
Fig. 3. Mechanoacoustic characteristics of the weakest specimen - compressive strength equal to 342 MPa. Linear scale of AE events

The mechanical-acoustic characteristics of the individual samples demonstrated considerable diversity. Nonetheless, there were recognized characteristic, successive stages of degradation - the preliminary, the subcritical and the last - critical stadium. Figure 3 presents the course of the rate of AE events versus the increase of compressive stress for the weakest sample. Figure 4 represents the rate of events energy of the other specimen.

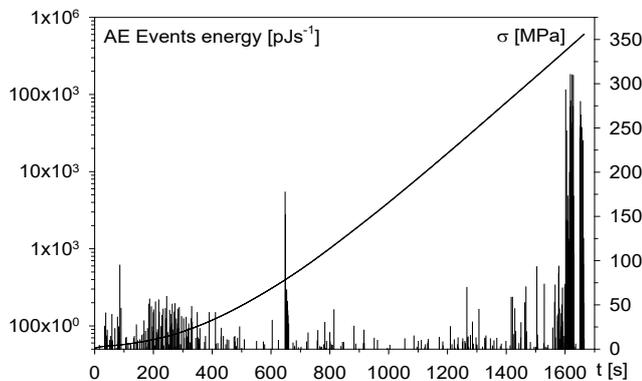
Fig. 4. The rate of events energy in one-second intervals as a function of the stress increase for the sample destroyed at 351 MPa. Logarithmic scale is used for the EA descriptor

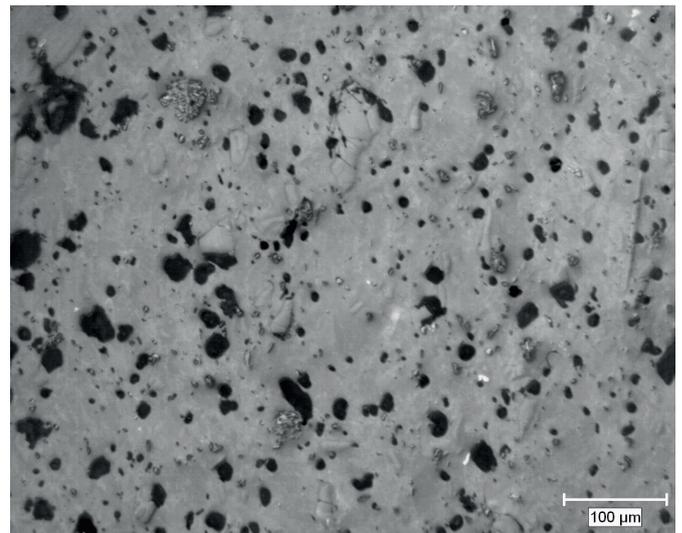
Fig. 5. The structure of siliceous material loaded up to the preliminary stage of degradation, magnification 200x. Numerous damages and crushed out grains of quartz are visible. Dark cavities cover about 10% of the surface

and crushing out of quartz grains was the source of AE signals. This effect referred particularly to the small grains - of the size of several microns. Susceptible to degradation were the grains with a lamellar morphology. The most resistant to failure and separation from the matrix were the grains of a middling size between 20 and 30 mm, distinguished by the regular shape and typical morphology. Besides quartz, there occurred crushing out of almost all particles of cullet. Mullite precipitates were not affected by degradation. They had a coherent structure and were well combined with the glass matrix. Damaged and crushed out elements of the structure covered over 10% of the area of tested surfaces of the stressed samples. In figure 5 is presented material of the sample loaded up to 60 MPa.

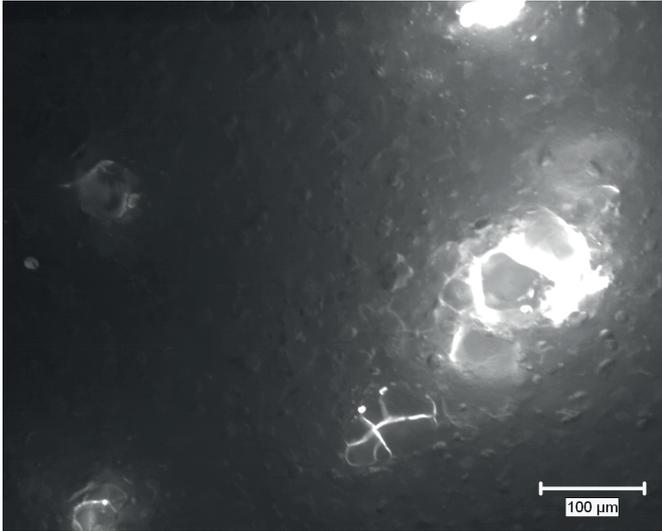
Fig. 6. Microscopic image of the material of the sample loaded up to 387 MPa, in UV light, at a magnification of 200 times. There is visible the area of loose structure - a cluster of large grains of quartz and distinctive grain cracking. Resin with addition of a UV fluorescent was used

Image analysis of the samples loaded up to 285 MPa and 387 MPa showed that further, relatively small degradation - in a wide range of stress - undergoes only the quartz phase. Circumferential and internal cracks are generated and increase in the grains. Thorough examination, using UV light, proved that in the material structure occur centres of cracks. These are the regions of loosened structure - the agglomerations of the larger grains of quartz, which crack with increasing stress and are being separated from the glassy phase. The cracks that can propagate into the matrix are initiated in these regions. These cracks, growing gradually in the matrix, are one of the most important factors in the process of degradation. Their rapid rise takes place during the critical stadium and leads to the sample destruction. Figure 6 presents the area of loose structure - the center of large cracks in the material of the sample, loaded up to 387 MPa.

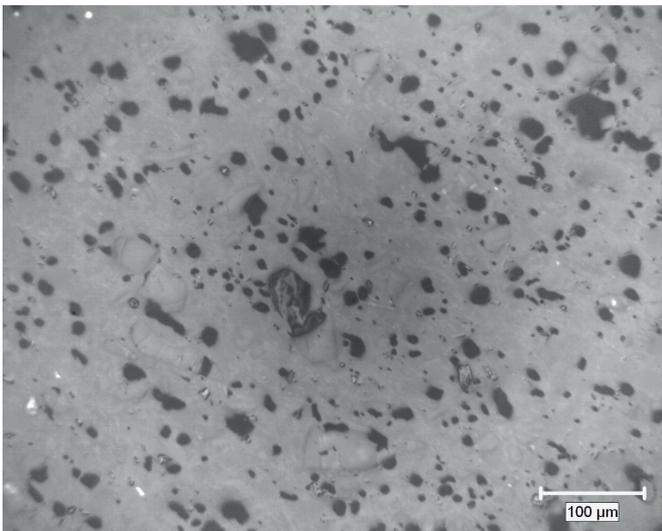
Fig. 7. Microstructure of the sample stressed up to 285 MPa, at a magnification of 200 times. Dark areas representing cracked and crushed out grains of quartz and their fragments as well as cullet fragments comprise above 11%. The mullite phase and the glassy matrix remain unaffected

The preliminary stadium of degradation was connected mostly with the effect of small quartz grains damage. During the next - subcritical stage was visible harmful influence of the clusters of bigger quartz grains - of several tens of microns. Destroyed and crushed out components of the structure in the advanced subcritical stage comprised about a dozen percent. The strongest constituent - the mullite phase remained without any damage. Figure 7 presents central part of the sample that was stressed up to 285 MPa. Advancement of degradation processes in its structure can be specified as average. There should be emphasized that these effects are limited only to the quartz phase and not numerous particles of cullet.

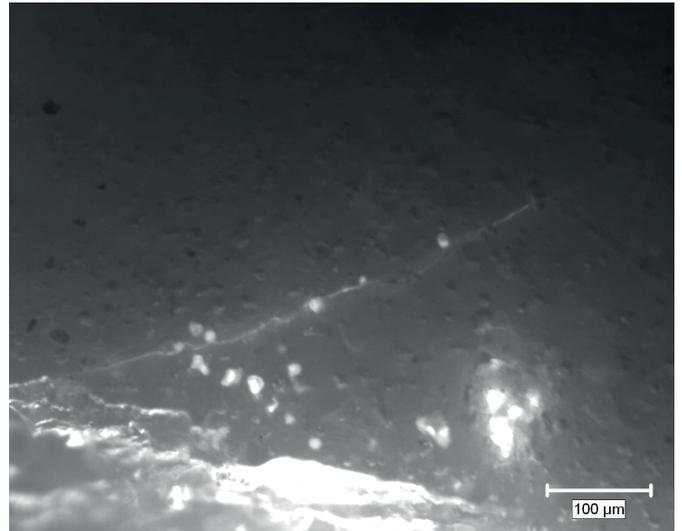
Fig. 8. Microscopic UV light picture of the material of the sample loaded up to 285 MPa, at a magnification of 200 times. The area in the immediate vicinity of the broken off fragment is visible. In addition to cracking, takes notice characteristic area of loose structure at the bottom right of the image. It is clearly visible due to applied resin with added fluorescent agent, visible under UV light

Sometimes, during the subcritical stage, a local fracture and splitting off the corners or even the whole wall of the stressed sample can occur. This effect is followed by strong AE signals, and is visible on the stress increase curves as a characteristic faults (leaps) – Fig. 3. In the vicinity of the broken off portion are then shaped large cracks. However they are typical for the critical stadium of degradation. Figure 8 shows a marginal area of the sample, loaded up to 285 MPa, in the area adjacent to the separated portion of the wall. Visible large cracks are not characteristic effect of the subcritical stage. There is also evident the typical area of loose structure.

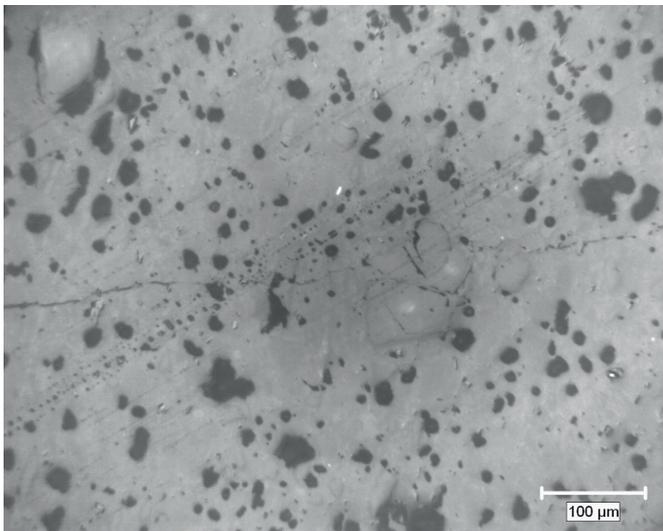
Fig. 9. Heavily fractured microstructure of the strongest sample fraction, at a magnification of 200 times. Separated and crushed out elements of the structure comprise about dozen percent of the surface

In the case of the sample with the highest strength (469 MPa), the agglomerations of the larger grains of quartz, forming a loose structure centers, occurred very rarely. The homogeneity of the material, observed in micro and semi-macro scales, was high. Therefore, the mullite phase distribution was the most advantageous, although very small number of individual crystals of mullite in the glassy matrix – typical for such type materials. This structure showed high resistance to compressive stress, even higher than in the case of the typical strength of aluminous C 120 kind material of the traditional, older type - generally about 400 MPa (in the case of modern material - over 500 MPa) [4]. Figure 9 shows the highly cracked microstructure of the fraction of the strongest sample. Beside the distinctive macro-cracks, plurality of the parallel cracks of the matrix are visible. Characteristic course of the cracking is a reflection of the loading direction.

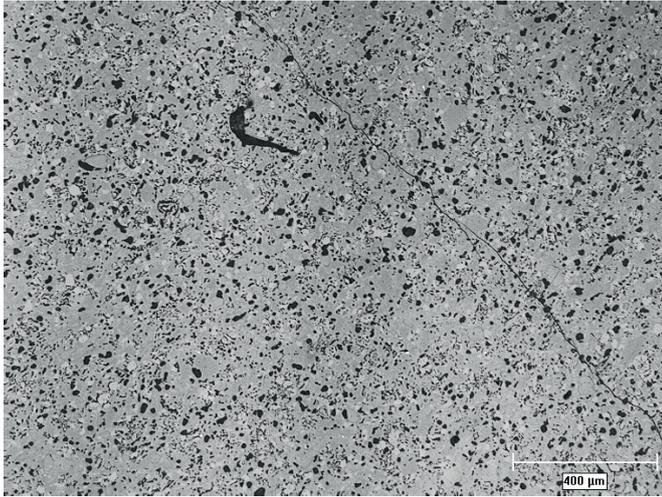
Fig. 10. The image of siliceous porcelain of LV stand-insulator after over 20 years operation period, at a magnification of 50x. Extended crack as well as black slit, elongated in a direction parallel to the axis of the insulator, are visible. There are a lot of micro-cracks within and at the boundaries of the quartz grains. Black areas that remained after crushed out grains of quartz and cullet fragments cover about 10%

Figure 10 presents advanced ageing processes in domestic siliceous material of the LV stand-insulator after over twenty years of exploitation. About 1/3 of initial amount of quartz phase (29 – 32%) were damaged and underwent crushing out during surface preparation. Remaining grains contained microcracks, especially peripheral. Structural integrity were much weakened and there were found elongated, nearly critical cracks propagating throughout all phases of the material and only deviated by precipitates of mullite.

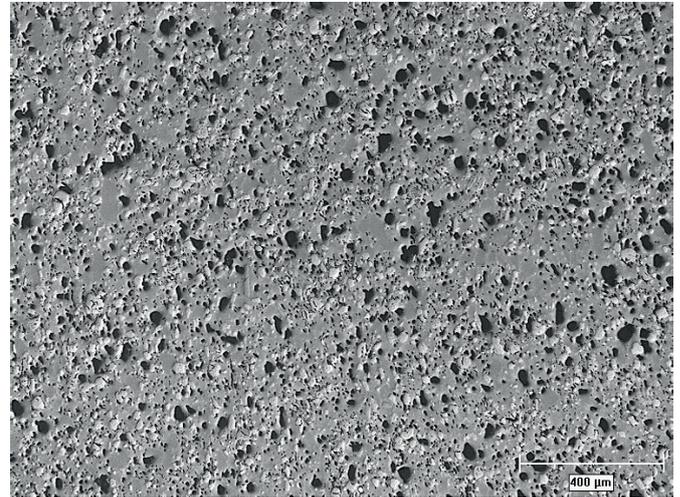
Fig. 11. The image of C 120 type porcelain of HV line insulator after about 30 years operation period, at a magnification of 50x. The effects of the degradation of the structure appropriate to the subcritical stage, with a high degree of advancement. Over 1/3 of the quartz grains (nearly 9%) was separated and crushed out from the structure. In the vicinity of the relics of quartz are present numerous micro-cracks in the glassy matrix

disintegration. In figure 11 is presented typical image of aged aluminous material of domestic line insulator after about 30 years operation period. Advanced degradation processes are visible. They are a consequence of high and diversified amount of the quartz phase in the material structure - initial average content 24%. This phase was the main source of internal stresses, initiation and growth of micro-cracks.
