Article

A Novel Method for High Temperature Fatigue Testing of Nickel Superalloy Turbine Blades with Additional NDT Diagnostics

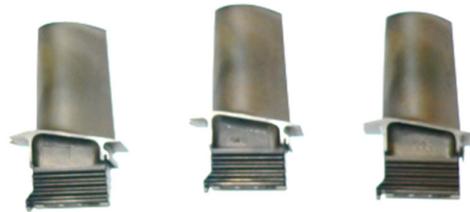
Figure 1. Turbine blades after exploitation for 303 h (a) and 473 h (b).

non-destructive testing. The exemplary turbine blades and their chemical composition are presented in Figure 1 and Table 1, respectively.

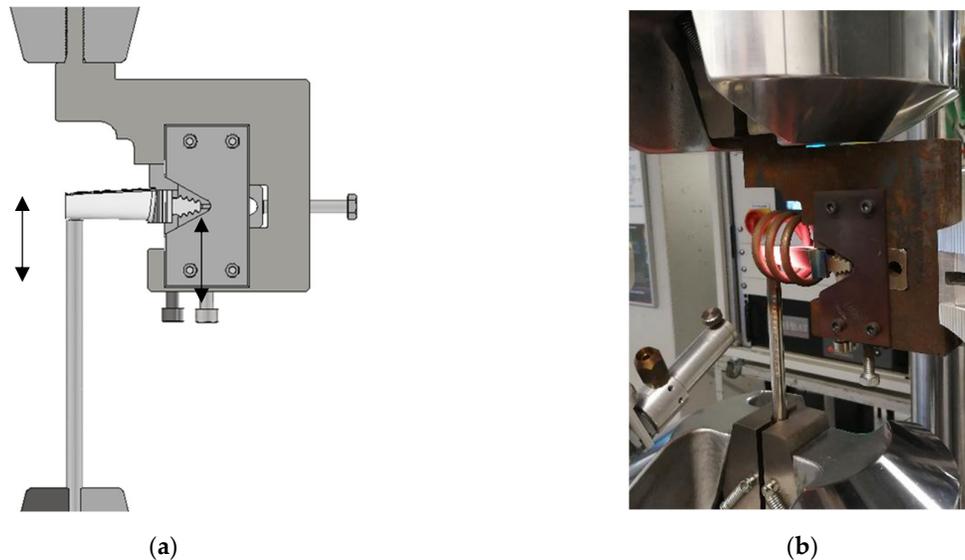
Figure 3. Schematics of a turbine blade grip (a) and its general view during the experiment (b).

Fatigue tests were performed on the MTS 810 testing machine (MTS System, Eden Prairie, MN, USA), with an axial force range of ± 250 kN, equipped with a FLEX digital controller (MTS System, Eden Prairie, MN, USA). The turbine blades were attached in the grip and heated with an induction heater (Ameritherm, New York, NY, USA) to a temperature of 950 °C. The load was implemented to the surface of the turbine blade in force control mode. Schematics of a turbine blade grip are presented in Figure 3a, while an experimental setup during fatigue test at 950 °C is presented in Figure 3b.

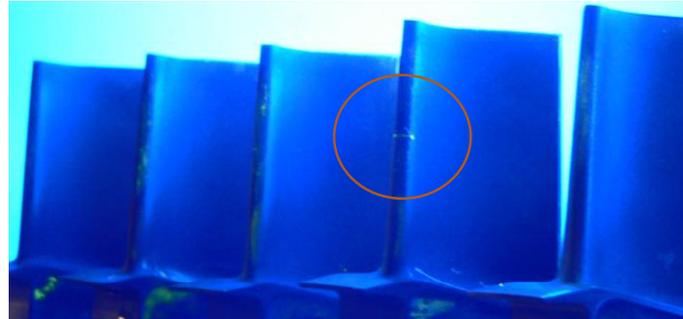
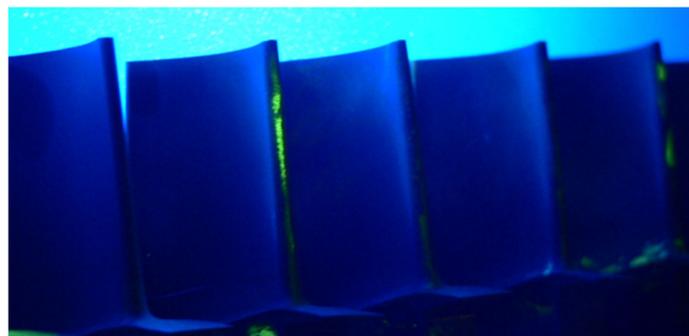
Figure 4. Fluorescent penetrant inspection (FPI) of turbine blades for series 1 (one crack) (a) and series 2 (no crack) (b).

Fluorescent penetrant inspection (FPI) is known as “dye penetrant inspection”. During such inspection, a fluorescent dye was applied to the surface of the object to detect structural defects that may affect the integrity or quality of the part in question. The yellow glow of the fluorescent penetrant caused by its reaction with ultraviolet light allows the FPI dye to sharply contrast with the dark background and further detect structural defects. FPI revealed high porosity at the leading edge of almost all blades of both series, as shown in Figure 4. Such porosity was probably caused by the operation under cyclic loads in a hot gas stream. Penetrant tests showed no cracks on the tested blades, with the exception of the one sample. Fluorescent indication of a crack on the

turbine blade is marked in Figure 5a, where turbine blades are shown in UV light. The fracture was located approximately in the middle of the blade's edge, oriented perpendicularly to the leading edge.

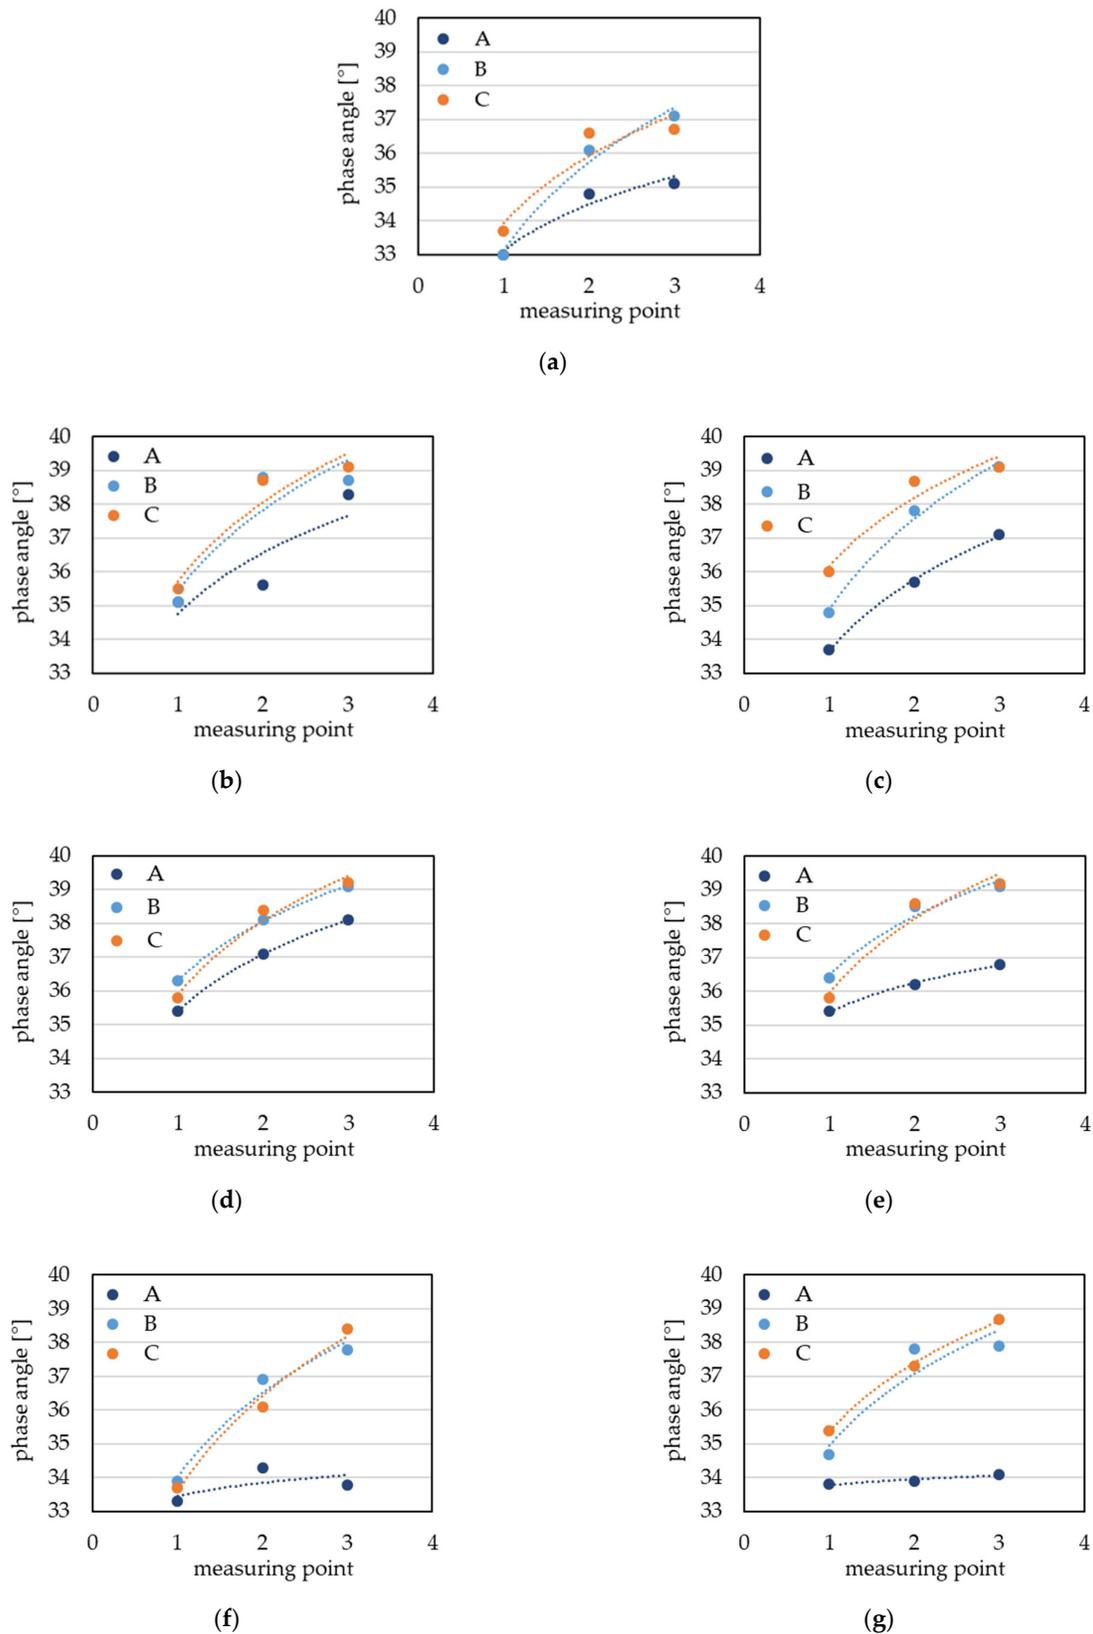
Figure 5. Phase angle measurements for different measuring points of turbine blades: as received state (a) after operation time of 303 h (b–d) and 473 h (e–g).

In this study, ET measurements were performed at three different locations near the blade's edge (A) and 10 mm and 20 mm from the edge, as shown in Figure 2. The crack identified by the penetration method was not disclosed by the eddy current method due to its location at the edge of the blade. In this location, a strong edge effect occurred, which distorted the signal significantly. The high porosity of this area also affected the quality of the signal. The lowest values of the phase angle were registered at the top edge of the blade. Such a location is mainly subjected to extensive performance at a high temperature and thus the phase angle values were the lowest. However, it should be mentioned that the initial thickness of blade itself also affects the phase angle recordings [24]. Based on the phase angle measurements and their distribution shown in Figure 5, it could be concluded that the values obtained for the A regions clearly indicate the difference in operation time and simultaneously in material integrity for both types of turbine blade in question.

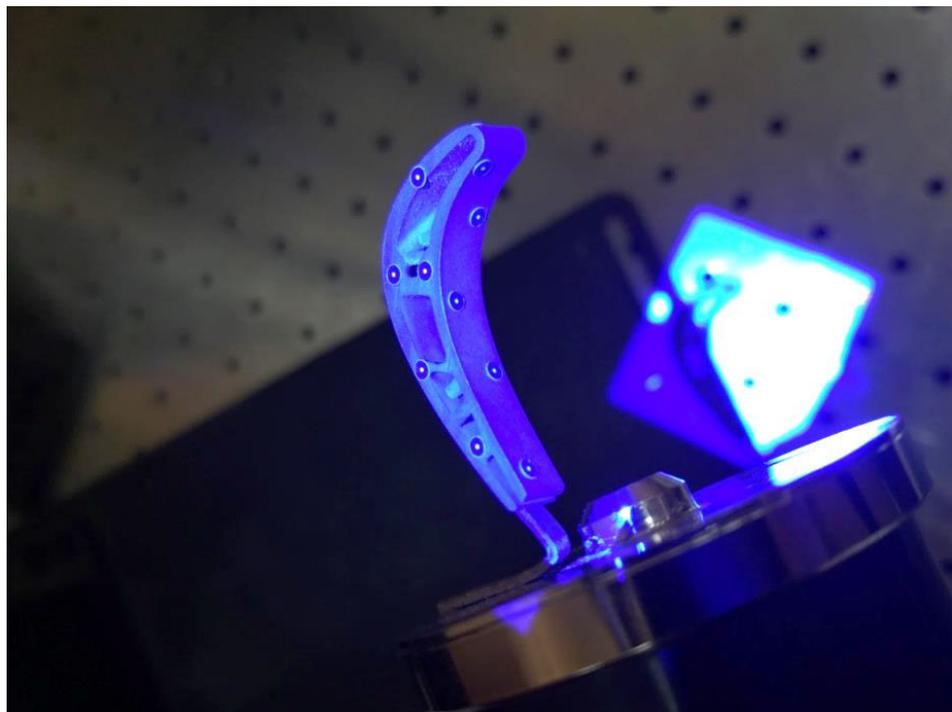
Figure 6. The turbine blade section during the digitization process.

The geometry of the high pressure turbine blade was developed as a result of the digitization process of outer and inner surfaces of the blade carried out by the Military University of Technology research team. The results of this process is usually the set of points (point cloud) that defines external geometry of an object. Thanks to the use of specialized research equipment and research staff with extensive experience in the field of reverse engineering, a reliable geometric CAD model was obtained, characterized by high accuracy of mapping surfaces. In order to create the geometry of the inner cooling channels, it was decided to cut the existing blade and make 3D scans of individual sections of the blade. Figure 6 shows one of the turbine blade sections during the digitization process. Furthermore, Figure 7 shows the created 3D CAD model of a high pressure turbine (HPT) blade.

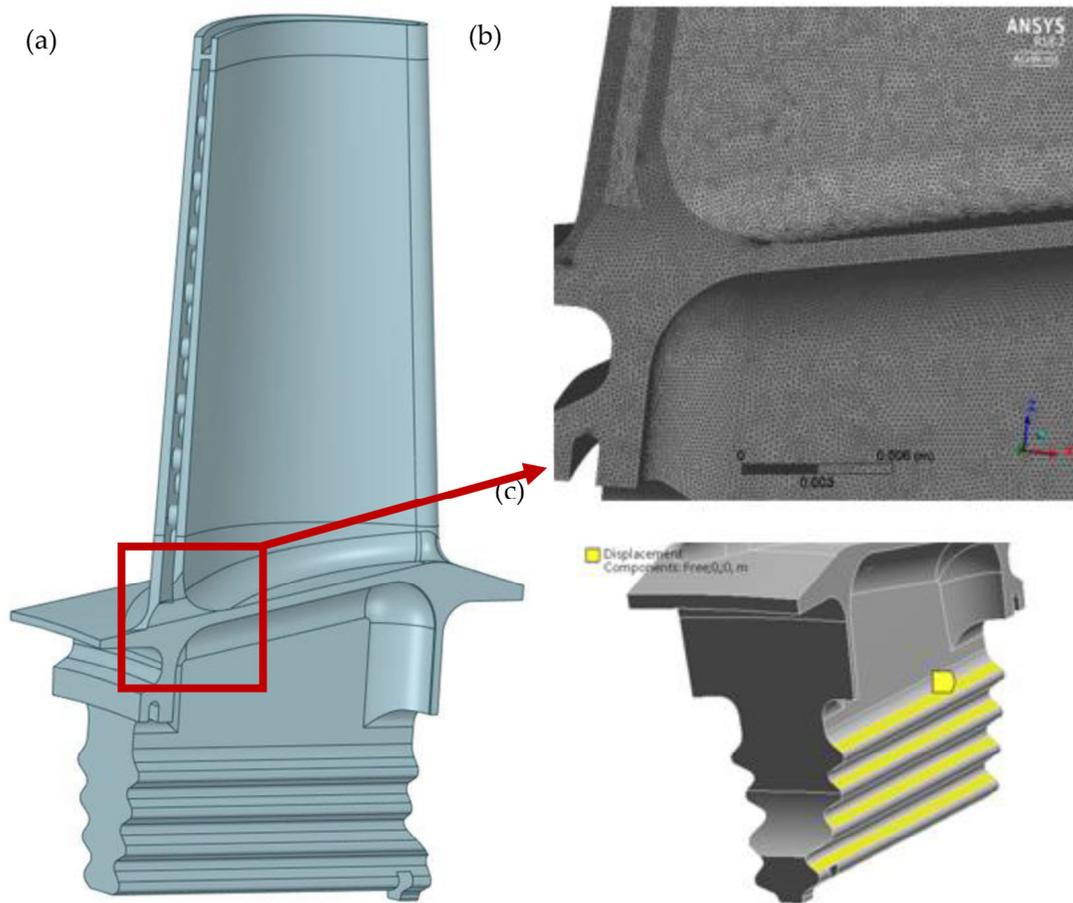
Figure 7. Created 3D CAD model of a high-pressure turbine blade (a) with computational mesh density (b); fix Boundary Condition on upper surfaces of the blade attachment (c).

In order to prepare the computational model of the turbine blade for strength analysis, we had to introduce appropriate corrections in the obtained surface geometry, enabling the generation of the computational mesh. A discrete model was obtained, consisting of about 9.5 mln nodes and 6.5 mln elements.

- Blade was fixed on upper surfaces of the blade attachment, as shown in Figure 7c,
- Angular velocity: 1627 [rad/s],
- HPT inlet pressure: 2,021,434 [Pa],
- HPT outlet pressure: 966,777 [Pa],
- HPT blade mass: 0.139 [kg],
- Density of HPT blade material: 8320 [kg/m³],
- Temperature: 950 [°C],
- Elastic modulus of HPT blade material: 190 [GPa],
- Poisson ratio of HPT blade material: 0.3.

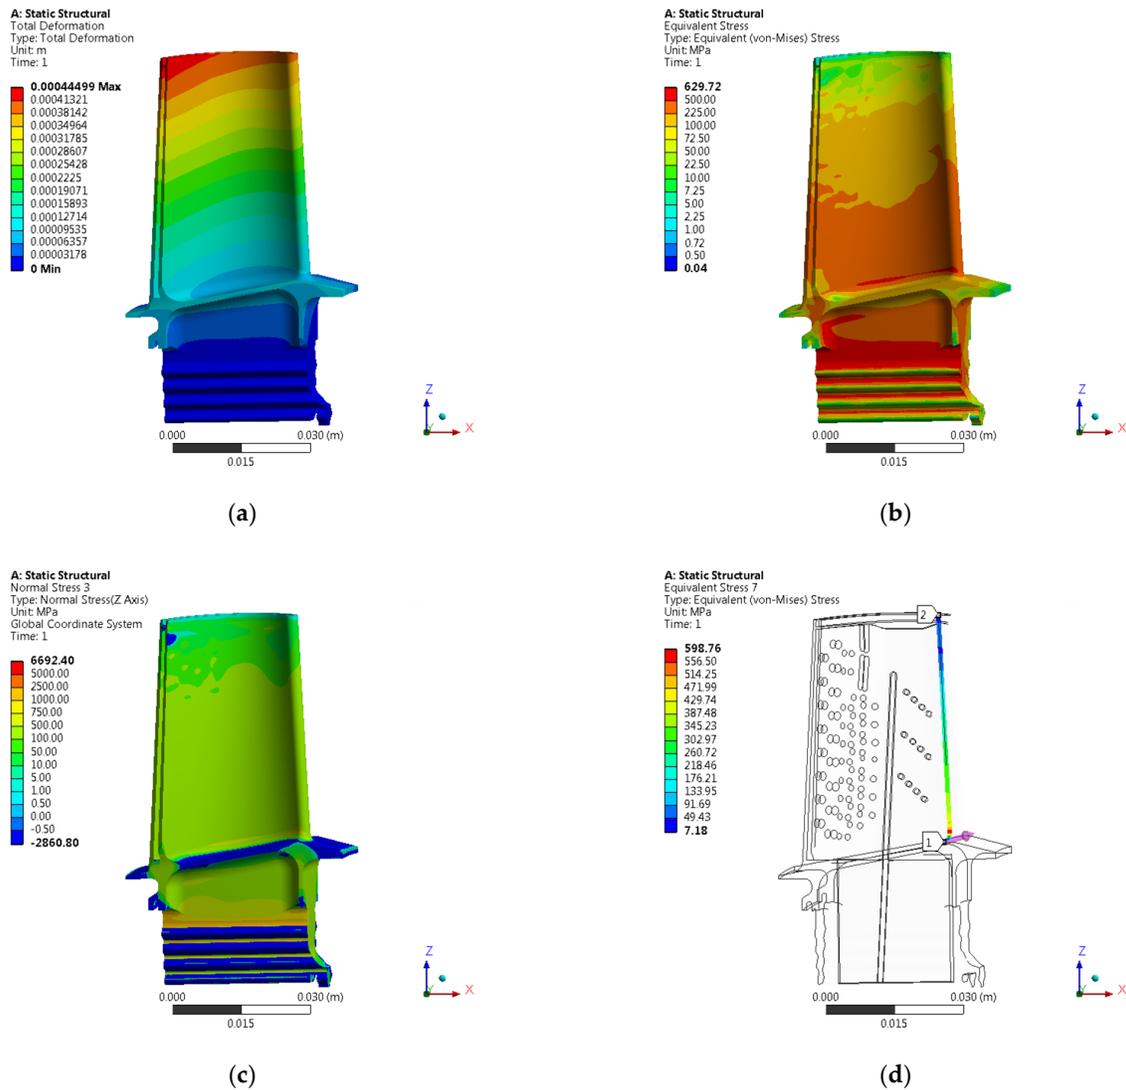
Figure 8. Results of HPT blade numerical analysis: (a) displacements [m], (b) equivalent stresses (von Mises) [MPa], (c) radial stresses [MPa], (d) equivalent stresses (von Mises) on blade leading edge [MPa].

Figure 8 presents numerical analysis results in the form of a graphical distribution of displacements, equivalent stresses (von Mises), radial stresses, and equivalent stresses (von Mises) on a blade leading edge. The results are shown for the entire blade (Figure 8), as well as for selected sections (Figures 9 and 10). The positions of specific sections were determined in relation to the lower surface of the blade attachment.

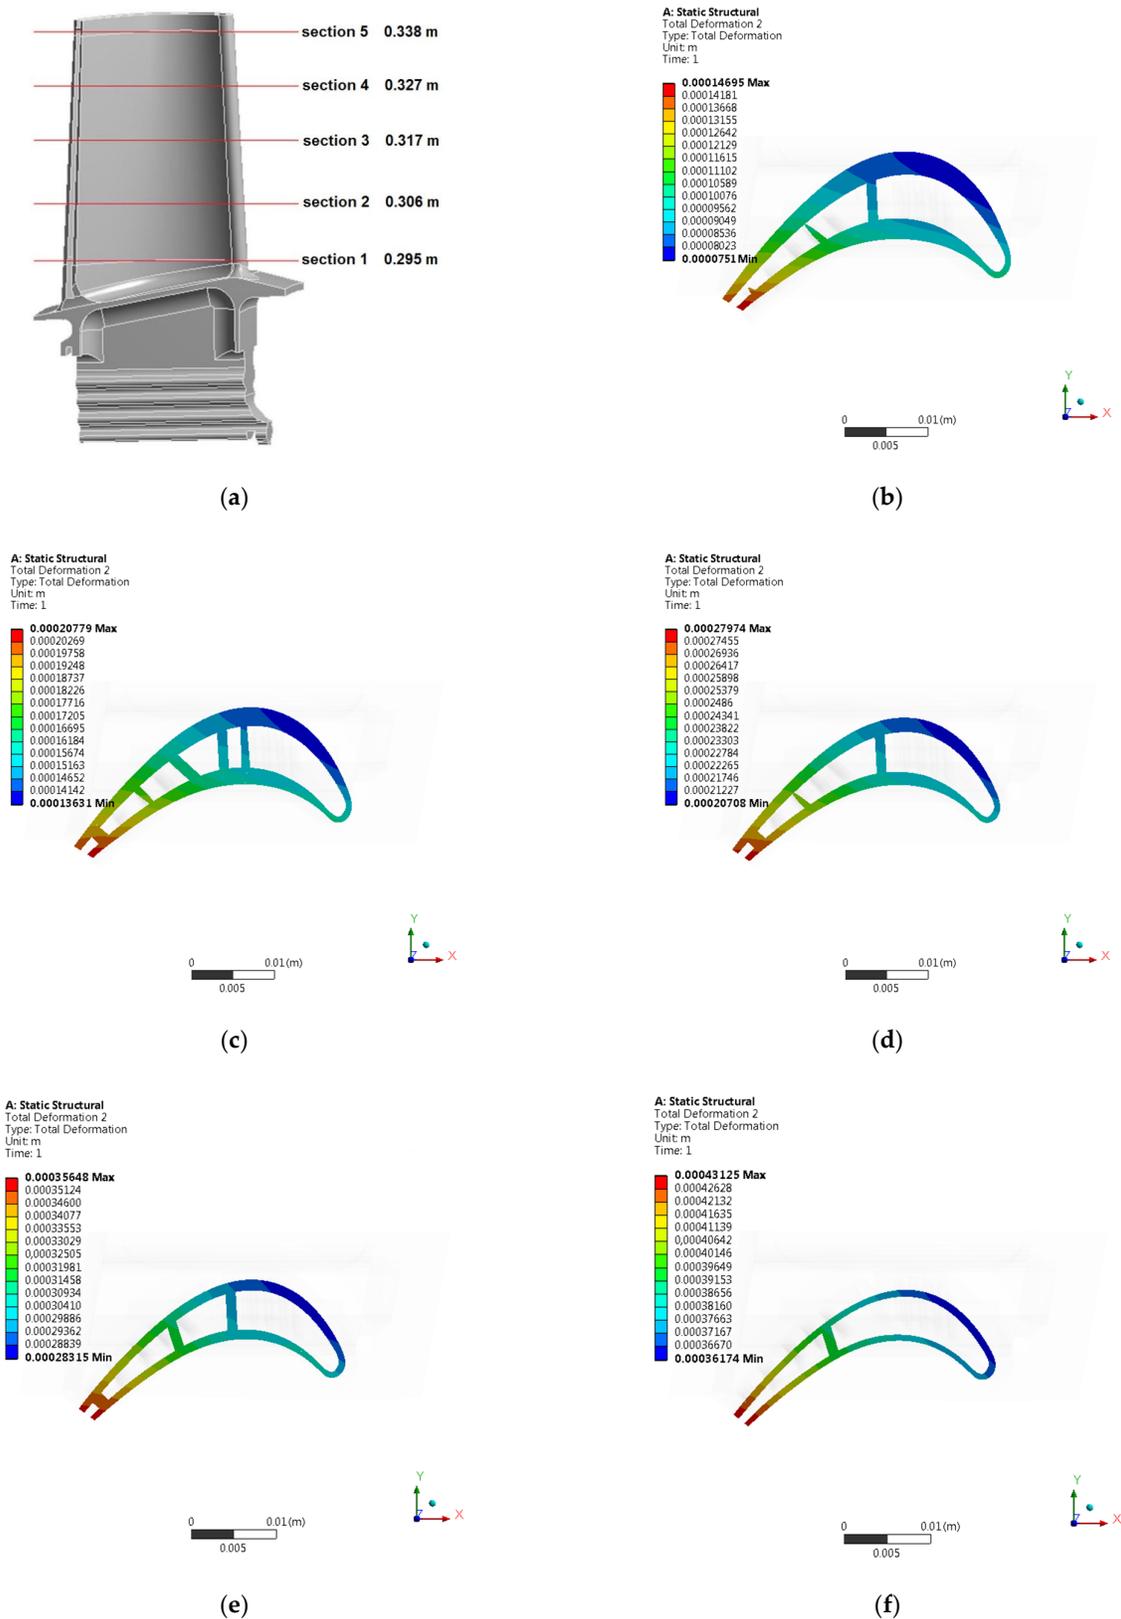
Figure 9. Position of the specific sections of the HPT blade (a); displacement [m] distribution in specific sections of the HPT blade: (b) Section 1; (c) Section 2; (d) Section 3; (e) Section 4; (f) Section 5.

During performed numerical strength analysis, results were obtained which indicate that, in the area of the blade trailing edge, the greatest value of displacements occurs. Moreover, the value of displacements varies along the height of the blade, reaching the highest values at its top. On the other hand, the highest values of equivalent stresses (von Mises) were obtained in the area of the blade leading edge and its high-pressure side. The value of equivalent stresses (von Mises) changed along the height of the blade, reaching the highest values at its base. Table 2 shows the maximum values of displacements and stresses obtained for the entire blade and in specific sections.

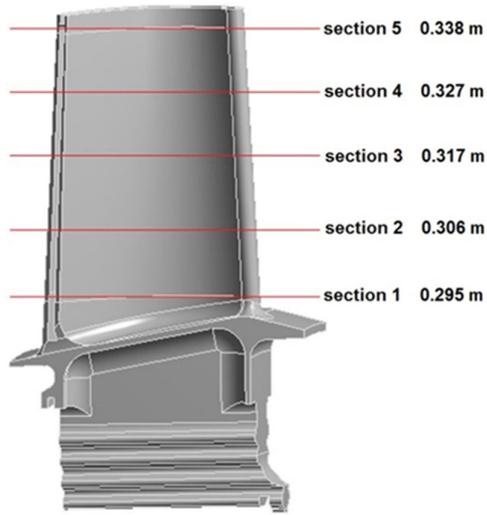
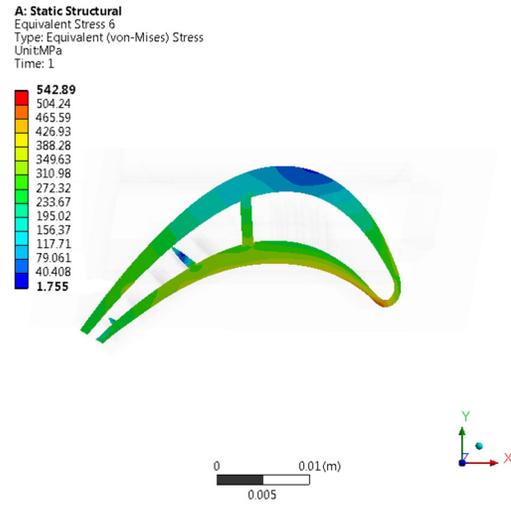
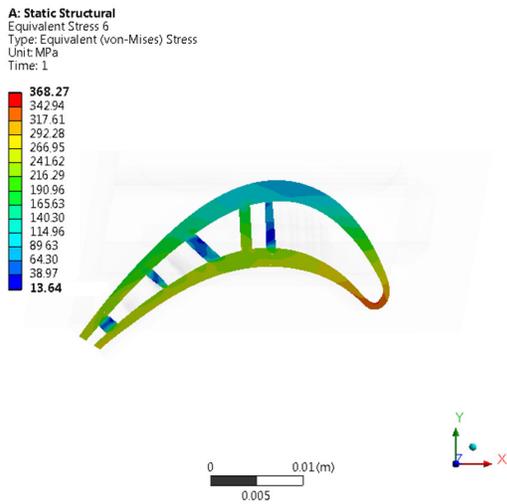
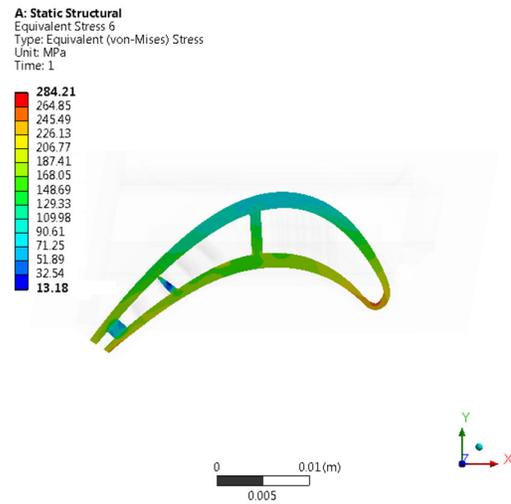
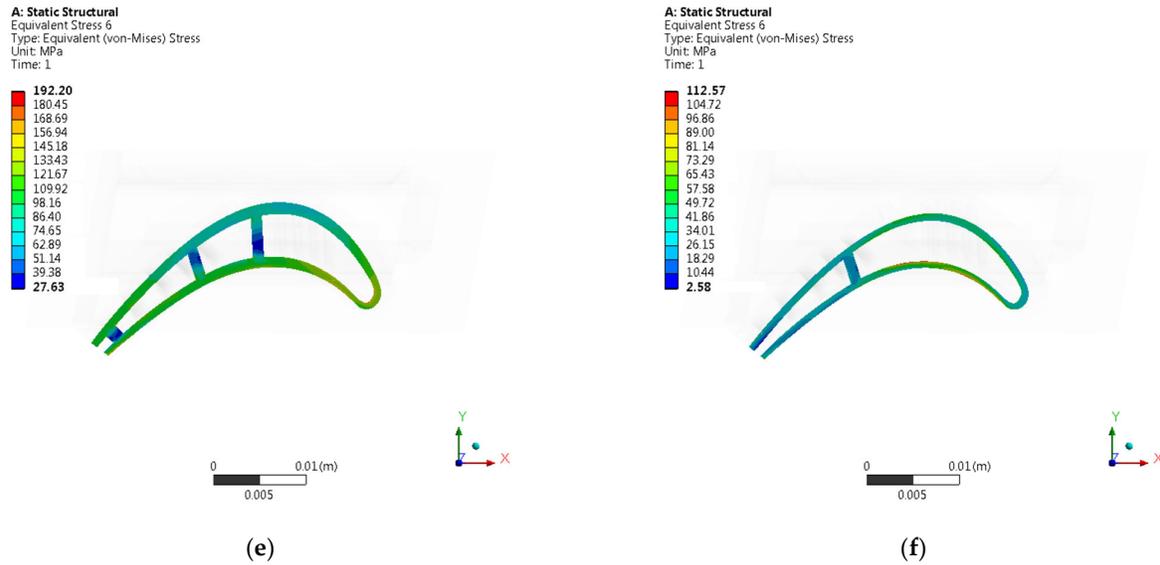
Figure 10. Position of the specific sections of the HPT blade (a); Equivalent stresses (von Mises) [MPa] distribution in specific sections. (b) Section 1; (c) Section 2; (d) Section 3; (e) Section 4; (f) Section 5.

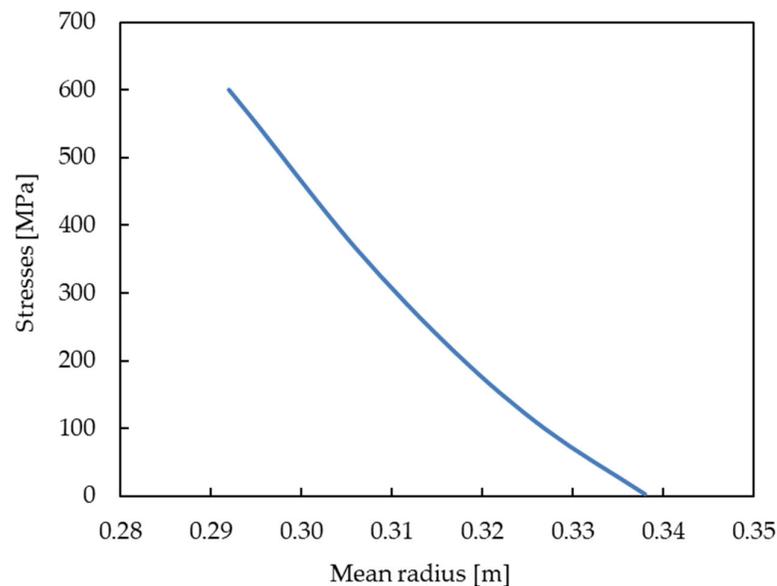
Figure 11. Change of stress values in the turbine blade.

During the calculations, the blade was divided into a selected number of segments. The volume of each segment was determined in Siemens NX software using the geometric model of the blade. Thanks to this, the volume of cooling channels inside the blade was taken into account and were subtracted from the analyzed material volume. Figure 11 shows the change of stress values in the turbine blade. The highest stress value obtained during the analytical calculations was 600.9 MPa and was found in the blade section near its base. It is worth noting that a high comparability of the analytical results with the results obtained from numerical analysis was achieved. This proves that the assumptions defined during the development of the HPT blade numerical model for the FEM analysis were correct.

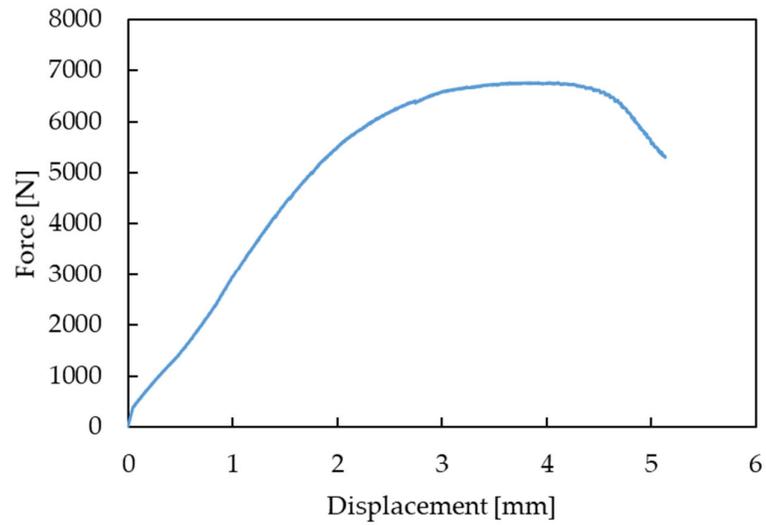
Figure 12. Static bending of the turbine blade at 950 °C.

The range of bending forces used in high temperature fatigue tests was established on the basis of static bending of the turbine blade at 950 °C (Figure 12) using the experimental setup presented in Figure 3. Such tests allows us to determine the maximal force to failure. In the next step of the experimental program, fatigue comparative tests were performed to elaborate the S-N curves for both types of the turbine blades. Selected hysteresis loops for the turbine blade subjected to cyclic loads of 5500 N are presented in Figure 13. As it is clearly seen, due to a longer time of exploitation (472 h), a significant decrease of fatigue strength by a factor of 20% was observed for the entire range of stress amplitudes considered, as shown in Figure 14. The fracture analysis of turbine blades after high temperature tests performed indicate that the failure of turbine blades occurred near the grip area, at the bottom part of the blade (Figure 15). It should be highlighted that this particular area was found to be the region with the highest stress concentration predicted by the FE model. The correctness of the FE model was therefore confirmed by the experiment performed.

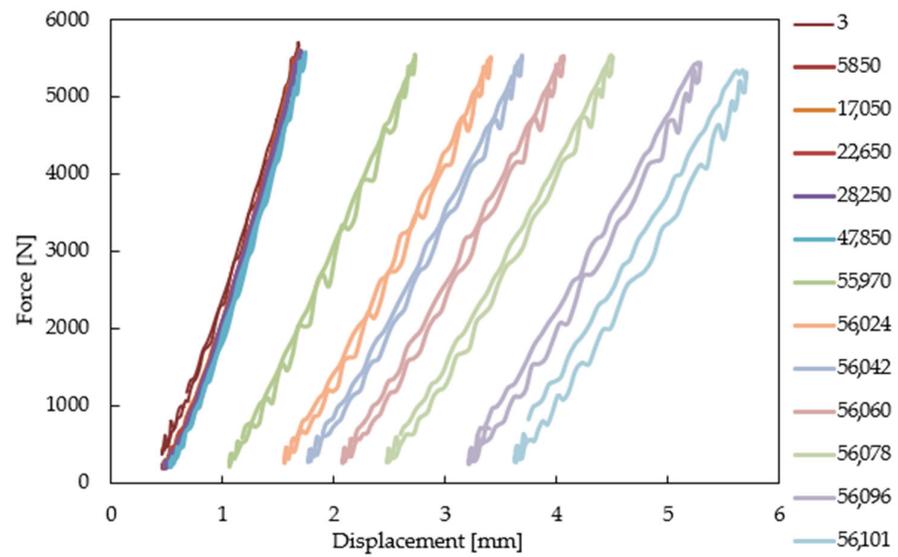
Figure 13. Selected hysteresis loops for the turbine blade subjected to cyclic loads of 5500 N.

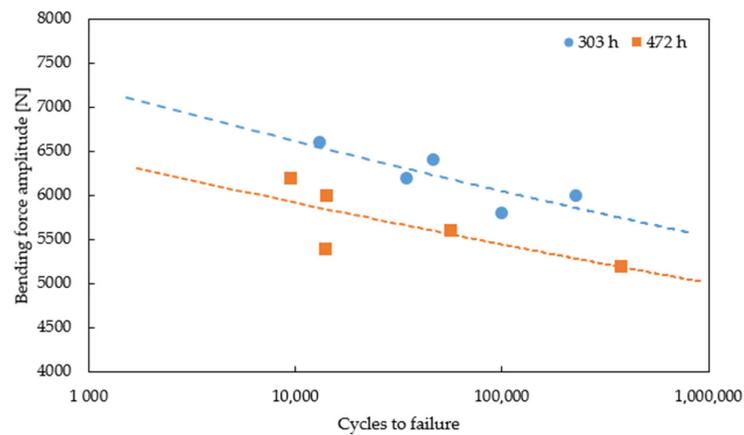
Figure 14. S-N curves for the turbine blades after different times of operation.

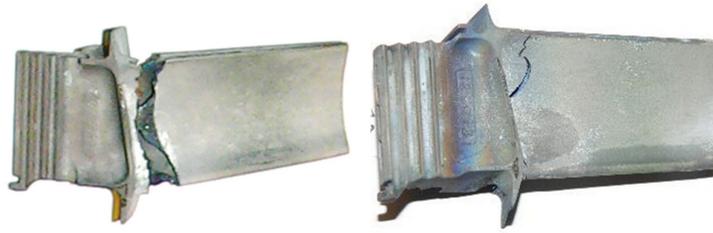
Figure 15. Photograph of the turbine blades after fatigue testing at 950 °C.

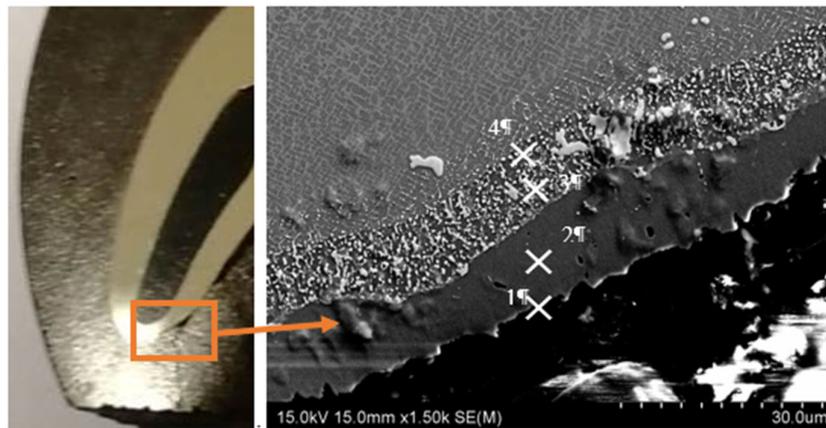
Figure 16. Photograph of the turbine blade metallographic section with SEM image after fatigue testing at 950 °C.

Microstructural characterization and chemical composition analysis was performed using scanning microscopy (Figure 16, Table 3). Microscopic observations revealed a typical structure of thermal barrier-coated nickel alloy with clear layer and interlayer zones. The coating itself consisted of two main sublayers. A chemical composition revealed that the outer sublayer, with a thickness of about 10 μm , contained mainly chromium (71.2% at) and nickel (21.6% at). In the interlayer area, aluminum (10.9% at.) was additionally observed. Such coatings effectively protect the substrate material against high temperature corrosion and oxidation [27].
