Microstructural Analysis of Fractured Orthopedic Implants

Abstract: In this paper, fracture behavior of four types of implants with different geometries (pure titanium locking plate, pure titanium femoral implant, Ti-6Al-4V titanium alloy pelvic implant, X2CrNiMo18 14-3 steel femoral implant) was studied in detail. Each implant fractured in the human body. The scanning electron microscopy (SEM) was used to determine the potential cause of implants fracture. It was found that the implants fracture mainly occurred in consequence of mechanical overloads resulting from repetitive, prohibited excessive limb loads or singular, un-intendent, secondary injures. Among many possible loading types, the implants were subjected to an excessive fatigue loads with additional interactions caused by screws that were mounted in their threaded holes. The results of this work enable to conclude that the design of orthopedic implants is not fully sufficient to transduce mechanical loads acting over them due to an increasing weight of treated patients and much higher their physical activity.

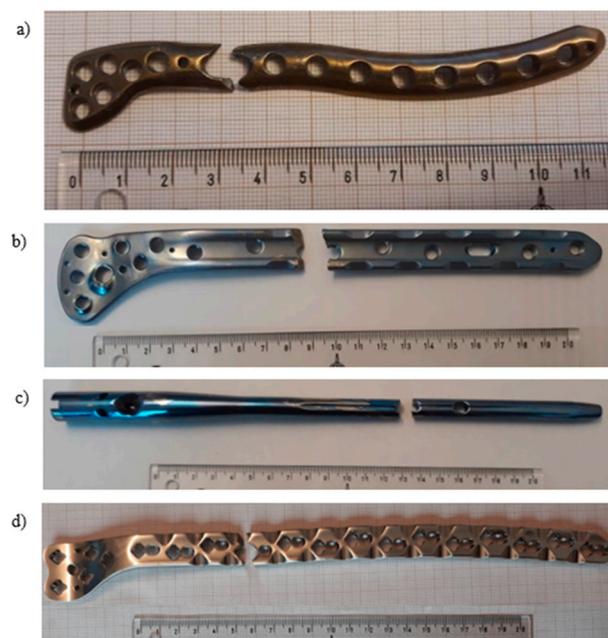
1. Pure titanium, angularly stabile, clavicular, locking plate (5.0 ChLP; ChM, Juchnowiec Kościelny, Poland; Figure 1a);
2. Pure titanium, angularly stabile, femoral, condylar plate (7.0 ChLP, ChM, Juchnowiec Kościelny, Poland; Figure 1b);
3. Ti-6Al-4V intramedullary nail (Triple Proximal Femoral Nail, Medgal, Poland; Książyno, Figure 1c);
4. X2CrNiMo18-14-3 steel femoral plate (4.5 mm VA LCP® Condylar Plate, DePuy Synthes, Warsaw, Indiana, USA; Figure 1d).

Figure 1. General view of the exploited implants with different geometries made of pure titanium clavicular (a) and distal femoral (b) plates, Ti-6Al-4V femoral gamma nail (c) and a X2CrNiMo18-14-3 femoral condylar plate (d).

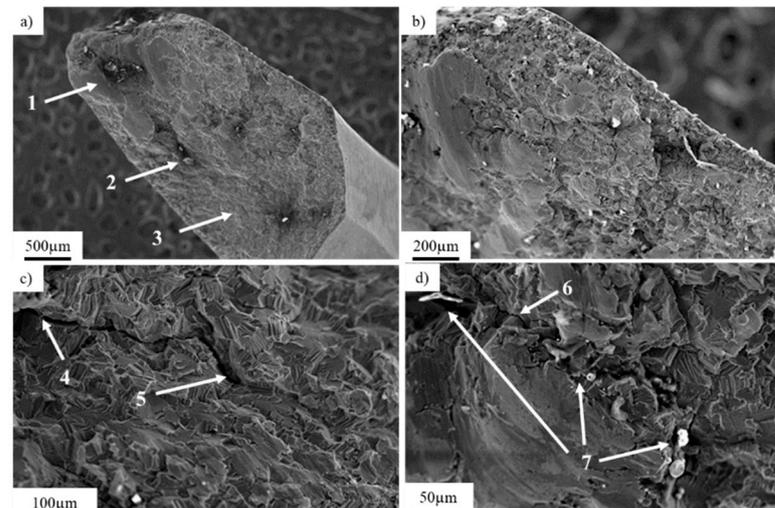
The chemical composition of a titanium locking plate is presented in Table 1. The implant's fracture zone was subjected to observations using a scanning electron microscope (Figure 2b). Figure 2a presents a general view of the fracture of exploited titanium implant with marked fracture zones characteristic for fatigue damage: (1; Figure 2a) the focus of the crack initiated around the inclusions with characteristically smoothed surface and the (2; Figure 2a) zone of fatigue breakthrough characterized by a coarse-grained structure (3; Figure 2a) residual area.

Figure 2. Fracture area of the titanium implant with marked fracture zones (a; 1–3) and its magnification showing the fatigue crack propagation zone (b); the crack development observed on titanium explant (c; 4–5) and its magnification showing the fatigue crack propagation area (d; 6) with local inclusions (d; 7).

Nucleation of cracks was initiated on the side part of the implant and was followed by a progressive crack development (Figure 2b) in consequence of cyclic loading. A further microscopic analysis performed on the fracture zone showed analogical fracture characteristics throughout the sample surface, as well as the same nucleation points and fracture paths. Nucleation of the crack (4; Figure 2c), as well as their development (5; Figure 2c), can be observed. Crack development led to the material fracture due to the friction between surfaces of the crack during crack propagation. Typical fatigue behavior of the material (Figure 3b) [42] with the direction of crack propagation (6; Figure 2d), as well as visible traces of inclusions (7; Figure 2d), were observed. The mechanism of the implant's fracture points to its mixed nature due to the presence of both plastic and brittle zones. On the fracture surface, cavities and extrusions (Figure 3a), characteristic for plastic deformation and cracks at the grain boundaries that are typical for brittle fracture, were observed (Figure 3b).

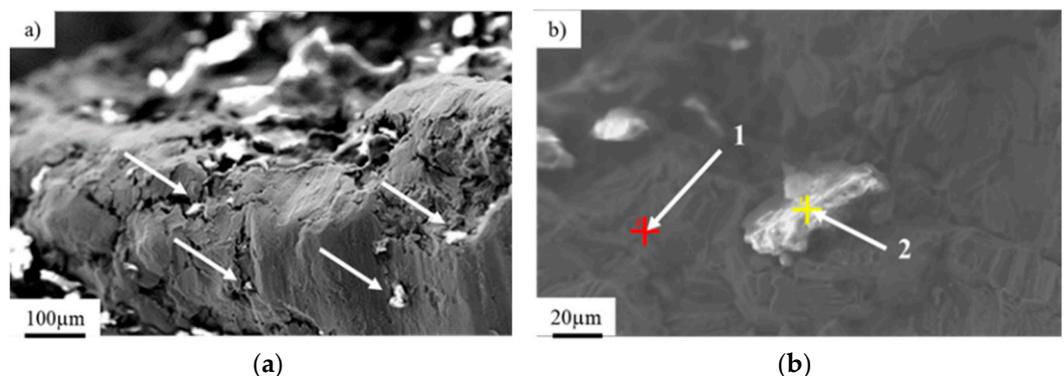
Figure 3. View of inclusions and precipitates on the implant surface and near the fracture zones (a); enlarged view of the inclusions on the implant surface (b).

Analysis of the chemical composition of the implant material (Figure 3b, point 1) and inclusions in the implant's fracture areas (marked with arrows, Figure 3a,b, point 2) using

the EDS technique showed characteristic peaks of oxygen and aluminum, clearly indicating that the inclusions consisted of aluminum oxide Al_2O_3 (Figures 3 and 4). These precipitates, which are characterized by extremely high hardness, serve as stress concentrators during loading. Stress components allocated around them make the crack initiation much easier in those areas rather than in homogeneous material [43]. The content of other elements in the inclusions may indicate the formation of precipitates as a result of reaction with the human body.

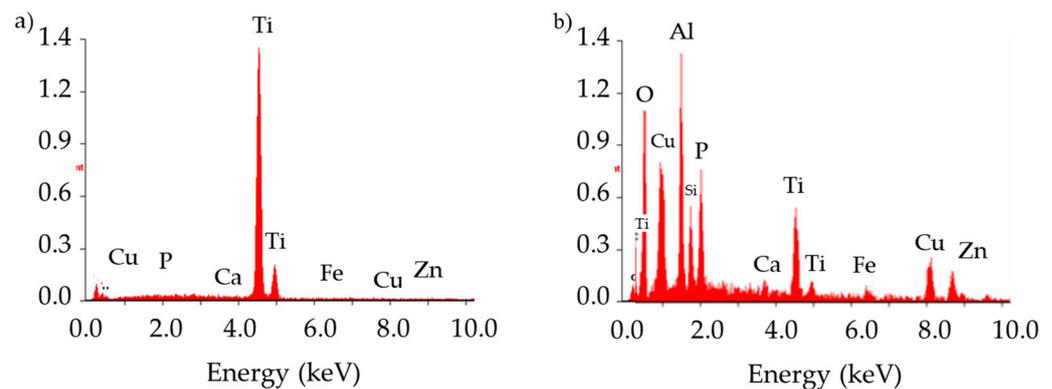
Figure 4. Analysis of the chemical composition of the implant (a) and the inclusion (b).

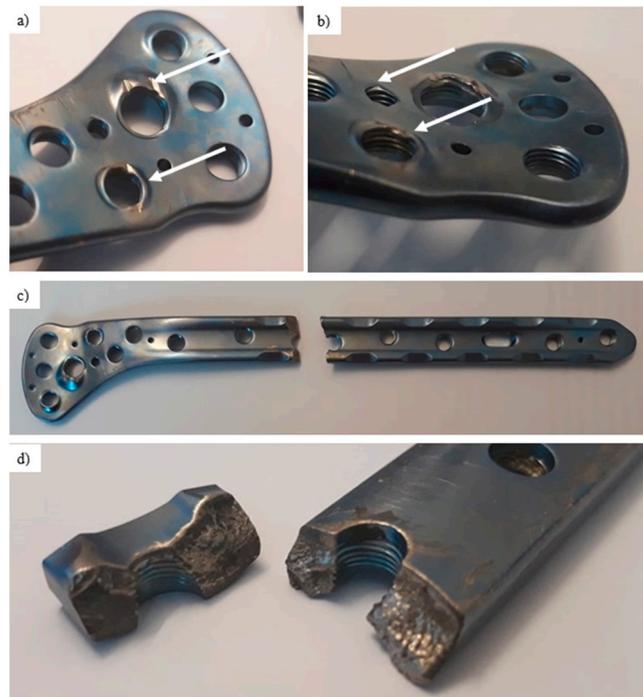
The chemical composition of the titanium alloy locking plate is presented in Table 2. Visual inspection performed on the femoral implant surface (Figure 5) allows to observe numerous local plastic deformation areas of the material around the threaded holes (Figure 5a,b, areas marked with arrows). Although no material losses were found on the screws, it was assumed that they led to permanent deformation of the implant. Figure 5d presents a macroscopic view of the fracture surfaces found near the threaded hole. These fracture surfaces were characterized by high smoothness, which may indicate that long-term friction occurred between them. As the fracture of the implant was found in this particular area, scanning electron microscopy was used to investigate the potential cause of failure. The SEM observations were performed on the inner part of the thread.

Figure 5. General view of the exploited titanium implant: plastic deformations found around the threaded holes (a,b), fractured implant (c) and fracture surfaces (d).

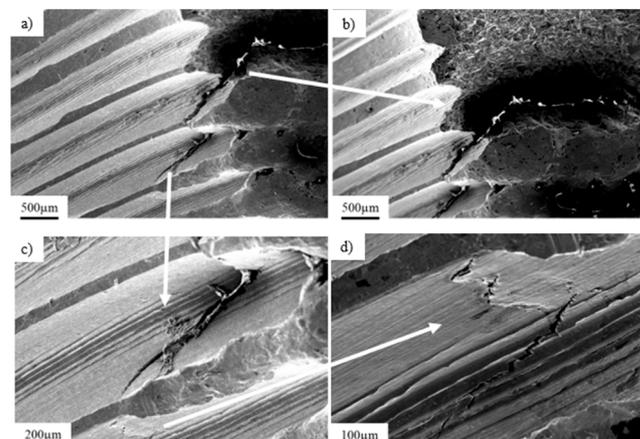
Figure 6 presents a general view of the crack in the inner thread of a titanium implant. The fracture was initiated in the center part of the thread (Figure 6a) and propagated deeply into the material as shown with the arrow (Figure 6b), leading to complete fracture of the implant, as shown in Figure 7. Furthermore, in the area of the dominant crack (Figure 6a, marked with the arrow), a 300- μm microcrack was observed (Figure 6c,d, marked with the arrow). Based on the observations performed on the fracture surfaces (Figure 8), it was found that, after the implant fracture, the two separated parts interacted with each other. The observed smooth surfaces (Figure 8a,b) are characteristic for friction processes, which result in surface wear of the material. The analysis of the fracture surface and the nature of the fracture allow us to state that the material was damaged due to the interaction of the implant and the screw that fastened the implant and the femur. Pieces of bone tissue were observed in the structure of the fracture, which was confirmed by the analysis of the chemical composition presented in Table 3.

Figure 6. View of the dominant crack observed inside the thread (a), crack propagation from the thread surface (b), enlarged area of the crack initiation (c) and surface cracks observed near the dominant crack (d).

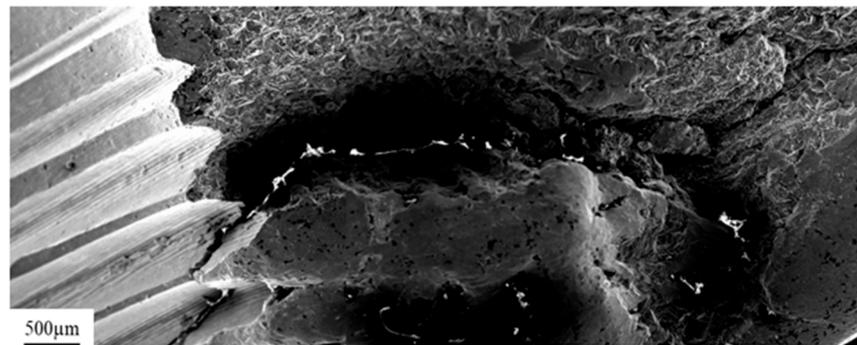
Figure 7. Crack propagation initiated in the center part of the thread.

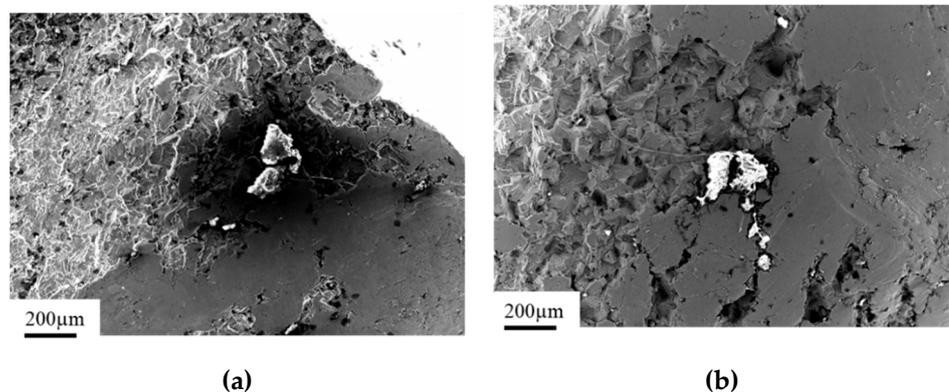
Figure 8. Fracture surfaces observed on both parts of the fractured implant: left part (a); right part (b).

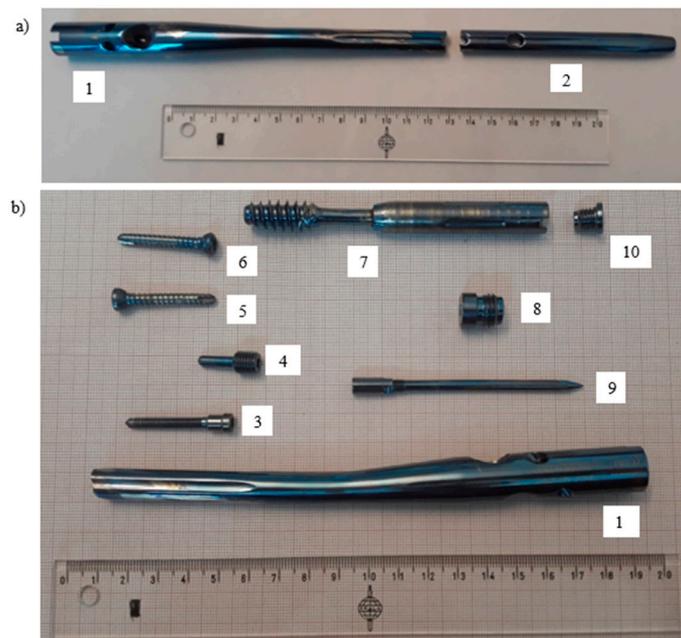
Ti-6Al-4V titanium alloy femoral gamma nail with a full set of its components (Figure 9) was subjected to visual inspection at first and, then, to microscopic observations. The chemical composition of the Ti-6Al-4V titanium alloy implant is presented in Table 4. Macroscopic examination of the implant surface allowed us to observe numerous local plastic deformations of the threads (Figure 10, marked with arrows) and the areas around the threaded holes (Figure 11, marked with arrows). These deformations caused the permanent deformation of the telescopic lag screw (part 7 in Figure 9) that was attached to the nail passing through the hole in the nail's shaft (Figure 10a). Additionally, propagation of the longitudinal crack from the shaft towards the thread was observed on the threaded surface (Figure 10b, marked with arrow). Simultaneously, the threaded part itself was plastically deformed (Figure 10c, marked with arrow), prohibiting damage and disabling its further usage. Permanent deformation of the inner areas of the threaded holes and their locking screws are presented and marked with arrows in Figure 11a–d. A significant abrasive wear of the thread was observed, probably due to the interaction of the screw and thread itself. On the other hand, traces of material wear in the unthreaded hole were observed as a result of long-term friction (Figure 11a,b, marked with arrows) of the telescopic screw of the nail's shaft.

Figure 9. General view of the broken femoral nail's shaft; its proximal (1) and distal (2) parts (a) with a set of assembling parts: proximal part of the broken nail's shaft (1); blocking bolt (3); nail's screw (4); two self-tapping locking screws (5 and 6); telescopic lag screw (7); end cap (8); anti-rotation pin (9); cap (10) (b).

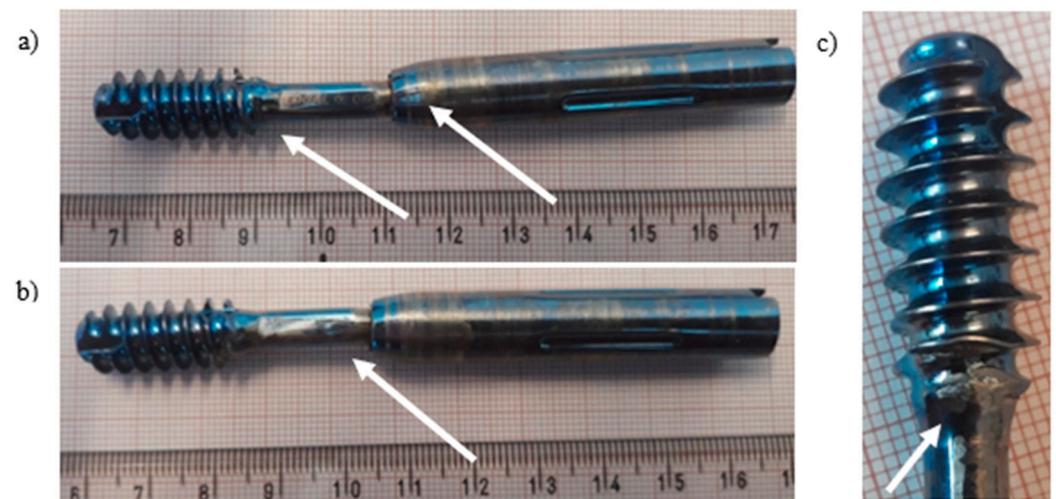
Figure 10. Visual inspection of the exploited telescopic lag screw (number 7 in Figure 9b) of the titanium implant: multiple cracks found on both sides of the telescopic lag screw (a,b); broken thread (c).

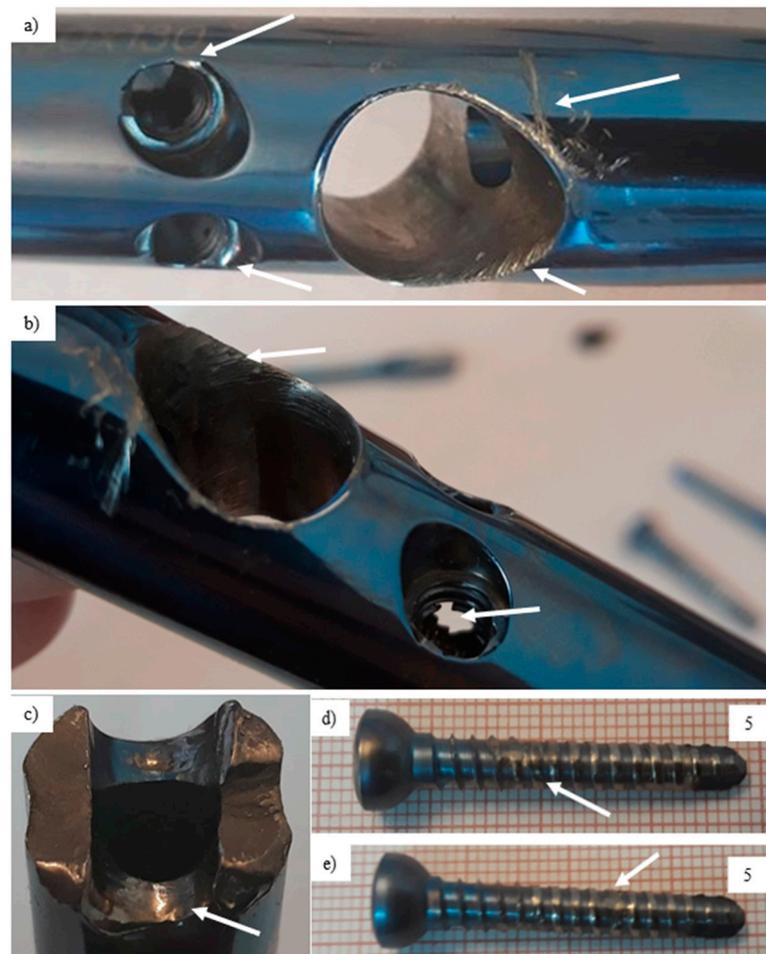
Figure 11. Visual inspection of the exploited part (number 1 in Figure 9a) of the titanium implant: worn marks (a); broken hole thread (b); fracture surface with area of wear (c); broken threads of screws (d,e) (number 5 in Figure 9b).

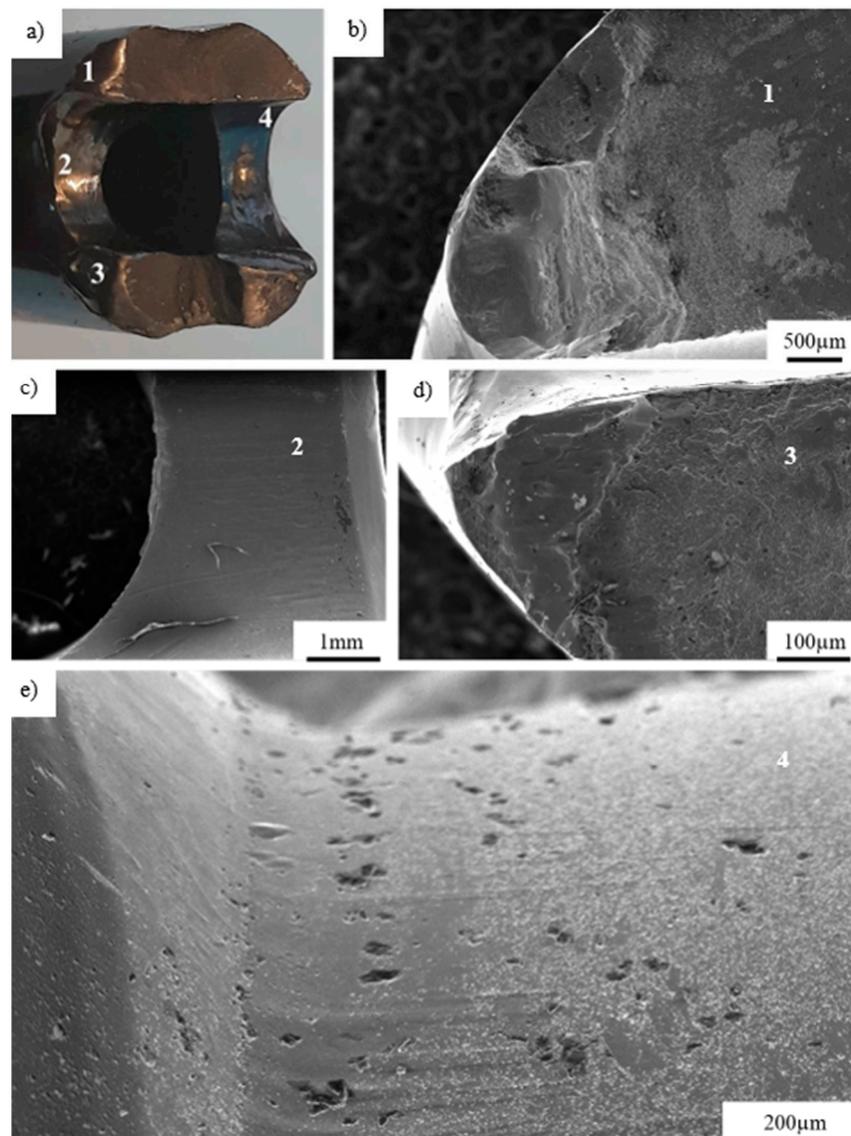
Figure 12 presents an overview of the fracture area observed in the outer part of the titanium implant hole. The areas numbered 1–4 in Figure 12a during visual inspection were subjected to microscopic observations and presented in Figure 12 b–e according to numbers given. The crack was initiated at the outer part of the hole (on its edge—Figure 12b,d) and propagated deeply into the material, leading to its complete fracture. Additionally, the 1.25-mm and 0.5-mm-long cracks were observed below the main crack (Figure 12c), as well as micropores found on the edge of fractured implant (Figure 12e). Based on microscopic observations, it could be concluded that, after the implant's break, both its separated parts rubbed on one another, producing characteristic smooth surfaces of the parts succumbing to friction. Inspection of the components of the implant and surfaces of its fracture allowed us to conclude that the implants broke in consequence of the overloads that transmitted excessive mechanical stresses from the bone to the implant's shaft by attaching the screws.

Figure 12. Macroscopic view of the fracture surface with marked areas of SEM inspection (a); the edge of fractured implant (b); cracks observed in the central part of hole (c); the second edge of fractured implant (d); micropores found on the edge of the fractured implant (e).

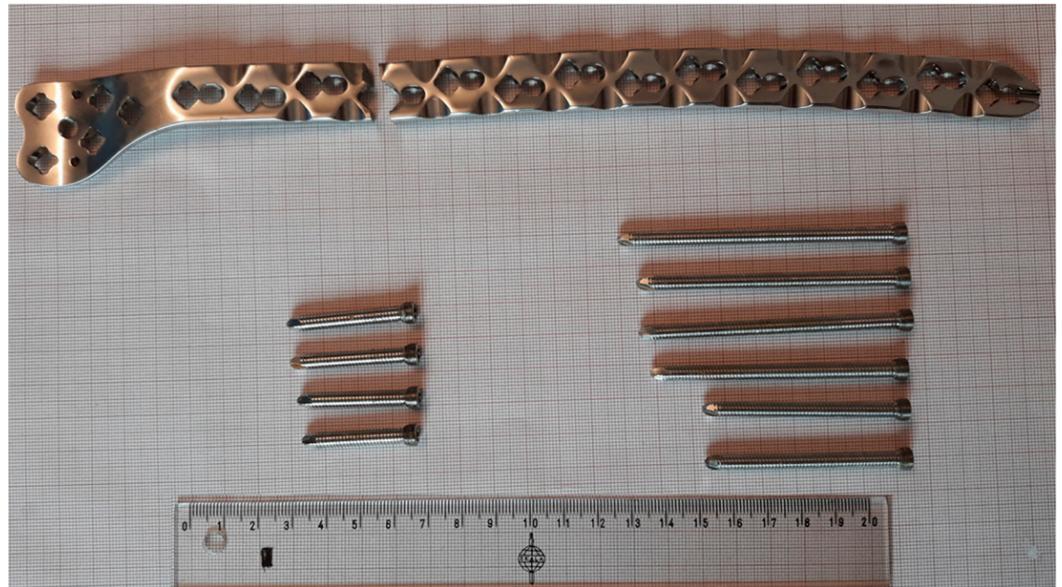
The steel femoral condylar plate (Table 5) was made of X2CrNiMo18-14-3 (D) steel (316L, PN-ISO 5832-1 Standard [44]). A macroscopic inspection (Figure 13) allowed us to observe the foci of the fracture in the area of the threaded hole (Figure 14). Smooth fracture surfaces are characteristic for the friction processes that indicated that two separated parts of the implant interacted between themselves after its break. Additionally, visible traces of wear were observed on one of the implant's mounting screws with damage of the 35-mm-long segment of its thread.

Figure 13. General view of the explanted steel femoral condylar plate.

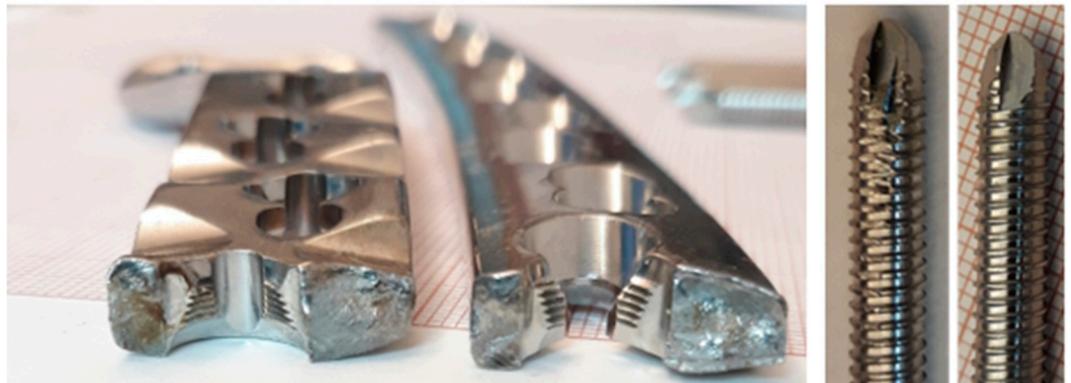
Figure 14. Visual inspection of the fracture surface of the steel implant compared to the as-received and exploited screw.

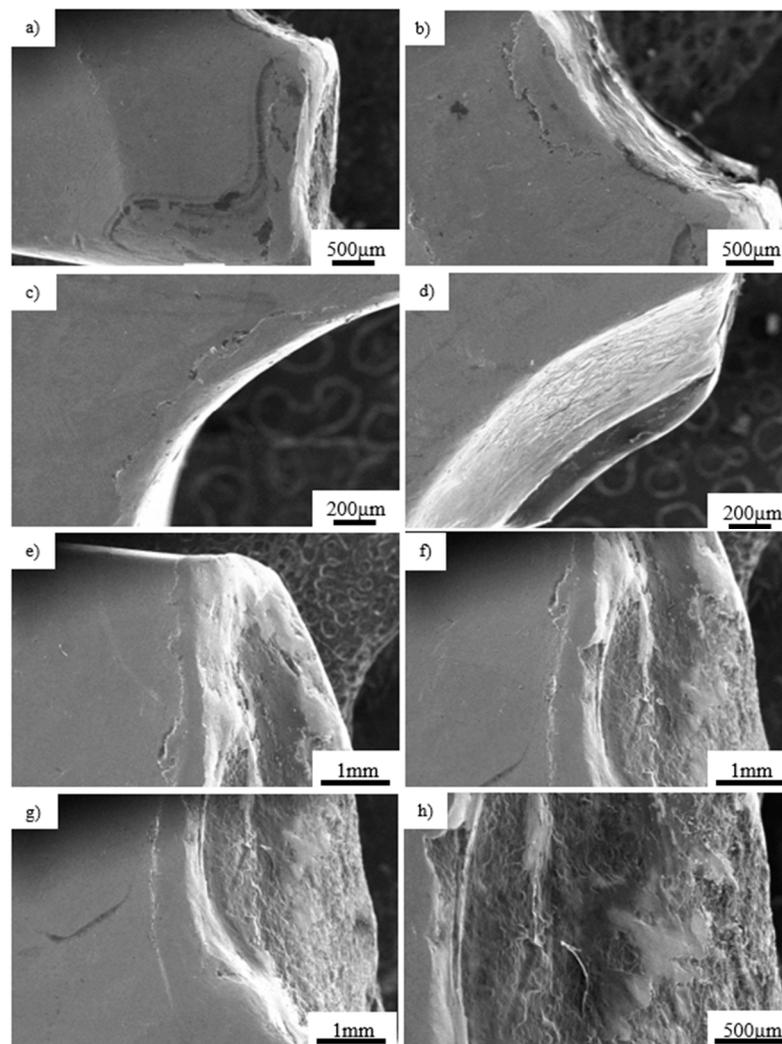
A visual analysis (Figure 15a) revealed a characteristic crater formed around the threaded hole that occurred due to permanent deformation of the material caused by the transmission of excessive forces by the screw mounted in it. Multiple cracks propagating from the crater along the edge of the hole could also be observed (Figure 15b,c). Moreover, numerous scratches inside the nonthreaded part of the hole were observed, most likely caused by screwing the bolt into the hole or the impact of the bolt head on the side surface of the hole (Figure 15d). The edges of the second part of the fractured implant were also characterized by numerous cracks (Figure 15e–g). Analogically, smooth surfaces of the fracture edge caused by friction of one part of the broken implant over another were observed (Figure 15h).

Figure 15. Microscopic observations of the fracture surface of the steel implant: crater formed around the threaded hole (a); cracks propagating from the crater along the edge of the hole (b, c); scratches inside the nonthreaded part of the hole (d); numerous cracks on edges of the second part of the fractured implant (e–g); smooth surfaces of the fracture edge caused by friction of one part of the broken implant over another (h).

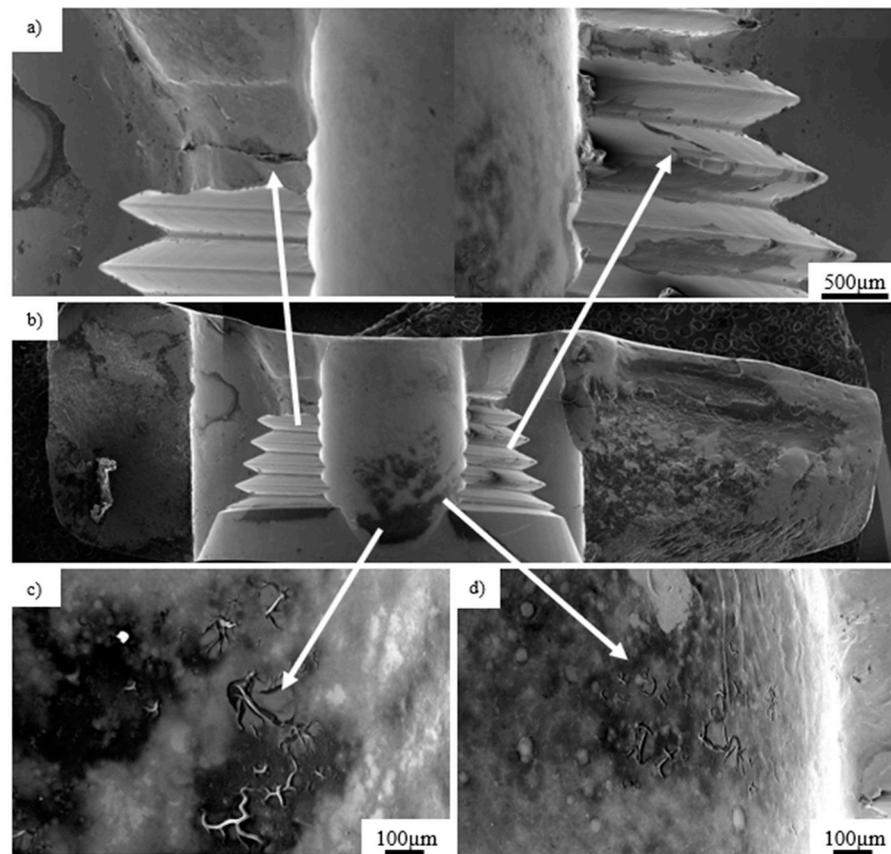
Microscopic observations of the inner area of the fracture surface revealed dominant cracks in the inner aspect of the thread (Figure 16, marked with arrow). The crack, which initiated at the upper part of the thread, propagating deeply into the structure of the implant up to its outer surface, leading to its fracture (Figure 16a, marked with arrow). In addition, 100–300- μm microcracks could be observed on the threads and around the unthreaded parts of the hole as marked with arrows in Figure 16c,d. Bolts were subjected to an additional analysis (Figure 17), showing a significant degree of wear in one of them. The entire thread, about 30 mm long, was significantly damaged. Inspection of the fracture surface and the nature of the fracture of the implant allowed us to state that the material was damaged due to screwing it with excessive force to the plate.

Figure 16. Microscopic observations of the inner area of the fracture surface.

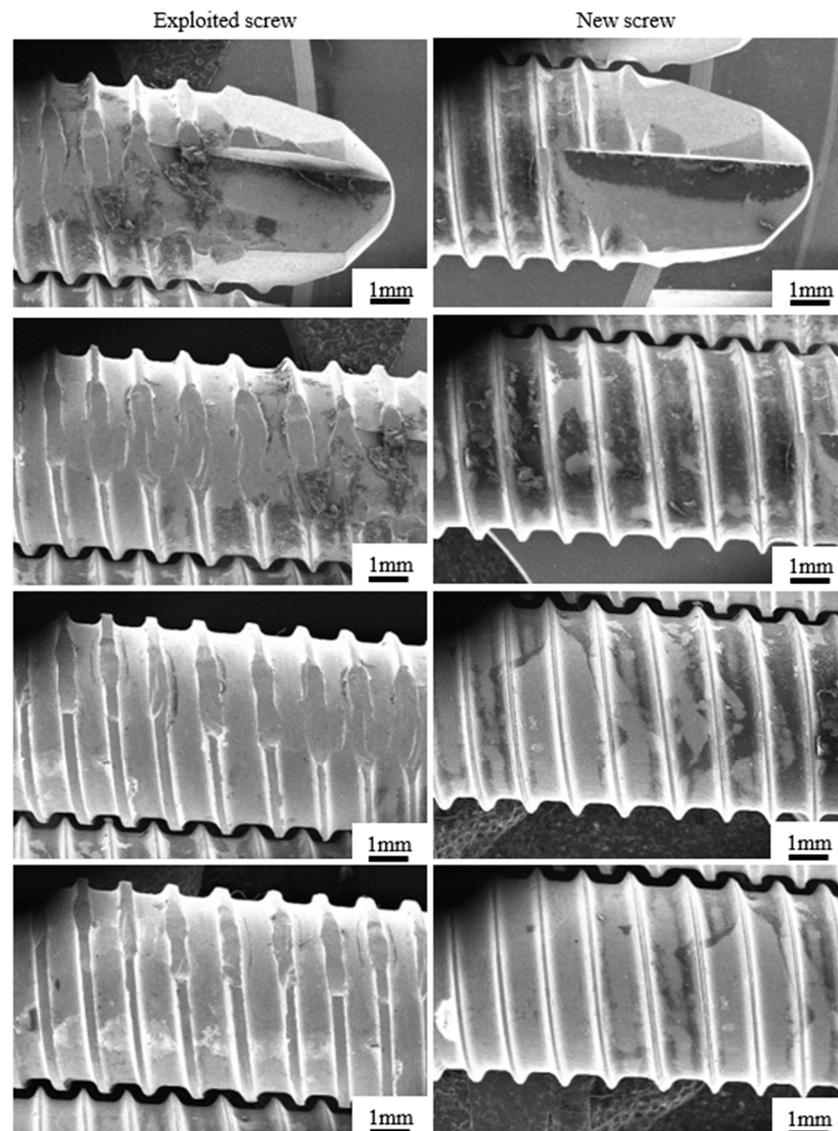
Figure 17. Comparison of the explanted screw (left column) and the new one (right column).
