Assessment of highway pavement concrete suffering from alkali-silica reaction: case study

ABSTRACT: After 15 years of exploitation, numerous instances of damage to the concrete pavement motorway located in northern Germany were observed. Detailed macro and microscopic analysis and determination of mechanical properties were performed on the collected cores. It was found that cracks in the coarse and fine aggregate resulted from advanced alkali-silica reaction. No impact of de-icing agents on the destruction of the concrete pavement was found, while attention was paid to the potential intensification of concrete degradation resulting from the increase in traffic on motorways. The results obtained are a detailed supplement to the German research, as this region (Rostock) has not been analysed before.

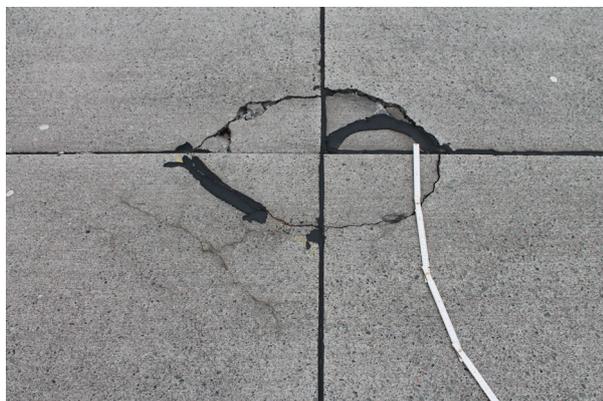
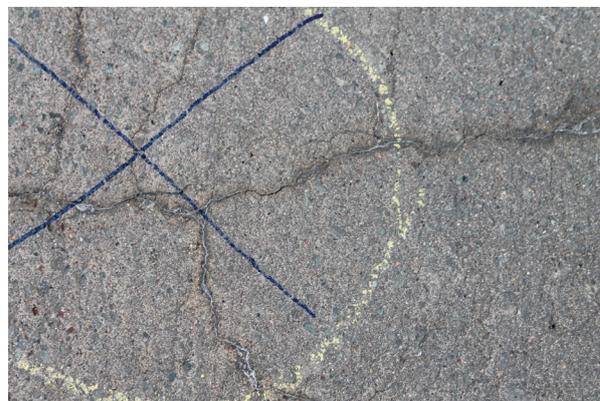
FIGURE 1. Surface cracking of concrete highway pavement suspected to be due to ASR.

The expressway was built more than 15 years ago and there is no original data on the composition of the concrete. It can only be assumed that the local resources of fine and coarse aggregate were used, as the current German ASR guidelines have been in force for only 9 years (17). The research was carried out on cores cut from the concrete expressway in the vicinity of Rostock. After 15 years of use, the concrete pavement was characterised by significant cracks (Figure 1). From representative locations on damaged sections of the concrete slabs, cores were extracted and were subjected to detailed laboratory tests and analysis.

The drill cores were taken via cracks or joints. The drillings were led from above through the structural concrete of the slabs (in the following also referred to as concrete, which had a thickness of about 265 mm).

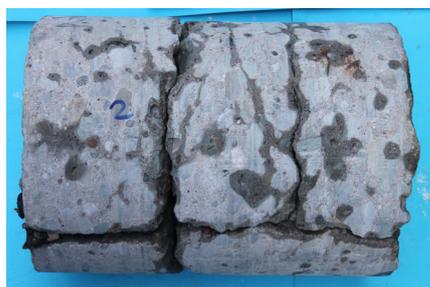
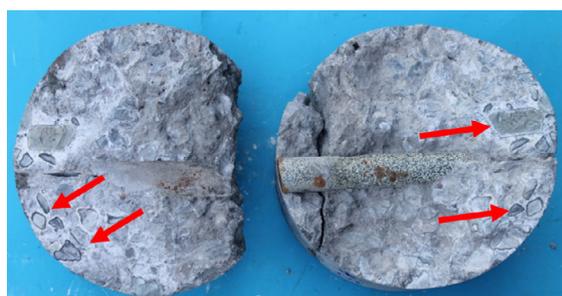
FIGURE 2. Photograph of the cores: a) jacket surface of core 2 during advanced drying, after immersion in water to make the cracks in the concrete more visible, b) typical signs of ASR - the edges or the fracture surfaces of the aggregates (s. arrows).

The drilled cores were subjected to a thorough visual inspection, photographed (Figure 2) and measured. Macroscopic analysis was performed on halves of 6 cores cut vertically. The remaining core halves were left as control and reference. The homogeneity of the concrete, general composition, type of fine and coarse aggregate as well as entrapped air and cracks were taken into consideration. After macroscopic analysis, the specimens were cut into 30 ± 2 mm sections, polished on SiC powders (180, 320, 600, 1000) and dried at 50°C for 24 h. The Damage Rating Index (DRI) method was used to quantify the internal deterioration of the concrete pavement (18). A petrographic examination was performed using a stereomicroscope at 30x mag. in order to identify and count defects associated with ASR. The assessment was made on the basis of summing up individual factors with different weights adopted in accordance with (18). The higher the DRI value, the higher the ASR-induced concrete degradation rate. The analysis was performed on 6 specimens (10×10 cm).

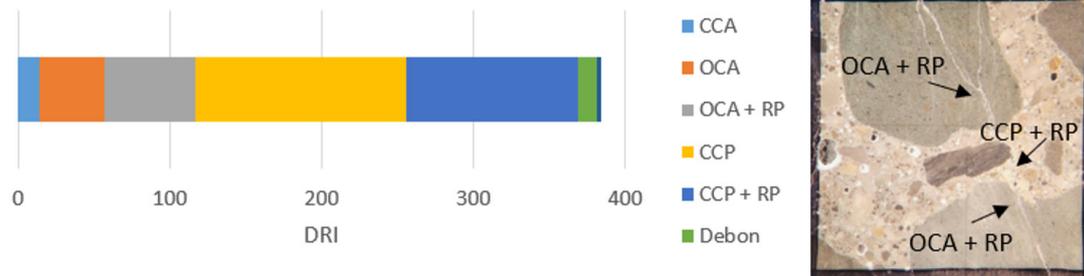
CCA-closed cracks in the coarse aggr. OCA- open cracks or network of cracks in the coarse aggr. OCA+RP-cracks or network of cracks with reaction product in the coarse aggr. CCP-cracks in cement paste. CCP+RP-cracks with reaction product in cement paste. Debon-coarse aggr. deboned

FIGURE 3. Results of petrographic examination for Damage Rating Index calculations performed on the concrete cores and exemplary analysed area 1x1 cm².

Summarised results of the calculation of the DRI are presented in Figure 3. The average value of the DRI from six specimens was 384 ± 32 , which suggests that the concrete pavement was damaged due to ASR. Sanchez *et al.* (20) and Fournier *et al.* (21) suggested a classification of ASR damage exposed to a moist-warm storage for the DRI using the weighting factors proposed by Villeneuve *et al.* (18), according to which the tested pavement concrete was moderately damaged as a result of ASR (3 on a five-point scale).

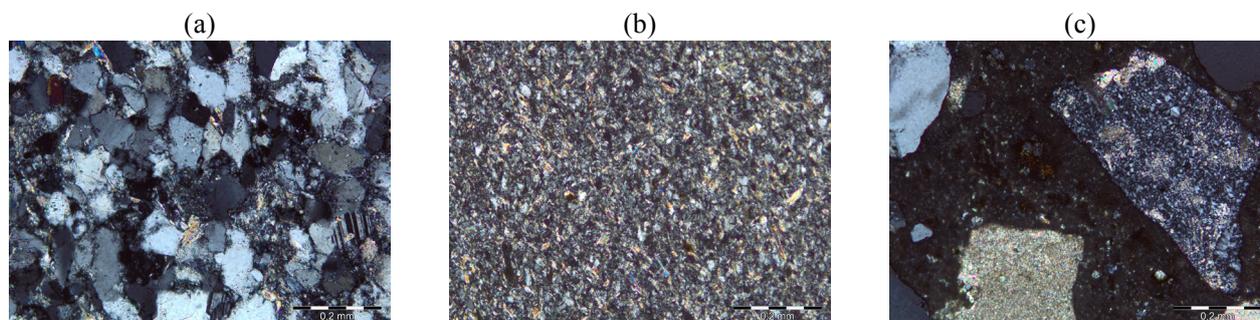
FIGURE 4. Cross-sections of coarse aggregate on thin section in XPL: a) sandstone, b) silt and c) fine aggregate: quartz, limestone and chert; scale bar = 0.2 mm.

In the concrete cores during petrographic analysis, three main genetic rock types were found: sedimentary, metamorphic rock and mineral clasts (Figure 4). Four aggregate size fractions can be distinguished: 16–32 mm: sandstone and silt, 4–16 mm: sandstone, weakly metamorphosed silt shale (phyllite), limestone, quartz, amphibolite, 0.063–4 mm: quartz, feldspar, limestone, chert, and below 0.063 mm: limestone, quartz, feldspar, amphibolite.

As coarse aggregate, sandstone (Figure 4a), a massive silt with aleuritic microstructure (Figure 4b) and weakly metamorphosed silt shale were found. The sandstone was characterised by well sorted grains with low sphericity, and subrounded. Plagioclase was present as well as carbonate crystals. As a binder, remains of primary clay matrix, secondary siliceous cement and carbonate cement were identified. In the silt, a primary clay matrix was abundant and the secondary matrix was cement. The silt shale was composed of quartz, carbonate, plagioclase, feldspar, muscovite and opaque mineral. As fine aggregate, grains of quartz and limestone were found as well as chert particles (Figure 4c). In most cases, the chert was formed by chalcedony and quartz, but it also contained carbonate.

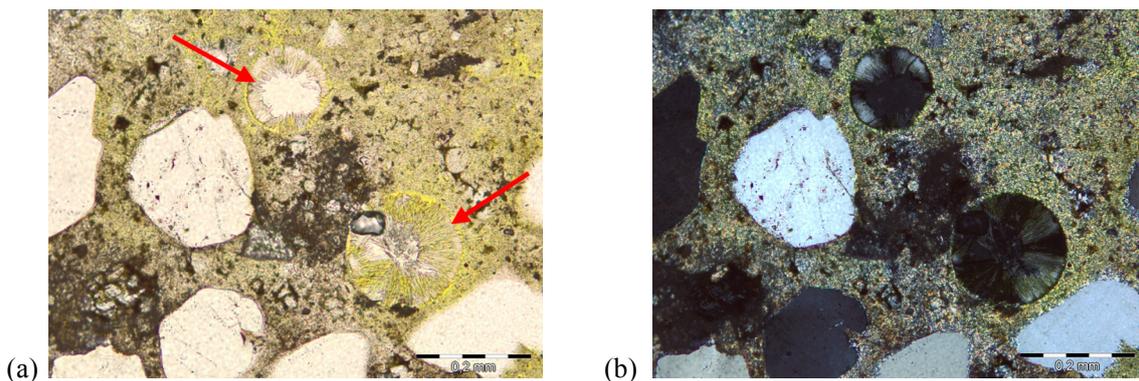
FIGURE 5. Cross-sections of the concrete microstructure: air-voids partially filled with ettringite needles, fine aggregate particles: quartz; a) PPL, b) XPL; scale bar = 0.2 mm.

The pavement concrete was air-entrained to ensure frost resistance. The air-void system was visible on the thin sections, but almost all the air-voids were partially or fully filled by ettringite (Figure 5). However, this should not significantly affect the concrete degradation caused by ASR.

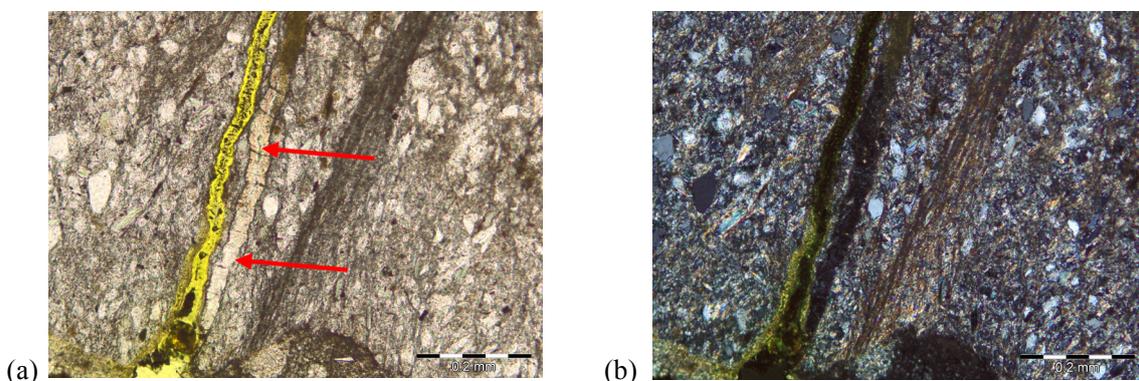
FIGURE 6. Cross-sections of the coarse aggregates: weakly metamorphosed silt shale (phyllite) on thin section with visible ASR gel (red arrows): a) PPL, b) XPL; scale bar = 0.2 mm.

gregate and cement matrix (Figures 6–8). Most of the cracks were propagating from aggregate grains through the cement matrix (Figure 6). They were empty or lined with ASR gel. The cracks located in the coarse and fine aggregate contained Si-Ca-K-Na gel (Figures 6 and 7). The microscopic analysis did not reveal any de-icer ions in the CSH. There was no presence of either chloride ions, ASR gel or Friedel's salt in the cement matrix.

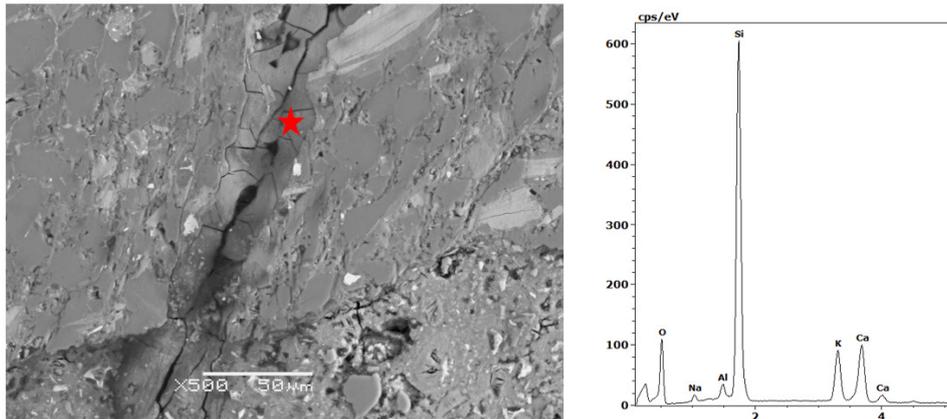
FIGURE 7. Scanning electron micrograph of the cracked coarse aggregate grain (phyllite) filled with Si-Ca-K-Na gel.

Much lower content of sodium ions compared to potassium ions was found in the alkali-silica gel (Figures 7-8), which may result mainly from the composition of the cement used and from the possible leaching of alkali from the aggregate. The cracks in the aggregate, regardless of its fraction, were of similar size – 30–40 μm , and were mostly filled with ASR gel which flowed into the cement matrix. The ASR gel was in an amorphous (Figure 7) and crystalline (Figure 9) form.

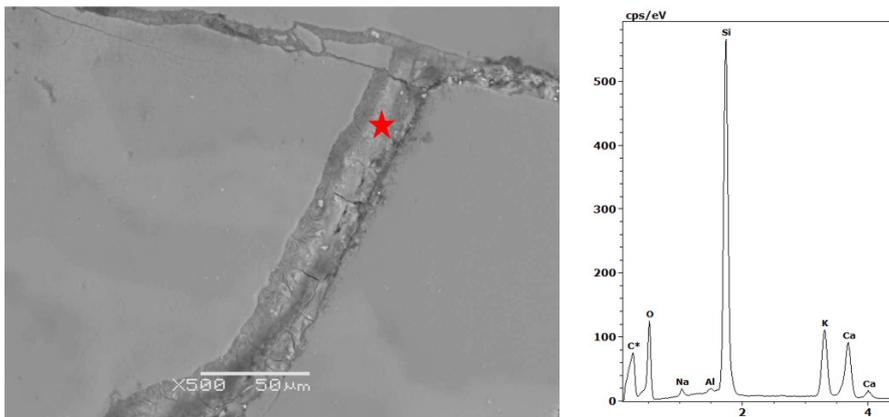
FIGURE 8. Scanning electron micrograph of the cracked fine aggregate grain (chert) filled with Si-Ca-K-Na gel.

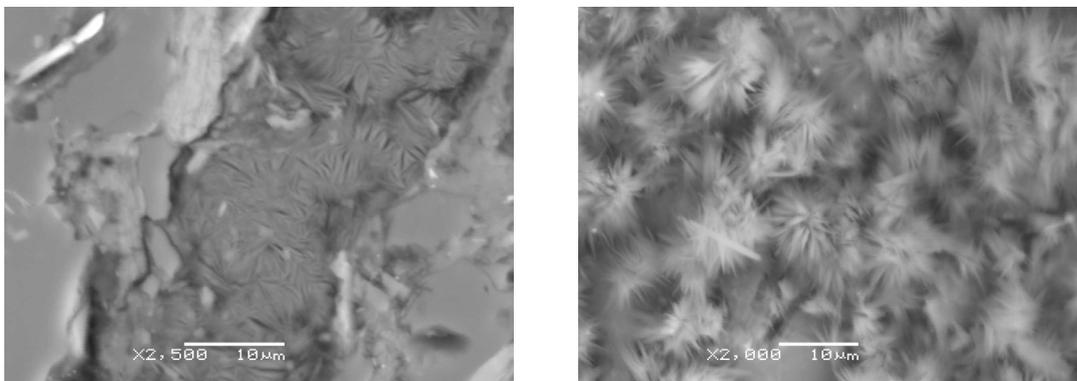
FIGURE 9. ASR gel on a) polished surface and b) fresh fracture surface; SEM, scale bar = 10 μm.

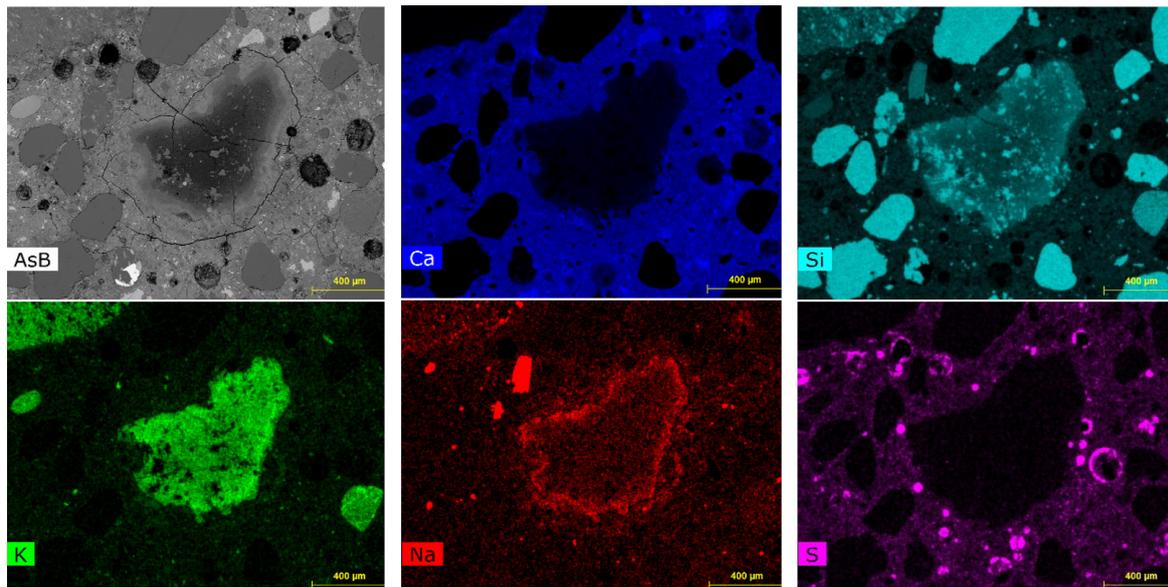
FIGURE 10. EDS mapping of the reacted aggregate grain (partially converted into an ASR gel).

In the analysed concrete cores almost whole reacted grains of fine aggregate were also found (Figure 10). The quartz fine aggregate (probably chert) was converted into Si-Ca-K-Na gel. EDS analysis showed the presence of residues of pure quartz. Additionally, the area seen in Figure 10 was analysed using EDS mapping. There were clearly visible whole grains consist-

ing of ASR gel (stronger indications of K and Na) and point indications from pure quartz (Si). The analysis of the sulfur (S) distribution showed the presence of ettringite in the air-voids and cement matrix.
