DAS35

Tow truck frame made of high strength steel under cyclic loading

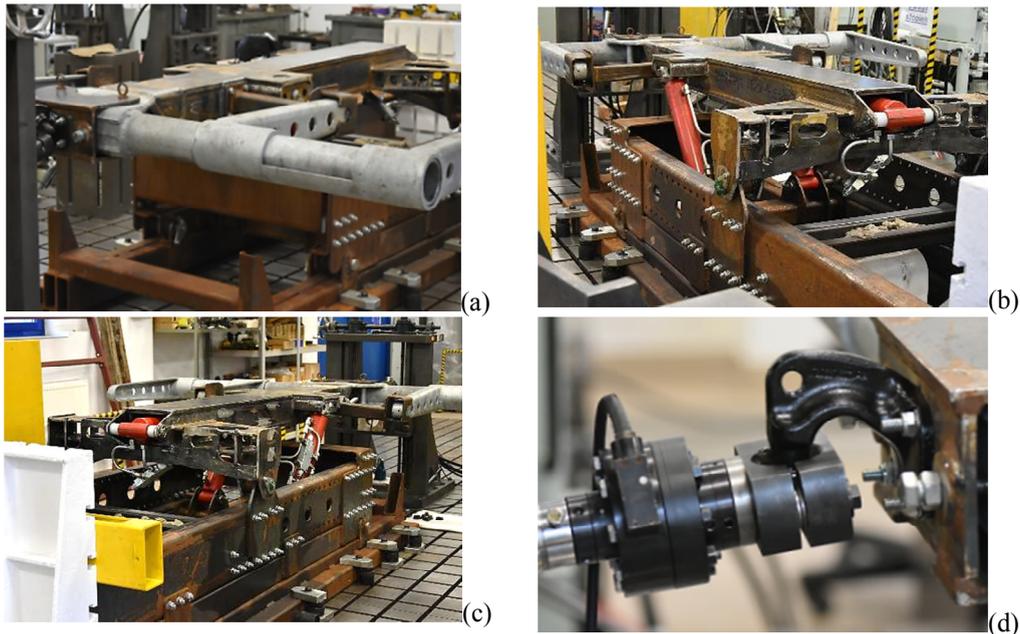
Fig. 4. The tested object on anti-vibration platform with T slots: (a) general view; (b) first side view, (c) second side view, (d) connection of the servo-motor and coupling device.

The 3D object (3.5 m×2 m×1.5 m), recommended for pulling of damaged vehicles (trucks, lorries or cars) due to road accidents was tested. It was mounted to the anti-vibration platform using chassis frame of tow truck by means of screws and clevises, Fig. 4a-c. Elements of the frame made of the high strength steel (S700 MC) were connected using welding technology.

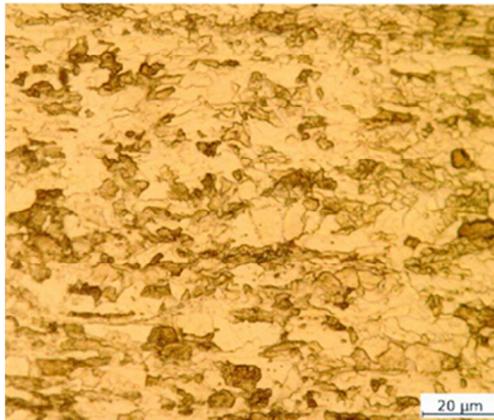
Fig. 10. Microstructure of the parent material (S700 MC) at magnification of 500×

Microscopic observations expressed various microstructure features, Figs. 10-12. In the case of parent material a ferritic/bainitic microstructures was evidenced, Fig. 11. In the HAZ a higher content of sintered carbides can be observed in comparison to the parent material. This was evidenced by SEM analysis at magnification of 1500 \times . It also revealed their irregular distribution, Fig. 12.
