TOW TRUCK FRAME MADE OF HIGH STRENGTH STEEL UNDER CYCLIC LOADING

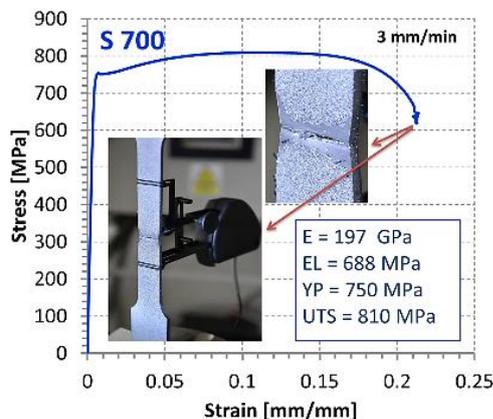
Modern materials of high strength are employed for new critical working conditions that are often taking place in many exploited devices and constructions. Among such materials the Strenx Steel plays an important role [1]. The Strenx Steel is recommended for production of special trucks frames. It is manufactured using hot-rolled process. The main advantages of the steel are high elastic limit and ultimate tensile strength usually equal to: 688 MPa and 810 MPa, respectively, Fig. 1.

Fig. 1. Tensile curve of the S700 MC steel.

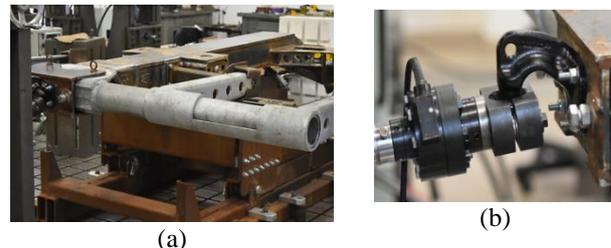
All tests were carried out on testing stand equipped with servo-motors, digital controller, anti-vibration platform (9 m×3 m) and coupling grip. A force signal in the form of sinusoid was used to control a piston movement. The tested component was placed on the anti-vibration platform. The loading process was executed by means of the spherical grip connecting the piston to the ball of the coupling device A50-X, Fig. 3a, b.

Fig. 3. The 3D anti-vibration platform: (a) general view; (b) connection of the servo-motor and coupling device.
