Investigation of Structural Degradation of Fiber Cement Boards Due to Thermal Impact

Abstract: The aim of the present study was to investigate the degradation of the microstructure and mechanical properties of fiber cement board (FCB), which was exposed to environmental hazards, resulting in thermal impact on the microstructure of the board. The process of structural degradation was conducted under laboratory conditions by storing the FCB specimens in a dry, electric oven for 3 h at a temperature of 230 °C. Five sets of specimens, that differed in cement and fiber content, were tested. Due to the applied heating procedure, the process of carbonization and resulting embrittlement of the fibers was observed. The fiber reinforcement morphology and the mechanical properties of the investigated compositions were identified both before, and after, their carbonization. Visual light and scanning electron microscopy, X-ray micro tomography, flexural strength, and work of flexural test W_f measurements were used. A dedicated instrumentation set was prepared to determine the ultrasound testing (UT) longitudinal wave velocity c_L in all tested sets of specimens. The UT wave velocity c_L loss

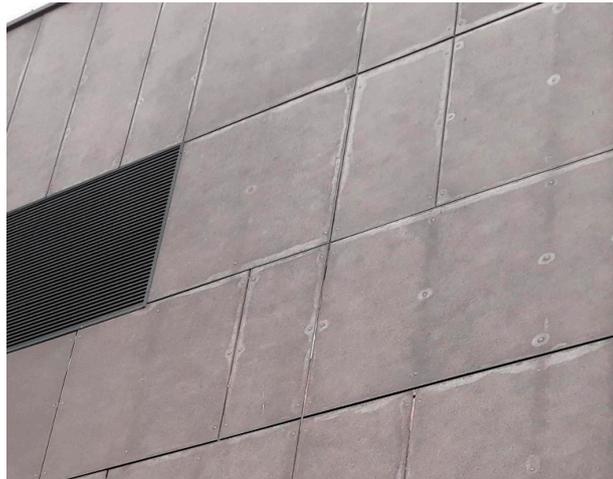
Figure 1. An example of a FCB façade showing considerable damage after ten years of exposure to climate hazards.

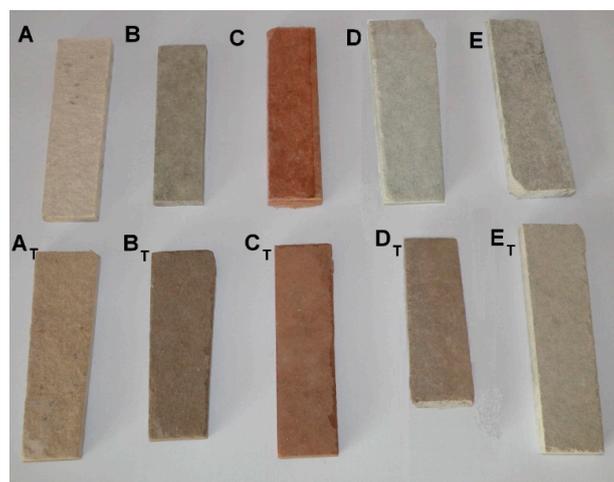
Figure 2. View of the small FCB (fiber cement board) pieces used for microscopic observation. Upper row: specimens of FCB types A, B, C, D and E before the elevated temperature treatment. Lower row: specimens of FCB types A, B, C, D and E after the elevated temperature treatment.

The specimens, which underwent the high temperature treatment, were labeled A_T , B_T , C_T , D_T and E_T . Small pieces of each FCB type were prepared for microscopic observation, both before and after the elevated temperature treatment, and are presented in Figure 2. The mechanical properties of the specimens are shown in Table 1.

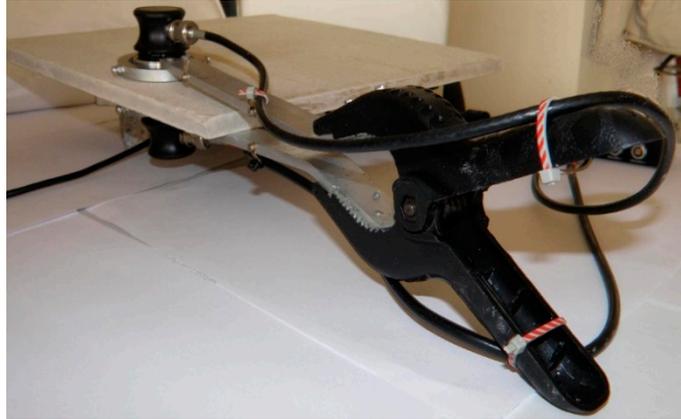
Figure 3. Detailed view of the custom-designed holder for correct coupling between the ultrasonic transducers and both sides of the rough surface board.

a 0.6 mm thick layer of polymer jelly interfacing foil (PM-4-12) produced by Olympus (Waltham, MA, USA) [20]. The custom-designed holder, with articulated joints and a compression spring, was prepared to ensure the correct coupling of the ultrasonic transducers to both surfaces of the investigated boards. A detailed view of the holder is presented in Figure 3.

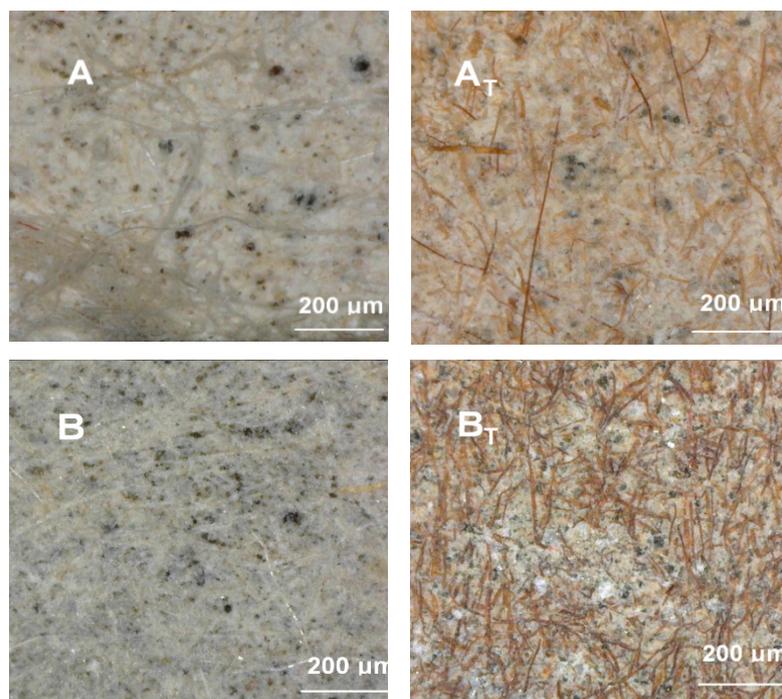
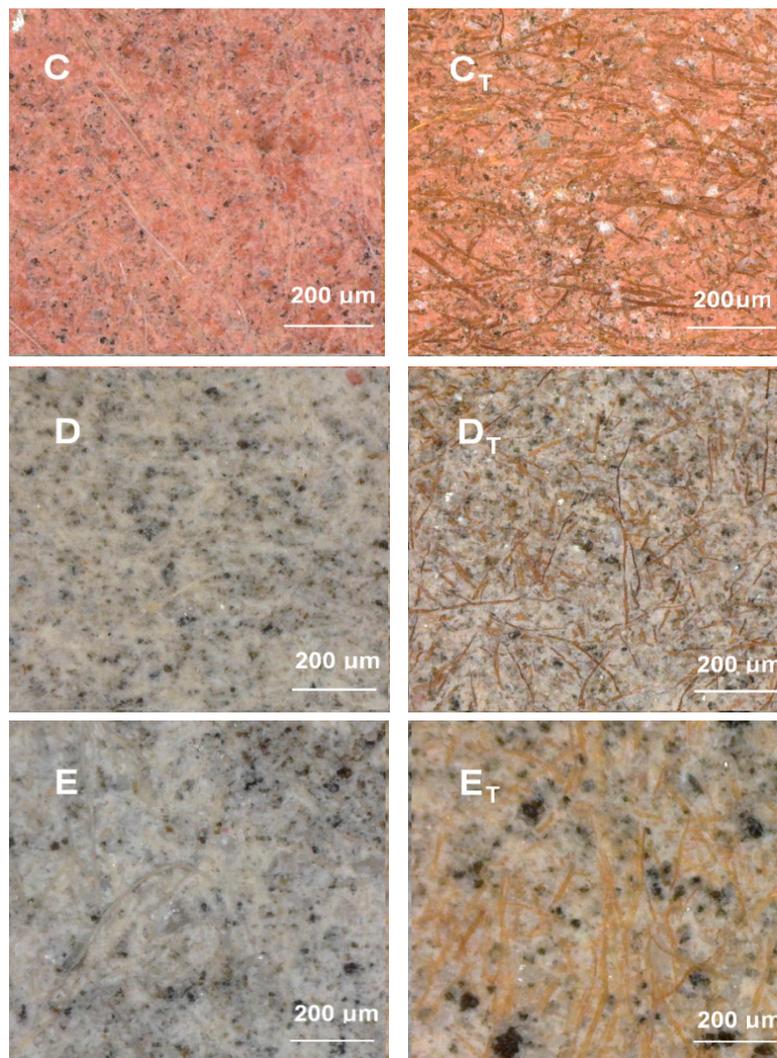
Figure 4. Cont.

Figure 4. Micrographs of the surface views of the investigated specimens. **Left:** before the elevated temperature treatment; **Right:** after the elevated temperature treatment.

The morphology and surface views of all of the investigated compositions were analysed by visual light microscopy (AM4113ZTL 1.3 Megapixel Dino-Lite Digital Microscope with integral LED lighting, AnMo Electronics Corp. (Hsinchu, Taiwan). The magnified surface views of the investigated specimens are presented in Figure 4. Highly-diverse fiber distributions, due to the different fiber compositions, are noticeable in the micrographs.

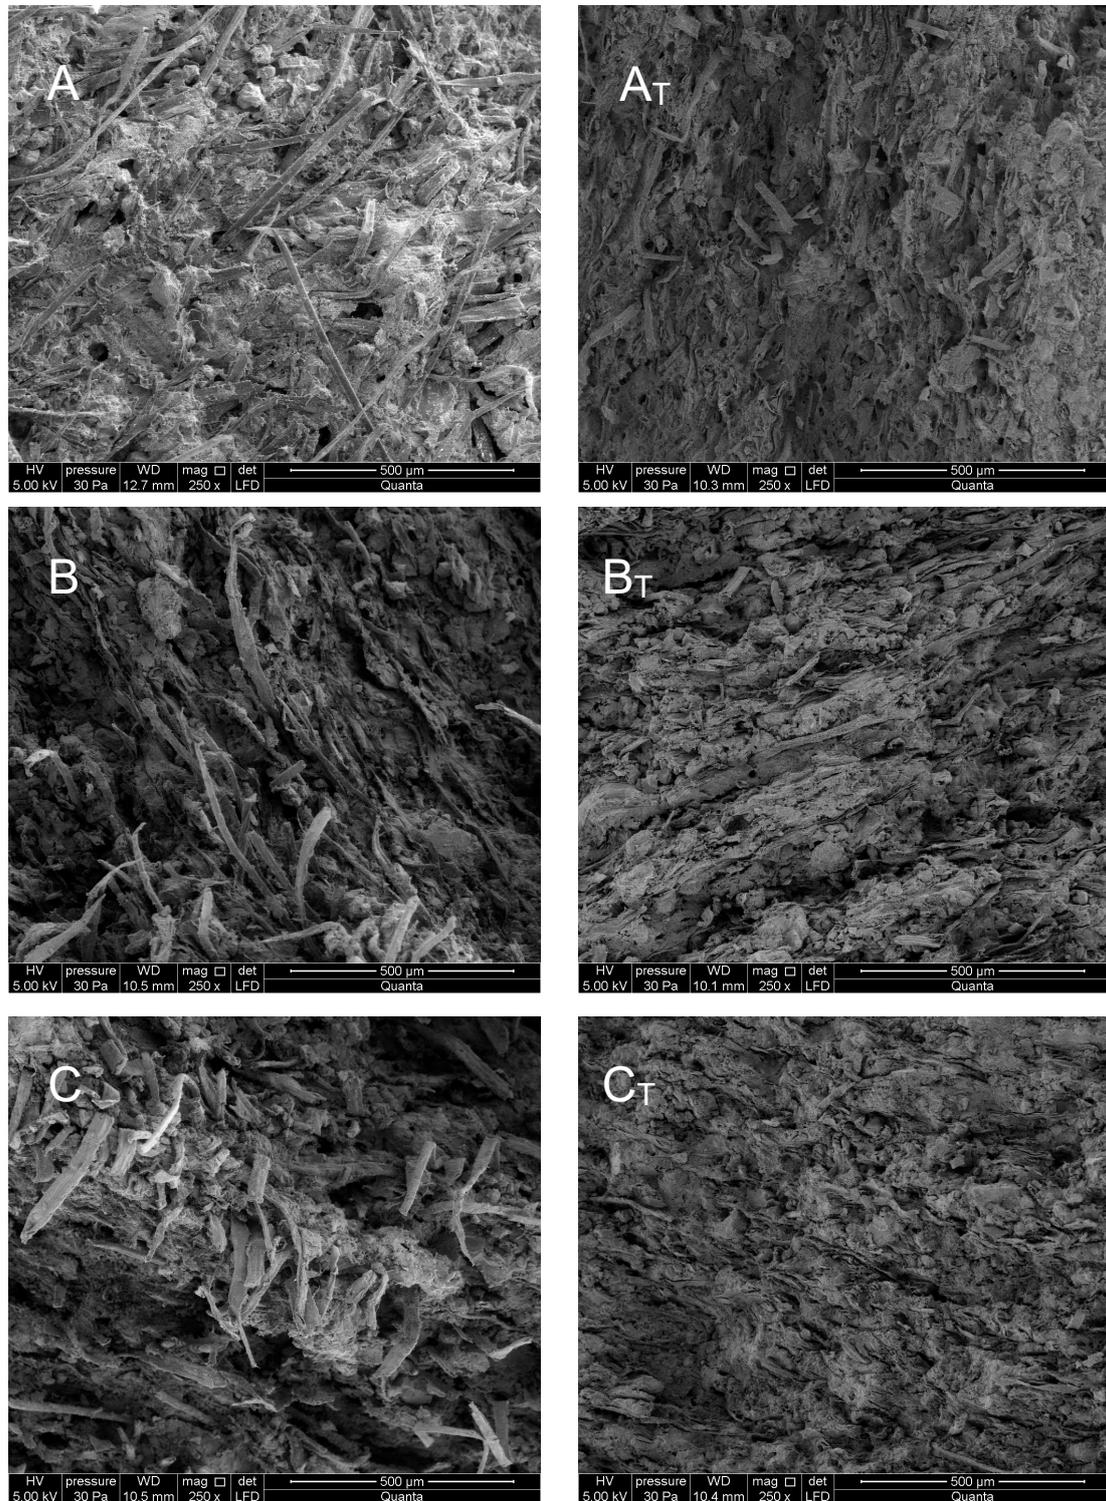
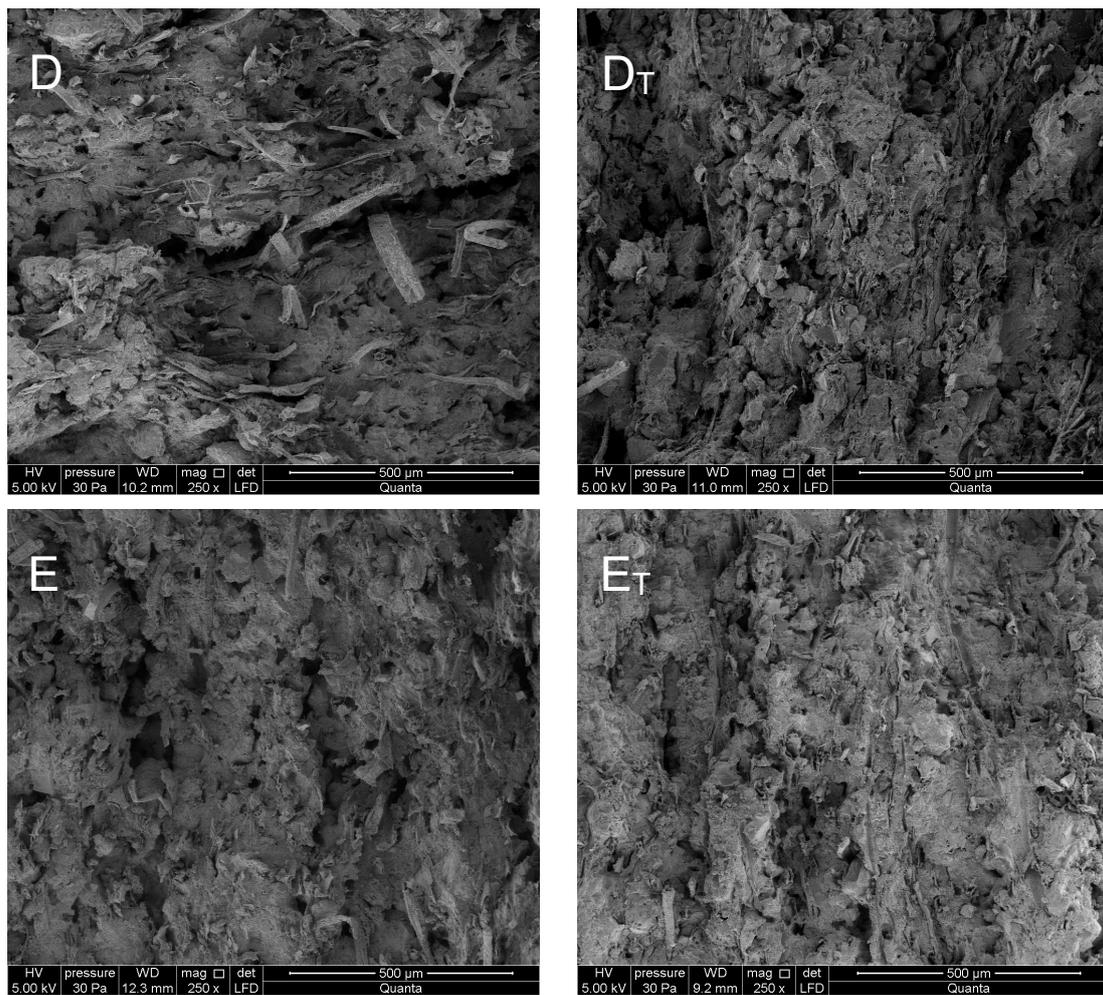
Figure 5. Cont.

Figure 5. SEM images for boards (A–E) (left) and (A_T–E_T) (right).

A high-resolution environmental scanning electron microscope, Quanta 250 FEG, FEI (Hillsboro, OR, USA), was used in the investigations, along with an energy dispersive X-ray spectroscopy (EDS) analyzer. Figure 5 shows the exemplary SEM images for the tested fiber cement boards. Samples that were not exposed to a high temperature are shown on the left, while those that were exposed to a temperature of 230 °C are shown on the right. Exemplary elemental composition results for board C, which were obtained using the EDS analyzer, are shown in Figure 6.

An analysis of the images obtained from the scanning electron microscope and the EDS analyzer shows that the fiber cement boards, in the A–E series, have a compact macrostructure. Microscopic examinations revealed a fine-pore structure, with pores of up to 50 μm in size. Cavities and grooves, up to 500 μm wide, were visible in the fracture areas where the fibers had been pulled out. Cellulose fibers and, in some boards (B and D), PVA fibers, are clearly visible in the images. Various forms of hydrated calcium silicates of the C-S-H type occur. Both an “amorphous” phase and a phase built of strongly-adhering particles predominate. An analysis of the fiber composition showed that fiber elements and some cement elements were present. An analysis of the chemical composition of the matrix showed elements that are typical of cement. The surface of the fibers was covered with a thin

A macroscopic analysis of the fiber cement boards in the A_T – E_T series, which were exposed to a temperature of 230 °C for 3 h, shows a clear change in the color of the samples. Examinations of the A_T – E_T fiber cement boards yielded consistent results. Most of the fibers in the boards were found to be burnt-out, or melted into the matrix, leaving cavities and grooves which were visible in all of the tested boards. The structure of the few remaining fibers was strongly degraded. Examination of the cement particles in further fractures revealed that burning-out also degrades their structure. The structure of the matrix was found to be more granular, showing many delaminations. Numerous caverns and grooves left by the pulled-out fibers, as well as the pulled-out cement particles, were observed.

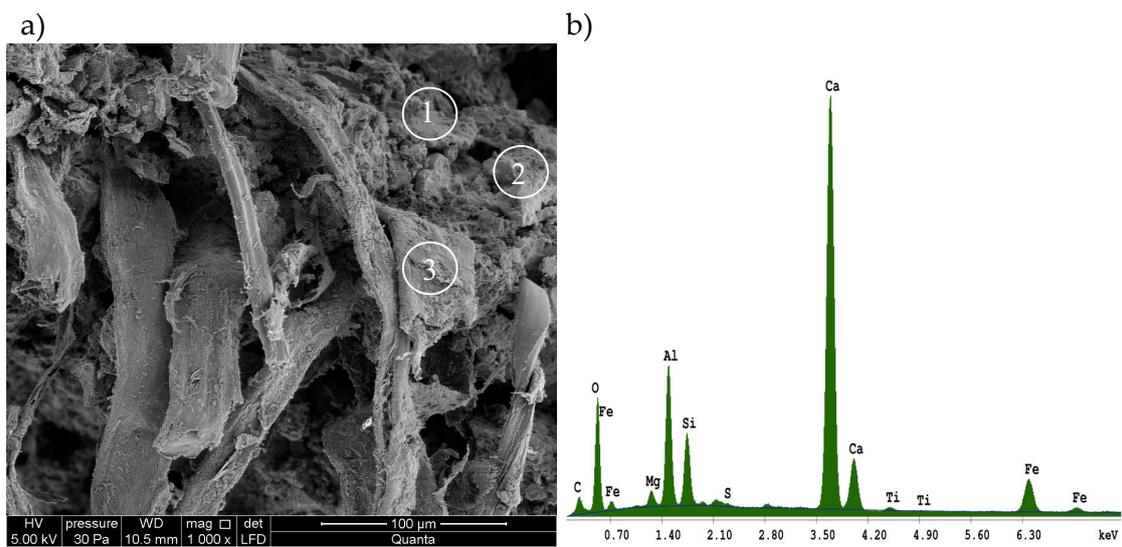
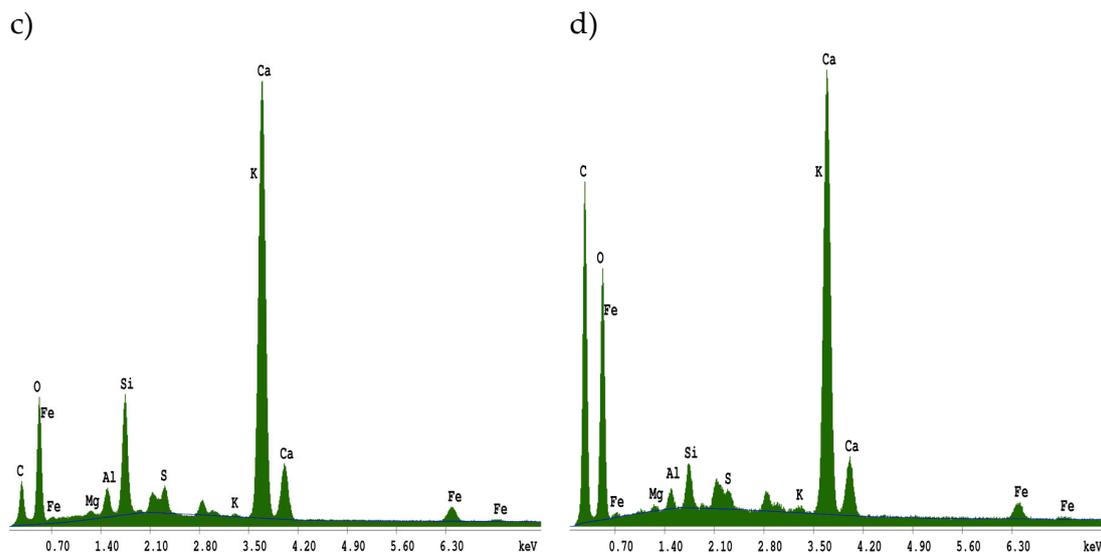
Figure 6. Cont.

Figure 6. Results obtained using the energy dispersive X-ray spectroscopy (EDS) analyzer for board C: (a) areas of elemental composition analysis, (b) results of EDS in point 1, (c) results of EDS in point 2, (d) results of EDS in point 3.

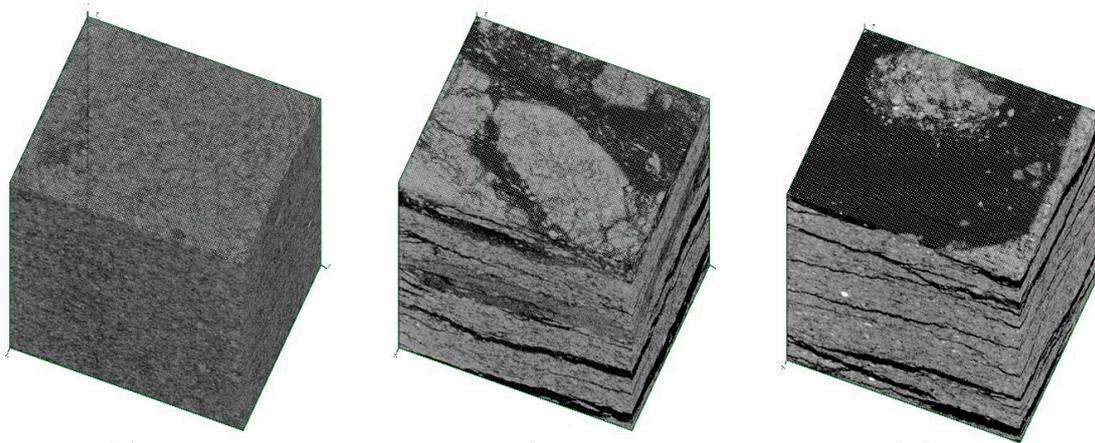
Figure 7. Examples of virtually-cut, three-dimensional projections of $4 \times 4 \times 4 \text{ mm}^3$ cubes from specimens “D” (left), “D_T” (center) and “B_T” (right). Specimen “D” shows the regular microstructure without faults such as delaminations. The results of the elevated temperature impact is visible within the volume of specimen “D_T” and “B_T” in the form of significant delaminations.

Examples of virtually-cut, three-dimensional projections of $4 \times 4 \times 4 \text{ mm}^3$ cubes, from specimens D, D_T and B_T , are presented in Figure 7. Specimen D, i.e., before the elevated temperature treatment, shows the regular microstructure without faults such as delaminations. The results of the elevated temperature impact is visible within the volume of specimen D_T , in the form of significant delaminations. The size and number of these delaminations are even more visible in the image of specimen B_T , which was made of a material with lower mechanical performance.

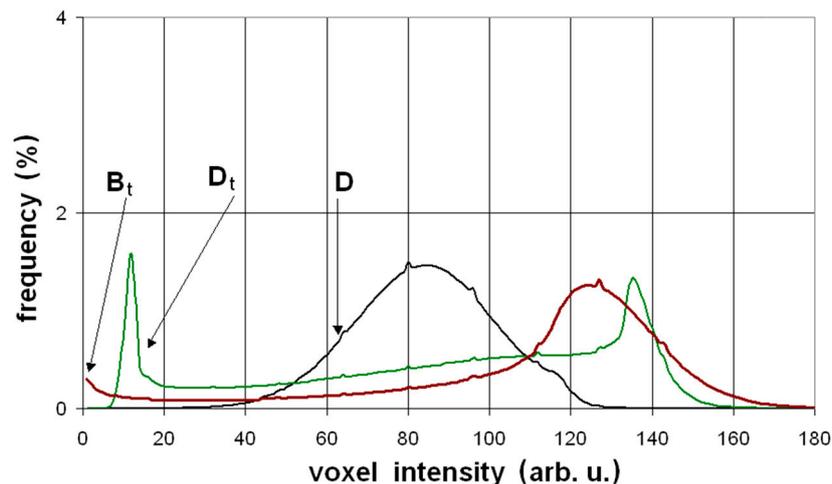
Figure 8. The greyscale brightness distribution (GBD) of all voxels belonging to the three examined specimens: “D”, “D_T” and “B_T”. The occurrence of the delamination processes caused a shift of the affected GBD curves to the left, i.e., in the direction of a region of voids.

Another way to present information about the specimens, derived from the X-ray scanning procedure, is to determine the brightness distribution of all of the examined voxels (i.e., volumetric pixels). The magnitudes of brightness of the different microstructural elements were included in the following ranges: the area of voids and fibers: 0–50 arbitrary units, a.u., fillers: 50–140 a.u., and dense phases; i.e., un-hydrated cement and fine aggregate grains: 140–170 a.u. The greyscale brightness distribution (GBD) of all voxels belonging to the three specimens presented in Figure 7, are shown in Figure 8. It is worth noting that the occurrence of the delamination processes caused a shift of the affected GBD curves to the left, i.e., in the direction of a region of voids.

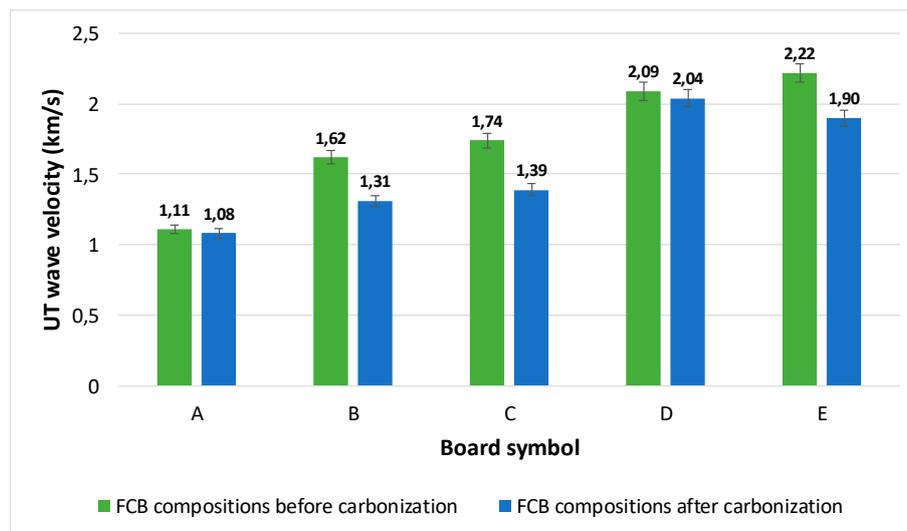
Figure 9. Results of the UT longitudinal wave velocity c_L tests, measured in all FCB compositions, before and after carbonization. The black marks depict standard deviations (2–3%), determined in populations of the measurements.

The results of the UT longitudinal wave velocity c_L tests are presented in Figure 9. For each $30 \times 30 \text{ cm}^2$ FCB board (A, B, C, D, E, A_T, B_T, C_T, D_T and E_T), two series, of ten measurements each, were performed in order to determine the dispersion of the results. The measurements were done, randomly, at different locations, over the entire surface of the boards. The standard deviation of a single series of measurements was included in the range of 2–3% of the average value of the readings. The UT longitudinal wave velocity c_L loss was observed in all cases of thermal treatment; however, that loss varied from 2% to 20% depending on the FCB composition. It is worth mentioning that the time to perform ten UT measurements took approximately 5 min, suggesting that this may be a good method for in-situ application.

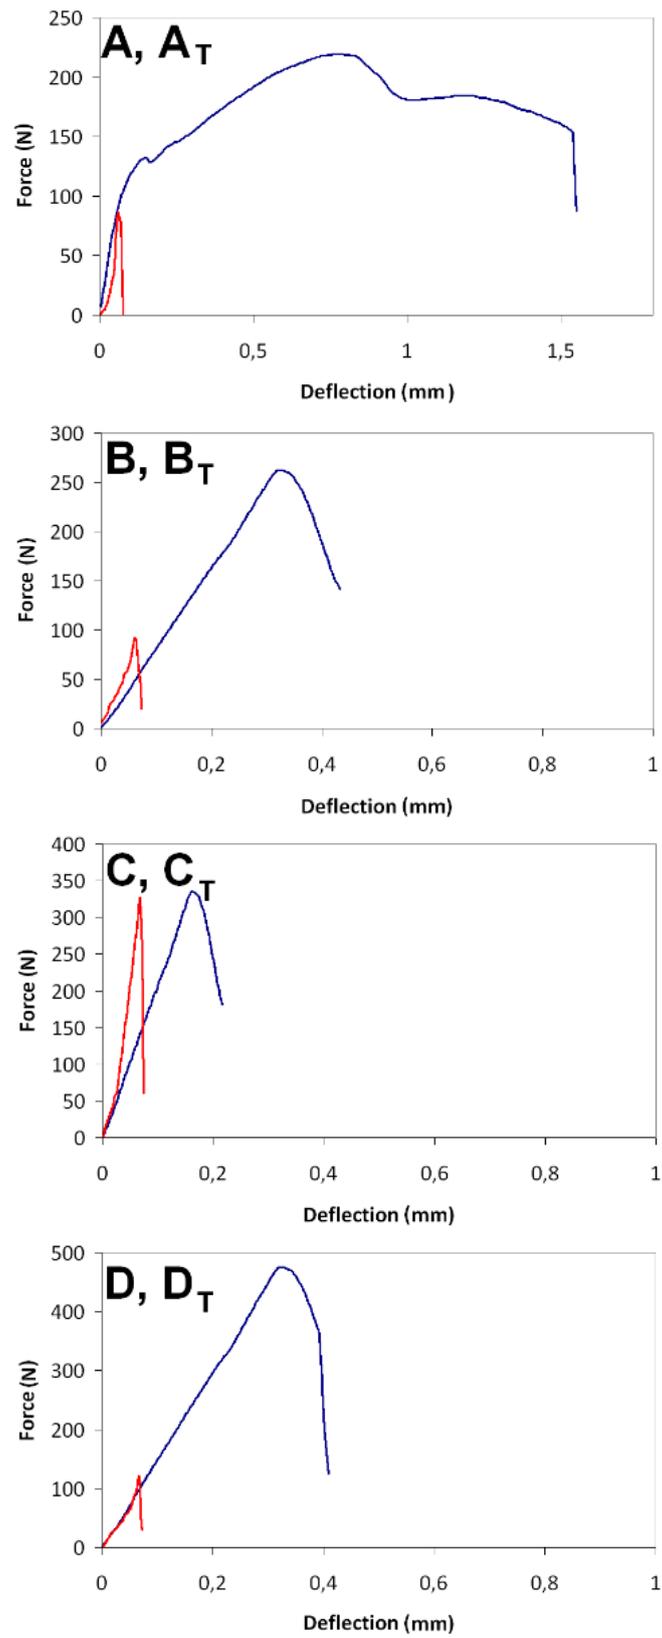
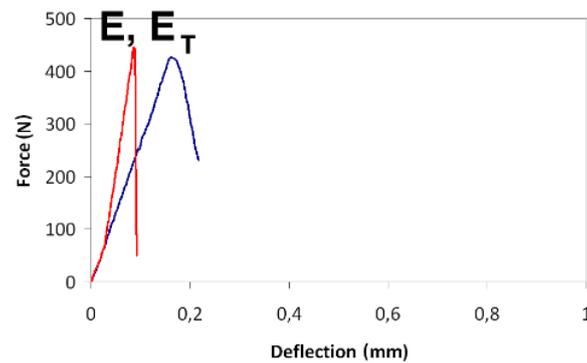
Figure 10. Cont.

Figure 10. Typical load-deflection curves of the tested FCB compositions. The blue curves show the behavior of the specimen in an as-delivered state and the red curves show the behavior of the specimens with the carbonized reinforcing fibers.

Figure 10 and Table 2 present the results of the mechanical tests. The blue curve shows the behavior of the specimens in an as-delivered state, and the red curve shows the behavior of the specimens with the pyrolyzed reinforcing fibers. Based on an analysis of the curves, the board specimens in an as-delivered state are capable of withstanding a load close to F_{MAX} for the time required to destroy the fiber reinforcement system. The energy required for that damage can be estimated as W_f , by applying Formula (1). The specimens that underwent the cellulose fiber carbonizing process demonstrated the brittle characteristics of the rupture, i.e., the break of the material cross section appeared immediately after reaching the critical F_{MAX} level. Work of flexural test, calculated for the carbonized specimens, equaled approximately 2–5% of the value estimated for the as-delivered state of the FCB specimens. It is also worth mentioning that, in the composition of boards with a low cement content, the brittle matrix broke under a relatively low loading force, while its internal fiber reinforcement system could withstand more stages of the damage process.
