Article

# Influence of the Welding Process on the Mechanical Characteristics and Fracture of the S700MC High Strength Steel under Various Types of Loading

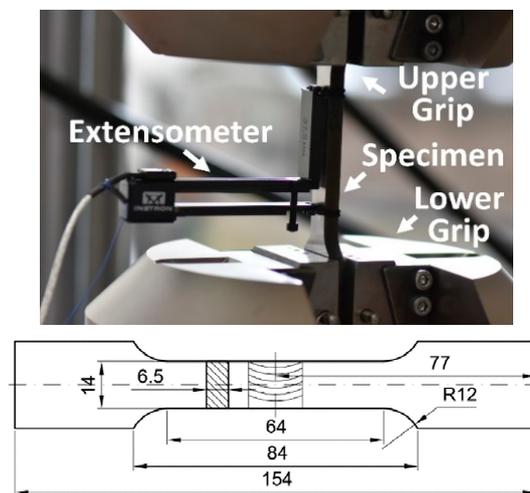
**Figure 1.** Flat specimen with weld in grips and its engineering drawing.

The 8802 INSTRON servo-hydraulic testing machine and the 2620 INSTRON uni-axial extensometer of 50 mm gauge length were used in tests (Figure 1).

The monotonic tensile tests were conducted using flat specimens of total length and gauge length equal to 154 mm and 64 mm, respectively. They were manufactured from the parent material and the weld located in the middle of the specimen gauge length. In the case of parent material, a cross-section of the measurement zone was of 3.25 mm × 7 mm, while for the material in weld it was represented by the dimensions equal to 6.5 mm × 14 mm (Figure 1). A thickness of the weld was reduced by a machining process in order to adjust it to the specimen thickness defined.

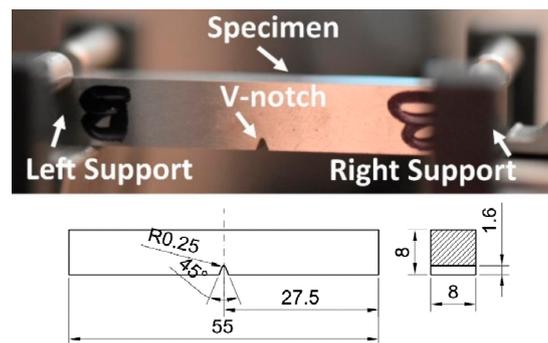
**Figure 2.** V-notched Charpy specimen in grips and its engineering drawing.

The V-notched specimens, designed according to the PN-EN ISO standards [21], were used to determine a behaviour of the material under impact (Figure 2). They had cuboidal shape of the following dimensions 8 mm × 8 mm × 55 mm, a notch of 45° angle in a tip, and 1.6 mm depth. All tests were conducted by means of the 9529 HV Instron Drop Tower at room temperature. The accumulated energy, force, projectile velocity, and deflection were collected during experiments. They were captured by means of the sensors located in the tower. Before the test, an initial value of energy must be set. It was done directly by contact of the projectile with a specimen to set zero level. Subsequently, the projectile with a mass box was automatically lifted to the position, guaranteeing the required value of the impact energy. The first value of energy was chosen experimentally under the assumption that the projectile impact should not fracture the specimen. It was equal to 50 J. Subsequent values of the impact energy up to 300 J were set by multiplication of the initial one. In a similar way, a set of impact energy levels for specimens with welds was selected.

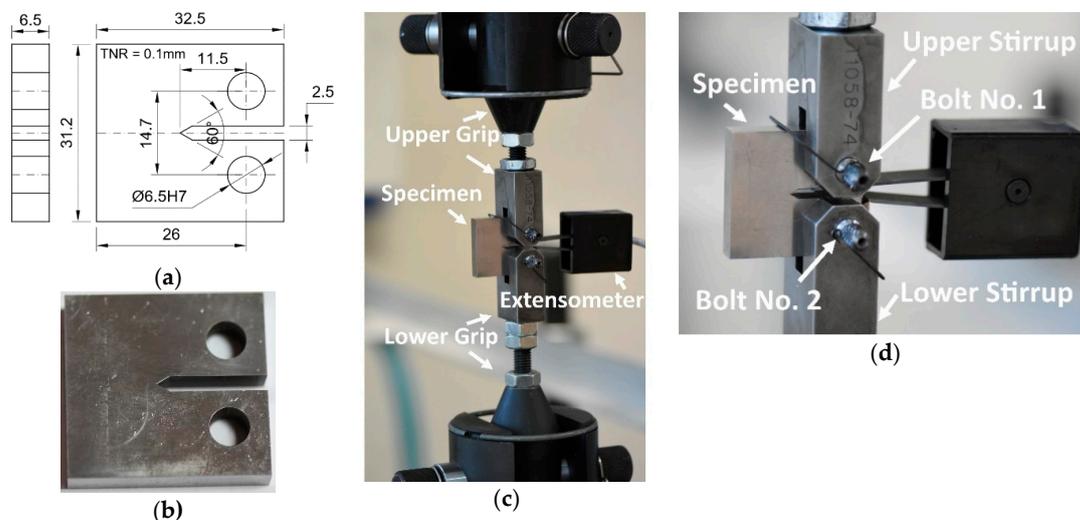
**Figure 3.** Compact tension (CT) mini-specimen: (a) engineering drawing; (b) after manufacturing; (c,d) fixed in the testing machine before experiment.

The fracture toughness experiments for CTOD determination [22,23] were designed to reflect the behaviour of the parent material, HAZ, and weld. The CT (Compact Tension) specimen geometry (Figure 3a) was elaborated based on requirements of the ASTM and PN-EN ISO Standards [24,25]. The specimens (Figure 3a,b) were prepared for all regions of the welding joint that contains the HAZ, weld as well as the parent material. They were selected from the welded sheet of the S700MC, having a thickness of 10 mm. The specimens were mounted in the special gripping system (Figure 3c,d), which guaranteed elimination of the bending moment. The Crack Opening Displacement (COD) was measured by means of the 2670-114 CTOD INSTRON extensometer of 5 mm gauge length and 2 mm displacement capacity (Figure 3d). The fatigue pre-cracking tests were conducted at the stress ratio ( $R = \sigma_{\min}/\sigma_{\max}$ , where  $\sigma_{\min}$  and  $\sigma_{\max}$  denote respectively, minimum stress and maximum stress during cyclic loading) equal to 0.1, up to a nominal crack length of 1.85 mm.

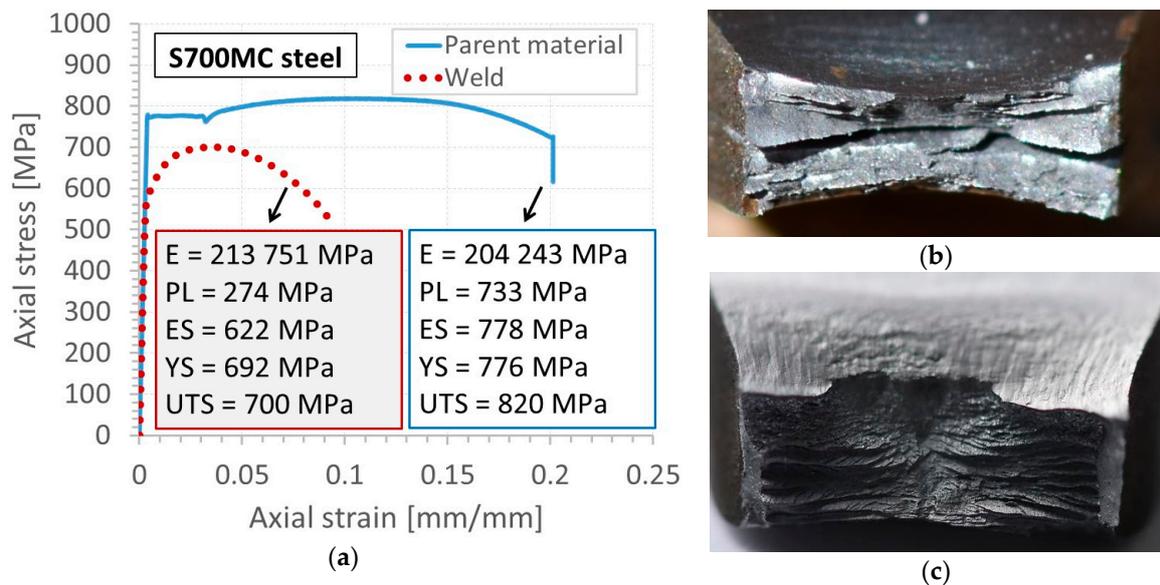
**Figure 4.** Tensile characteristics of the S700MC steel and its weld (a), with the fracture regions of the parent material (b), and the zone close to the weld (c).

Although the tensile curve of the S700MC steel in the as-received state exhibited elastic-plastic features with the characteristic plateau and clear hardening, it was changed significantly by the welding process. All typical mechanical parameters of this steel were reduced (Figure 4a). The greatest lowering of the mechanical properties was observed for the proportional limit, i.e., 37.5%, while the yield stress in the form of plateau disappeared entirely. The welding process also affected the fracture zones (Figure 4b,c). Contrary to the parent material fracture results that exhibited longitudinal cracks induced as an effect of the hot-rolling process of the S700MC steel (Figure 4b), the fracture region close to the weld was more uniform (Figure 4c). It indicates that the typical crack features disappeared due to temperature exposure during the joining technology applied (Figure 4). Nevertheless, low-depth cleavage facets were observed. They were relatively densely distributed.

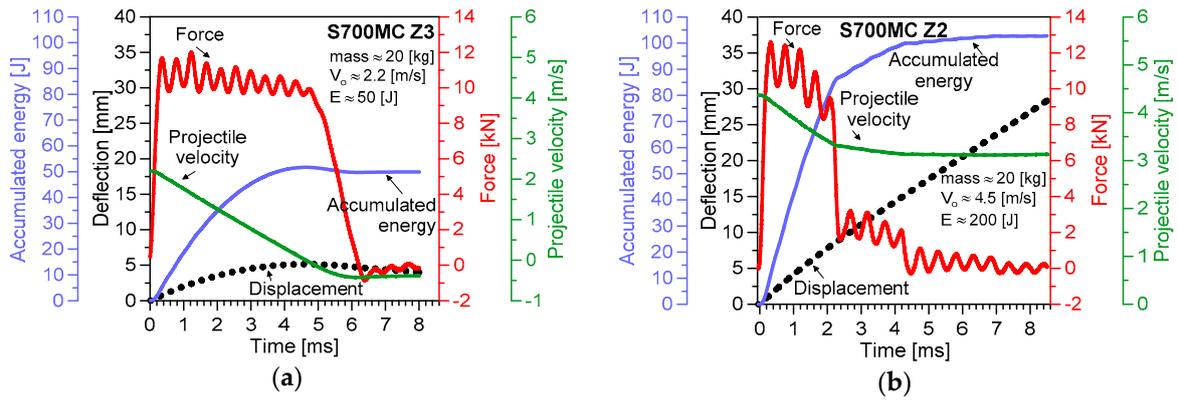
Figure 5. Variations of the Charpy test parameters for the S700MC steel (parent material) under impact energy of: (a) 50 J; and (b) 200 J.

The results of the impact tests are presented in Figures 5–9. The maximum accumulated energy for the parent material reached 100 J, defining the limit value of the absorbed energy for the range of the impact energy applied (Figure 9a). The variations of deflection were represented by a quasi-linear relationship independently of the energy applied in the tests, and thus, reflected a stable response of the steel tested under the impact (Figures 5–8). Force variations one can interpret as the damping reduction with the energy-applied increase (Figure 9b). In the case of the projectile velocity, its linear course was disturbed for the impact energy higher than 50 J (Figure 9c).

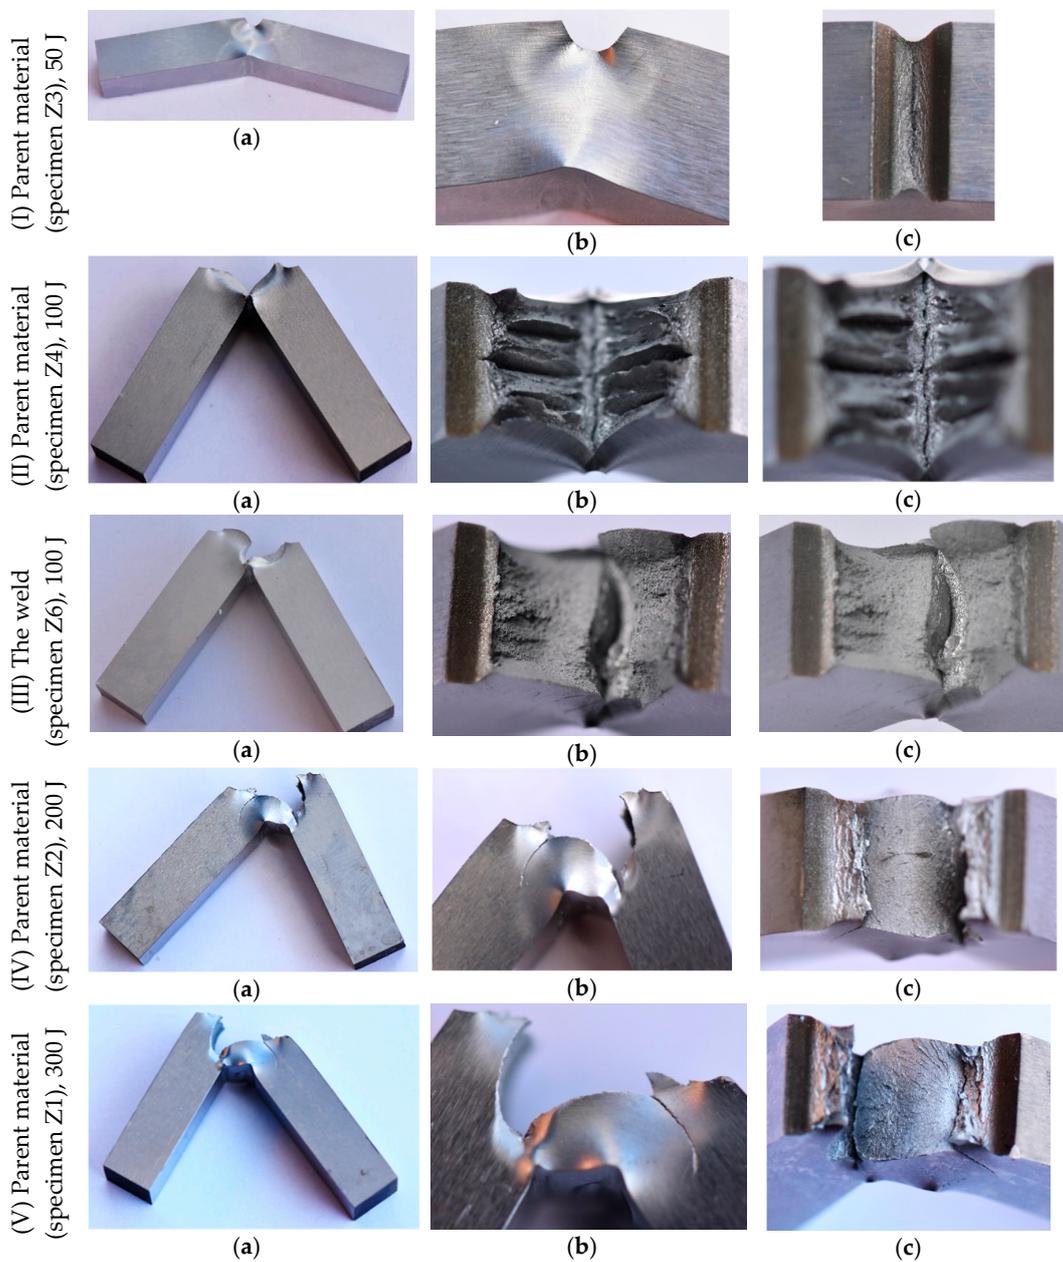
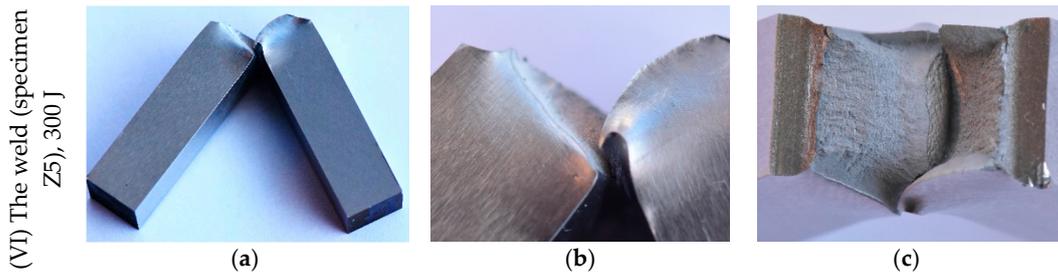
**Figure 6.** V-notched specimens of the parent material and weld of S700MC steel after Charpy test: (a)—specimen after test; (b,c)—fracture zone from side and top view, respectively.

The fracture zone of the weld expressed different character than that for the parent material obtained. A smooth surface was observed at 100 J (Figure 6(III)b,c) and 300 J (Figure 6(VI)b,c). For such energy levels, the material fracture was strongly dependent on the velocity. A comparison of the results achieved confirmed that the parent material exhibited better resistance than that for the welding joint obtained (Figure 9). This was clearly reflected by the higher values of accumulated energy, longer time of the force action, and larger values of the projectile velocity for the weld material in comparison to the parent one (Figure 9).

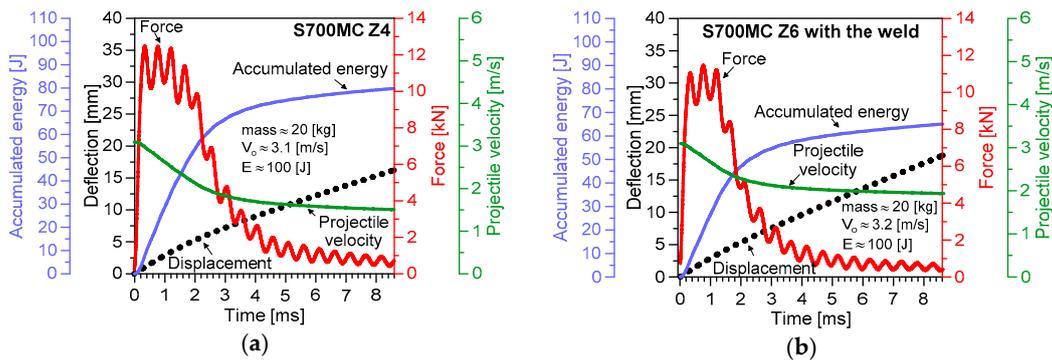
**Figure 7.** Variations of the Charpy test parameters for the S700MC steel: (a) parent material; (b) weld; (impact energy: 100 J).

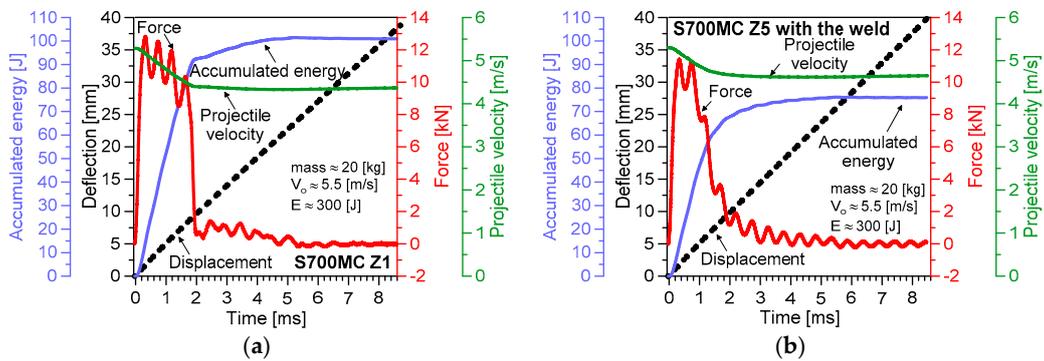
**Figure 8.** Variations of the Charpy test parameters for the S700MC steel: (a) parent material; (b) weld (impact energy: 300 J).

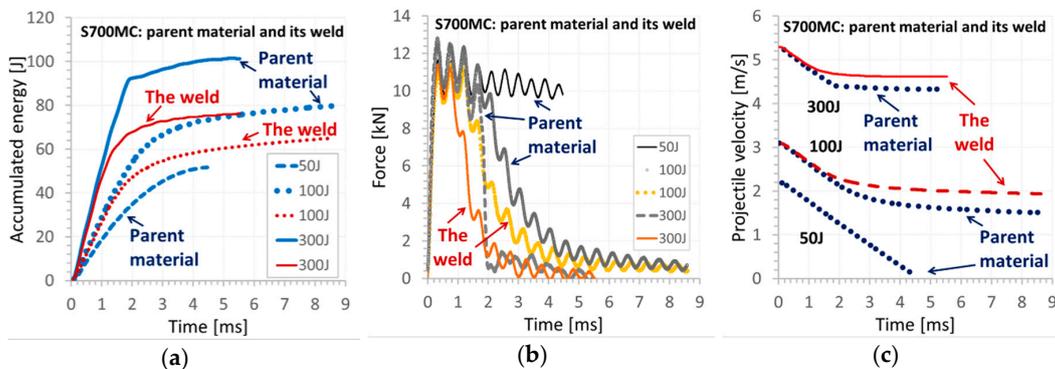
**Figure 9.** Variations of the following parameters: (a) accumulated energy; (b) force; (c) projectile penetration velocity for the parent material (S700MC steel) and its weld during impact tests.

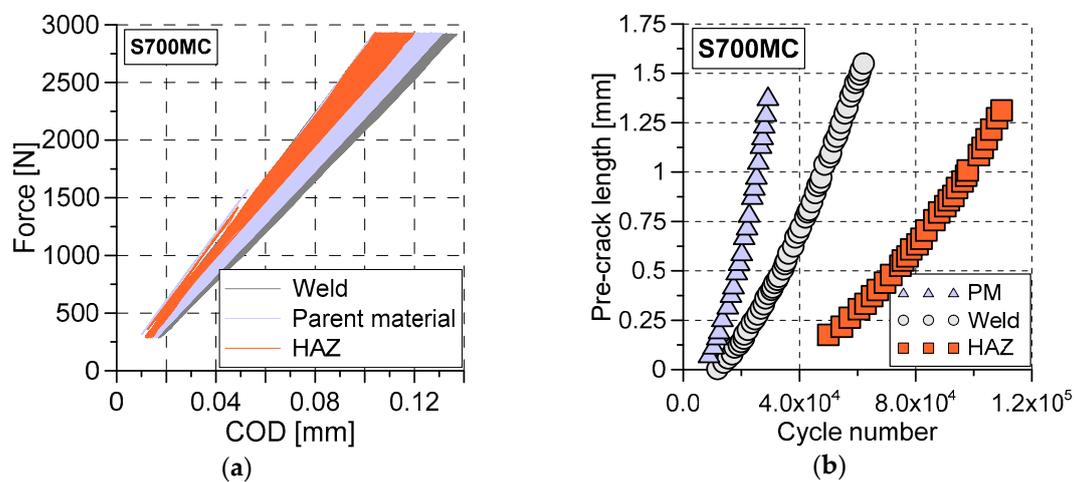
**Figure 10.** Results of CTOD experiments: (a) force versus COD; (b) pre-crack length-cycle number for the parent material (PM), weld and HAZ.

The highest stiffness for the HAZ specimen and the lowest one for the weld (Figure 10a) were identified during the pre-cracking fatigue stage. The number of cycles necessary to create the required length of the fatigue pre-crack and its propagation rate reached the greatest value (Figures 10a and 11a) for the HAZ region. Taking into account the welding quality, this is a beneficial effect. It means that the probability of cracks occurrence in this region is much lower than that in other zones tested.

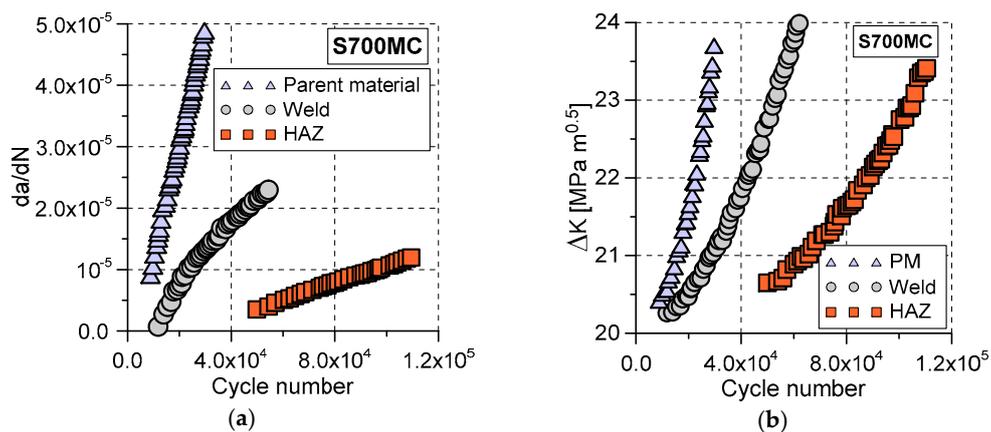
**Figure 11.** Variations of the crack propagation parameters: as a function of the cycle number for the parent material, weld and HAZ: (a)  $da/dN$ ; (b)  $\Delta K$ .

A similar character of the results can be observed in analysis of  $\Delta K$  variations (Figure 11b). A comparison of the fatigue data for three tested zones indicated that the HAZ region exhibited the highest cyclic loading resistance. Before the fatigue cracks development, three regions in question demonstrated similar ability to crack propagation along two different directions (Figure 12), however,

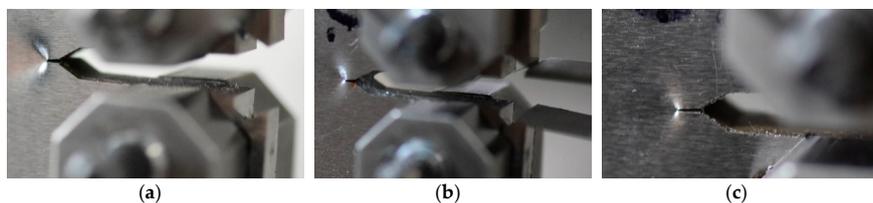
**Figure 12.** CT mini-specimens before the propagation of the fatigue pre-crack: (a) parent material; (b) HAZ; (c) weld.

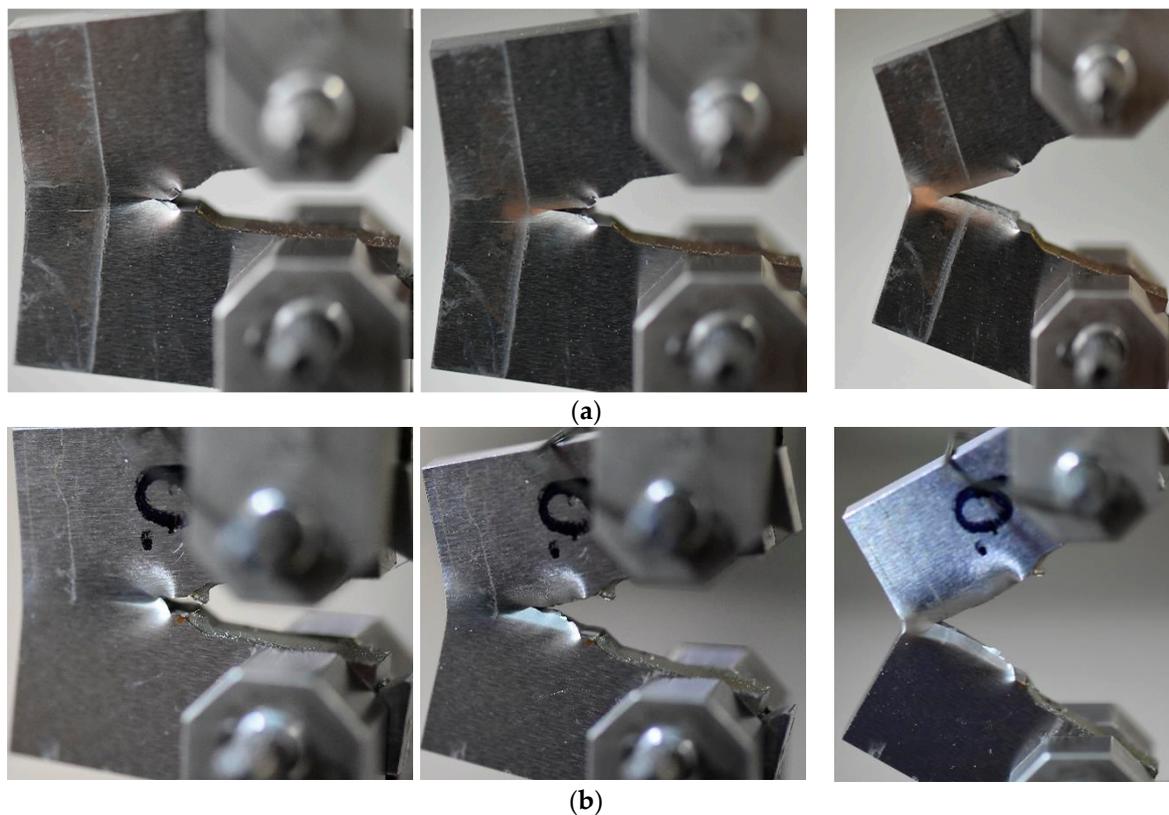
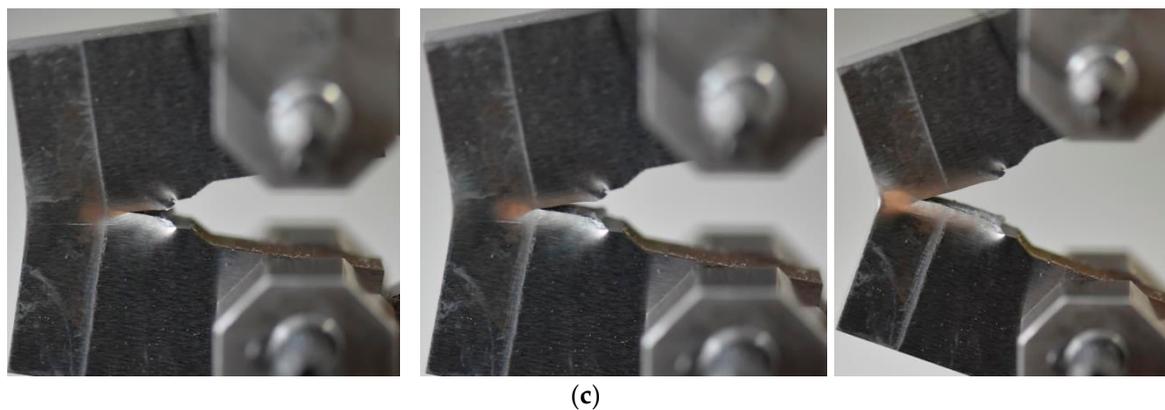
Figure 13. CT mini-specimens at the final stage of CTOD tests: (a) parent material; (b) HAZ; (c) weld.

during tension, the major crack propagated only in a single direction, which was orientated horizontally (Figure 13).

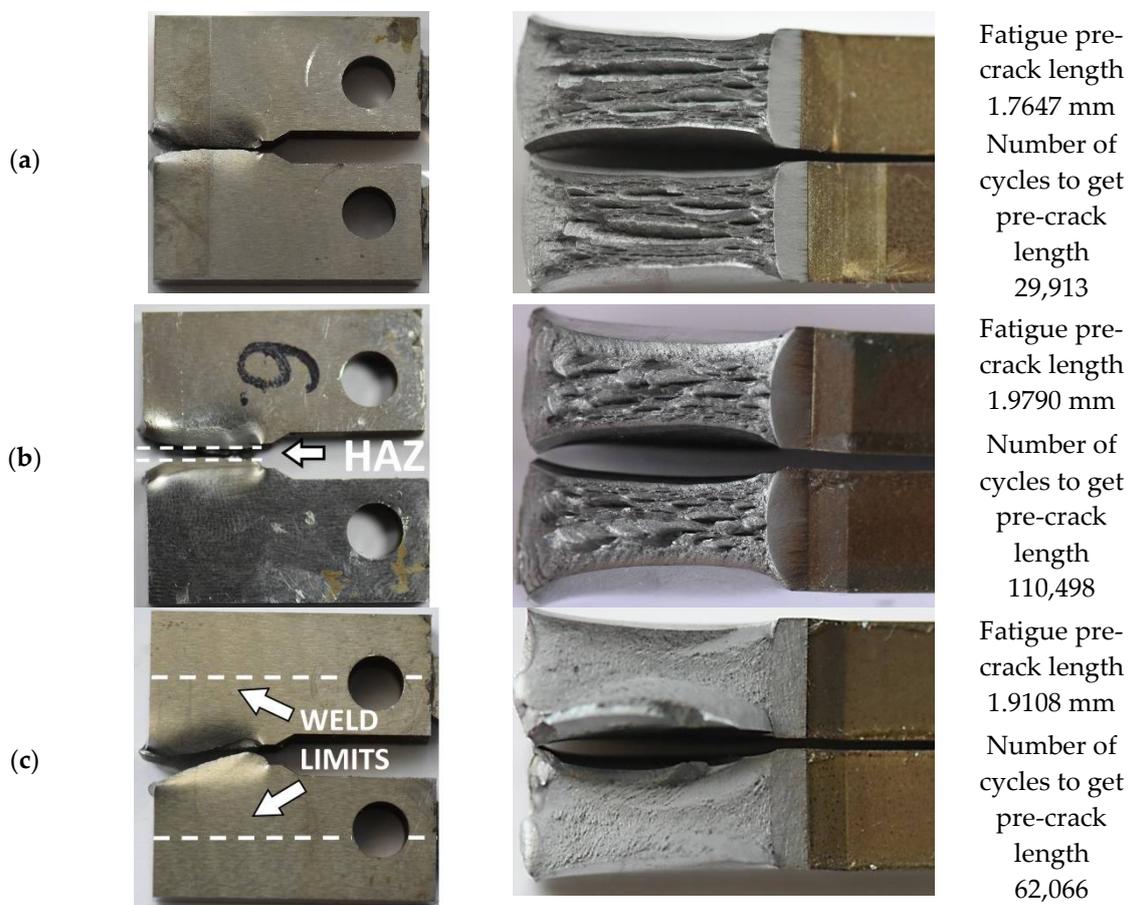
Figure 14. CT mini-specimens after CTOD tests: (a) parent material; (b) HAZ; (c) weld.

Significant differences in features of the zones taken into account can be indicated on the crack propagation surfaces (Figure 14). They are represented by a gradual vanishing of the longitudinal cracks depending on the zone. In the case of the parent material, the number of cracks was the largest, while for the weld it was almost imperceptible. Although the HAZ zone exhibited almost similar features to the parent material, the crack lengths of both zones were different, significantly shorter in the HAZ than those in the parent material observed.

The crack propagation zone of the parent material was captured using SEM in order to determine its significant features (Figure 17). Cleavage facets between defects looking like delamination were identified. Delamination-like fracture of the steel was the main feature of the zone examined (Figures 14a and 17a,b). This effect exhibited the same orientation in the area inspected. The same effect can be indicated for the HAZ, however, the number of longitudinal cracks was smaller (Figure 14b). It disappeared in the weld as a result of the joining process (Figure 14c).

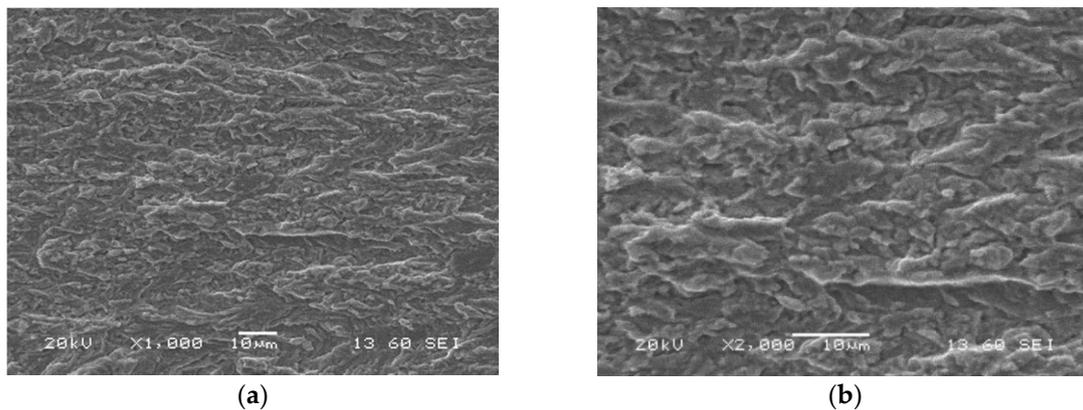
**Figure 15.** Microstructures of the fatigue pre-crack zone of the parent material (specimen No. 7) captured after CTOD test using SEM; magnifications: (a)  $\times 1000$ ; (b)  $\times 2000$ .

Figure 15 presents the SEM images of the fatigue pre-crack zone of the S700MC with visible segmental fatigue fringes randomly distributed. The features of the fatigue regions (Figure 15) were different than those for other structural steels, namely, the fatigue fringes were distributed irregularly.

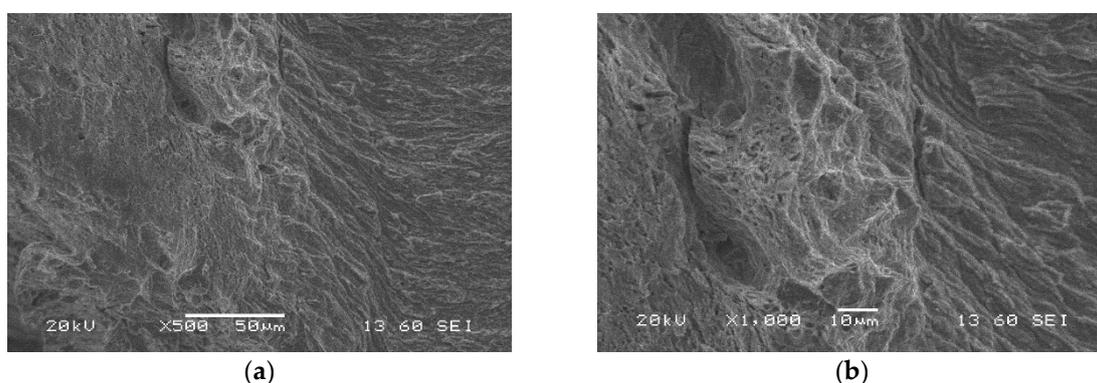
**Figure 16.** Microstructures of the transient region (fatigue pre-crack and crack propagation) of the S700MC (specimen No. 7) captured after CTOD test using SEM; magnifications: (a)  $\times 500$ ; (b)  $\times 1000$ .

Figure 16 shows the transition region (fatigue pre-crack and crack propagation) between two types of fracture. Also, the crack propagation direction is well visible. The lamellar fracture with very fine particle morphology was obtained. The lamellar character of the fracture corresponds to the anisotropic microstructure of the base material. It proves the entire removal of dislocation reinforcement after thermomechanical treatment [27]. The transient region expressed features of typical solid bodies that differ themselves in cracking type from brittle to brittle-plastic (Figure 16). It seems, that in the case of steel tested, the fatigue crack that grows under tension is similar to that of typical steels.

The transition zone reflected the material fracture in the stage preceding decohesion (Figure 16). It had the features representing coupled (brittle-plastic) cracking located in the entire area considered (Figure 16). One can conclude that the fatigue crack growth under tensile conditions is controlled by

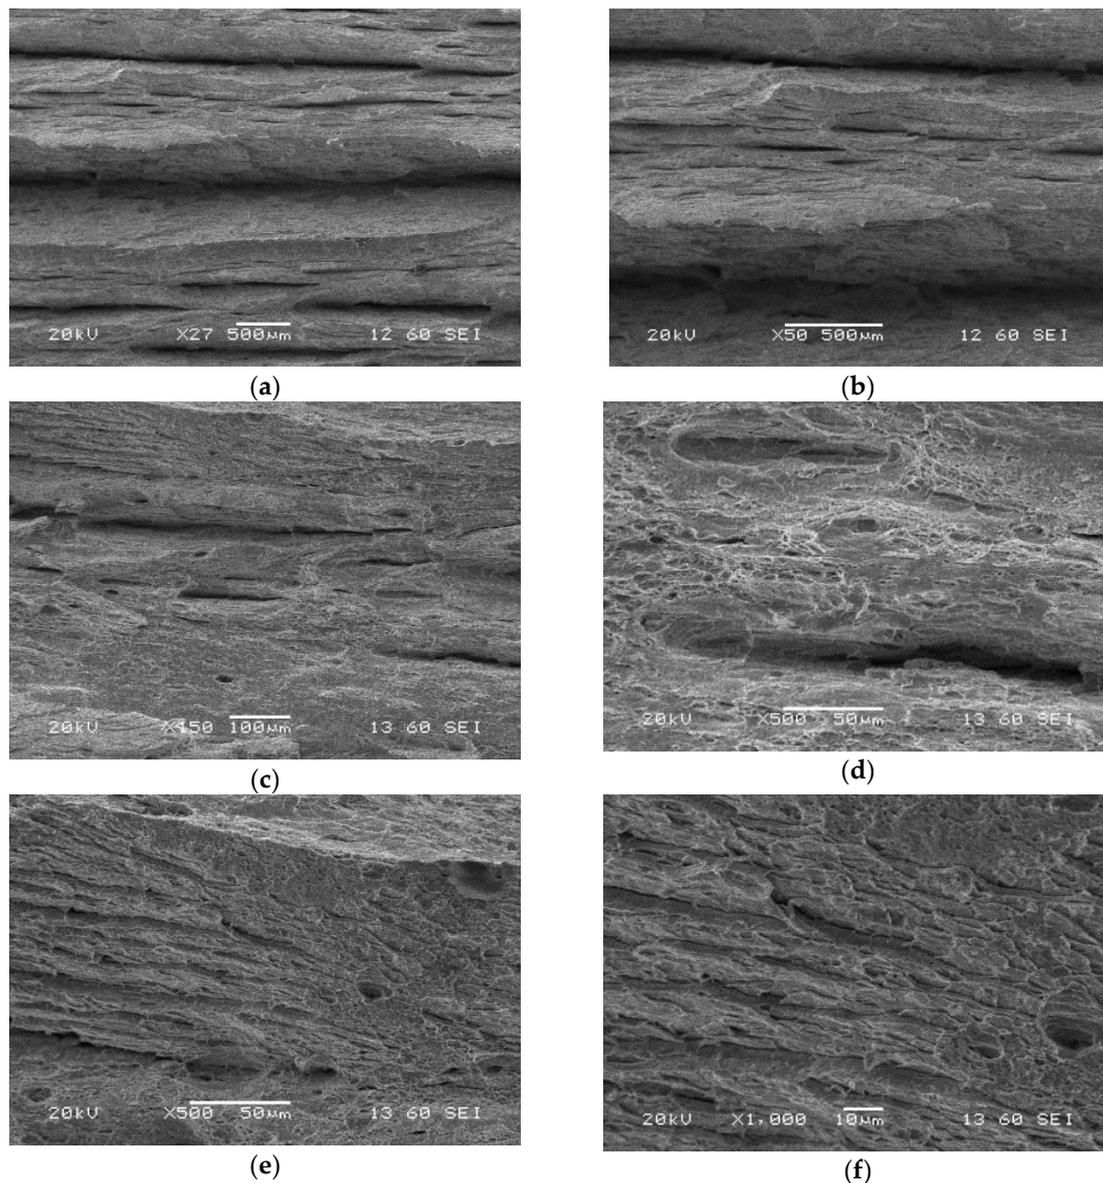
**Figure 17.** Microstructures of the crack propagation zone of the parent material (specimen No. 7) captured after CTOD test using SEM; magnifications: (a)  $\times 27$ ; (b)  $\times 50$ ; (c)  $\times 450$ ; (d) and (e)  $\times 500$ ; (f)  $\times 1000$ .

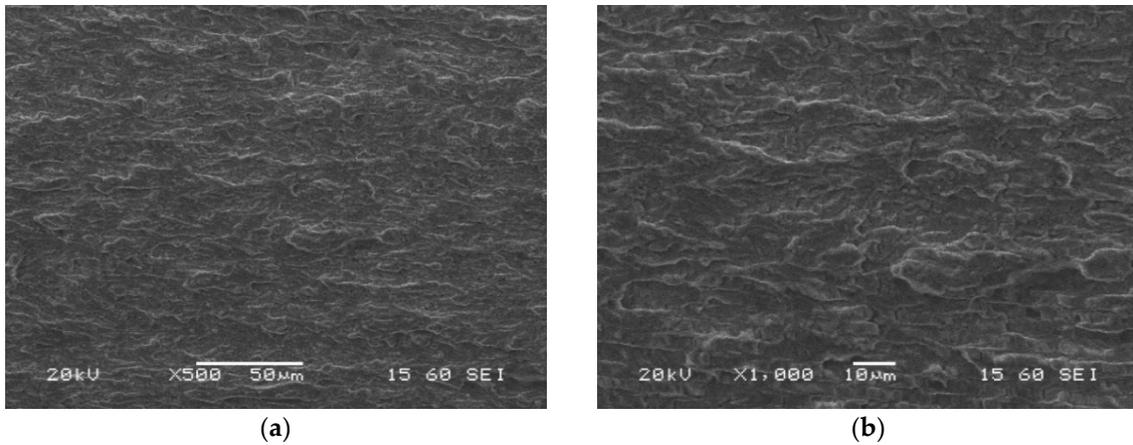
**Figure 18.** Microstructures of the fatigue pre-crack zone of the HAZ (specimen No. 6) captured after CTOD test using SEM; magnifications: (a)  $\times 500$ ; (b)  $\times 1000$ .

Similar features of the fatigue pre-crack zone (Figure 18), transition region (Figure 19) and crack propagation (Figure 20) were observed either for the parent material or HAZ. However, the characteristic effects noticed previously for each part of the fracture are visible at a lower scale. Secondary cracks and striations in the fatigue pre-crack zone (Figure 18) as well as the delamination-like areas in the crack propagation zone (Figure 20) exhibit smaller dimensions. In the area of the transient region of the HAZ,

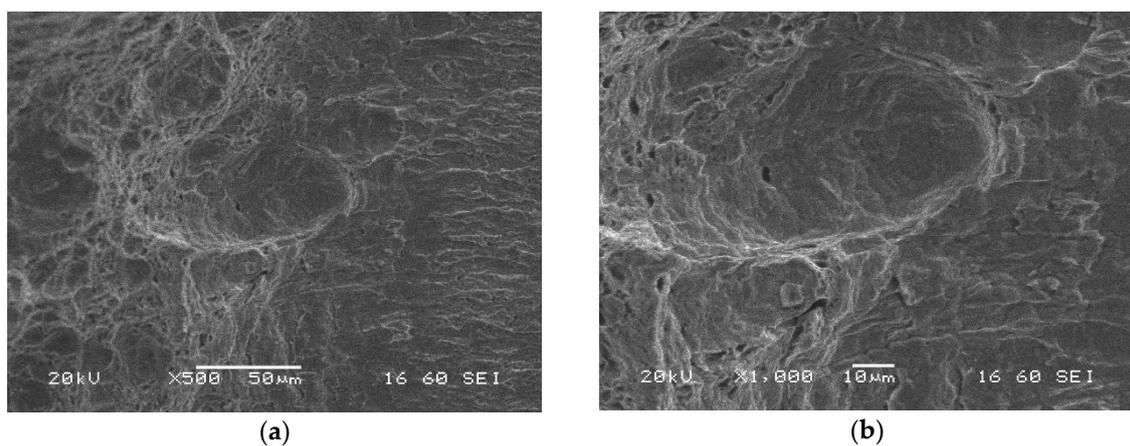
**Figure 19.** Microstructures of the transient (fatigue pre-crack and crack propagation) region of the HAZ (specimen No. 6) captured after CTOD test using SEM; magnifications: (a)  $\times 500$ ; (b)  $\times 1000$ .

larger perpendicular cracks appear in the loading direction (Figure 19). These changes in the fracture morphology can be explained by the carbide re-precipitation and microstructure homogenisation as a result of heat input accompanying the welding process.

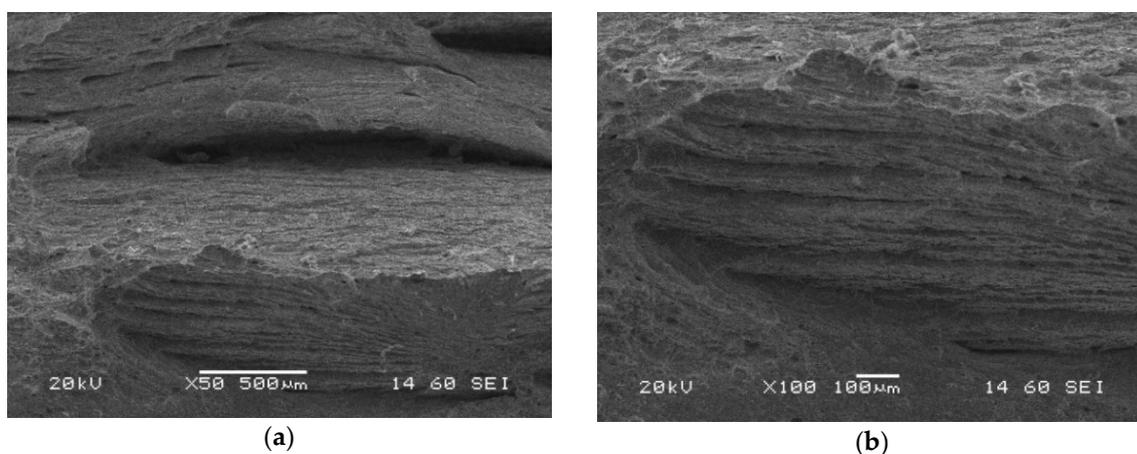
**Figure 20.** Microstructures of the crack propagation zone of the HAZ (specimen No. 6) captured after CTOD test using SEM; magnifications: (a)  $\times 50$ ; (b)  $\times 100$ .

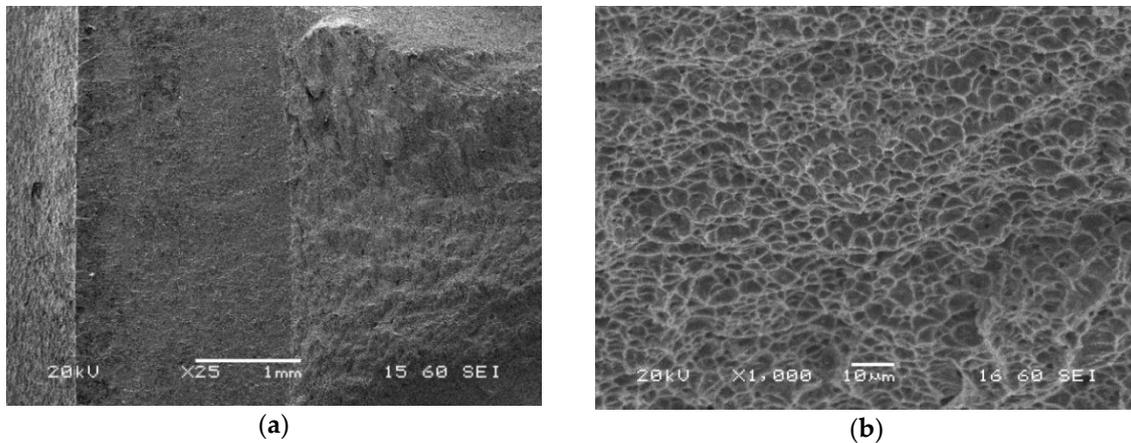
**Figure 21.** Microstructures of the zone located in the transition region of the weld (specimen No. 3) obtained during CTOD test using SEM; magnifications: (a)  $\times 25$ ; (b)  $\times 1000$ .

Contrary to these results, the zone was represented by the same features in the case of the weld, however, at a lower scale and with more regular distribution (Figure 21). The transient zone of the weld presents classical dimples that prove the ductile character of the region considered. The fracture morphology is isotropic without a delamination-like effect.

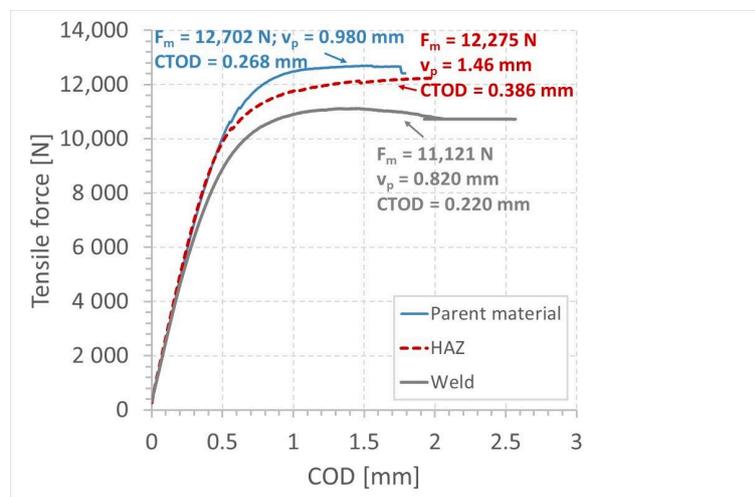
**Figure 22.** Force versus COD for: the parent material, HAZ and weld.

Despite the unstable crack growth in HAZ, the CTOD parameter in this zone took the highest value. It was equal to 0.386 mm (Figure 22). In comparison to values calculated for the parent material and weld, it was 37% higher.
